Non- destructive characterization of carbon fiber composite/Cu joints for nuclear fusion applications

Non- destructive characterization of carbon fiber composite/Cu joints for nuclear fusion applications / Casalegno, Valentina; Salvo, Milena; Ferraris, Monica; Smeacetto, Federico; Merola, M; Bettuzzi, M.. - In: FUSION ENGINEERING AND DESIGN. - ISSN 0920-3796. - 83:(2008), pp. 702-712. [10.1016/j.fusengdes.2008.04.005]

Several non-destructive testing methods, lock-in thermography, ultrasonic inspection, microtomography and microradiography, were used to assess the manufacturing quality of joints between carbon fiber reinforced carbon composites and Cu/ CuCrZr.

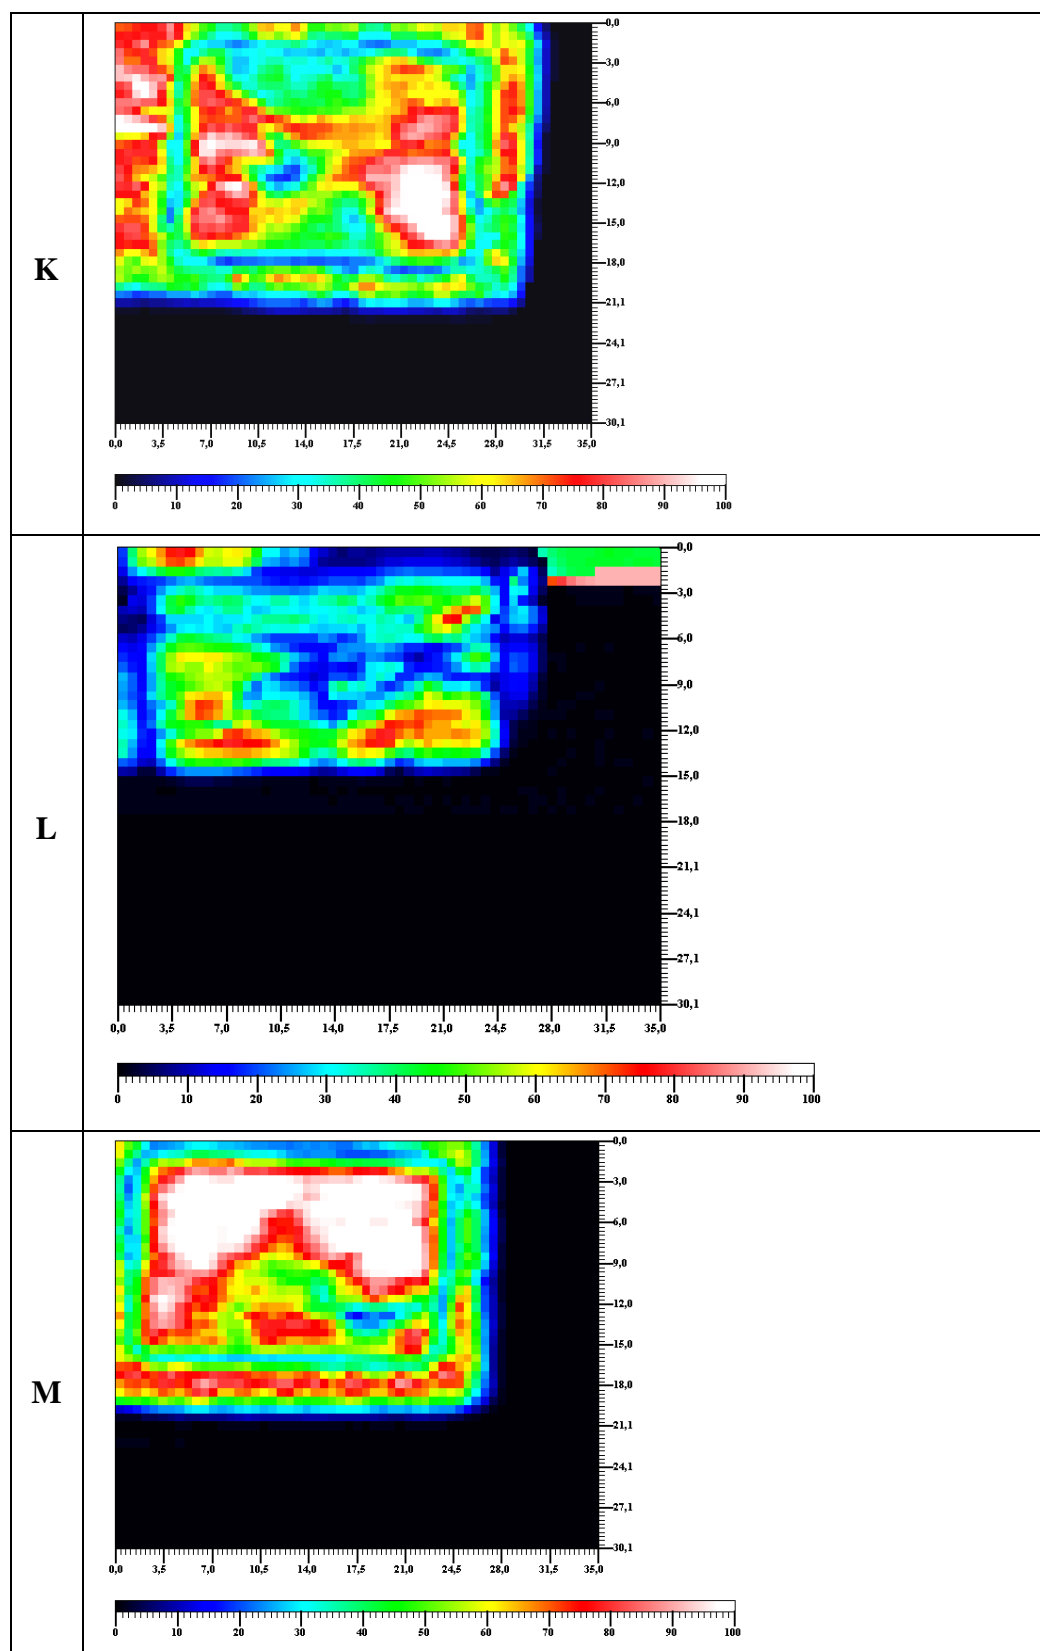
Figure 1 shows C-scans of each sample. Concerning sample K, it is possible to notice a significant echo (any sound from pulse that returns to the transducer) which means that defects through the specimen thickness reflect the sound, back to the transducer. White zones probably indicate a detached interface. A-scan in suspected detached region point out large echo and several reflected echoes; green/blue areas signify good joint interface.

With reference to sample L, one can note that, as for sample K, detected defects are located in the lower region of the samples, probably at interface CFC/Cu (yellow-red areas). Further tests (not reported here) showed an echo most likely due to Cu/CuCrZr interface that hides partly CFC/Cu interface. C-scan of sample M shows possible large defects at interface CFC/Cu, while only lower region (green area) looks not detached.

Figure 1 C-scan of a CFC NB31/Cu/CuCrZr joined sample

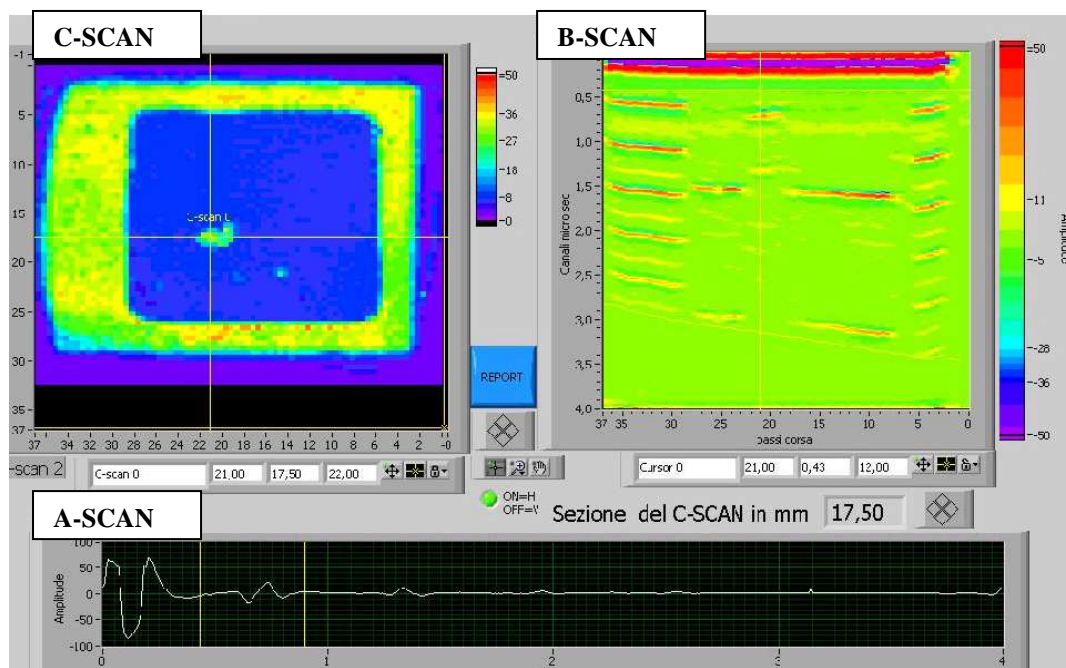
C-scan in area of sample K (figure 2) pointed out a defect at Cu/CuCrZr interface; defect sizes are limited (about 2 mm^2); B-scan corroborates defect localization (echo at Cu/CuCrZr interface hides echo at Cu/CFC interface).

Figure 2 Defect at Cu/CuCrZr interface in sample K

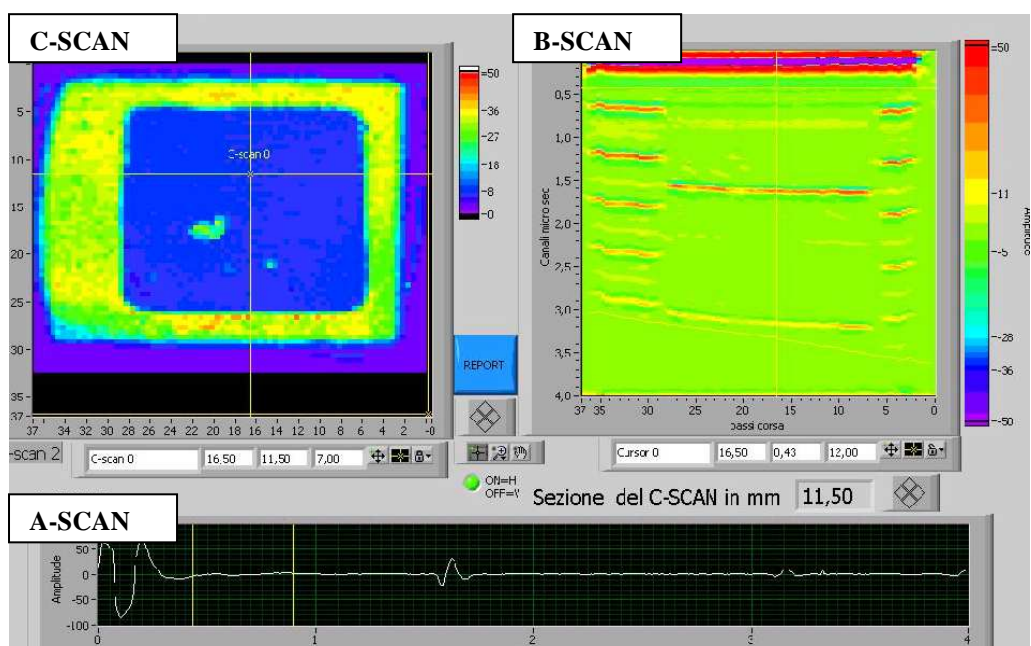
As a comparison, C-scan of a defects free area is shown in figure 3; it can be distinguished the signal at Cu/CFC interface at 3.5 mm (about $1.5\mu\text{s}$ in the B-scan).

Figure 3 Maps of ultrasonic investigation on sample K; defect free CuCrZr/Cu interface gets observable CFC/Cu interface

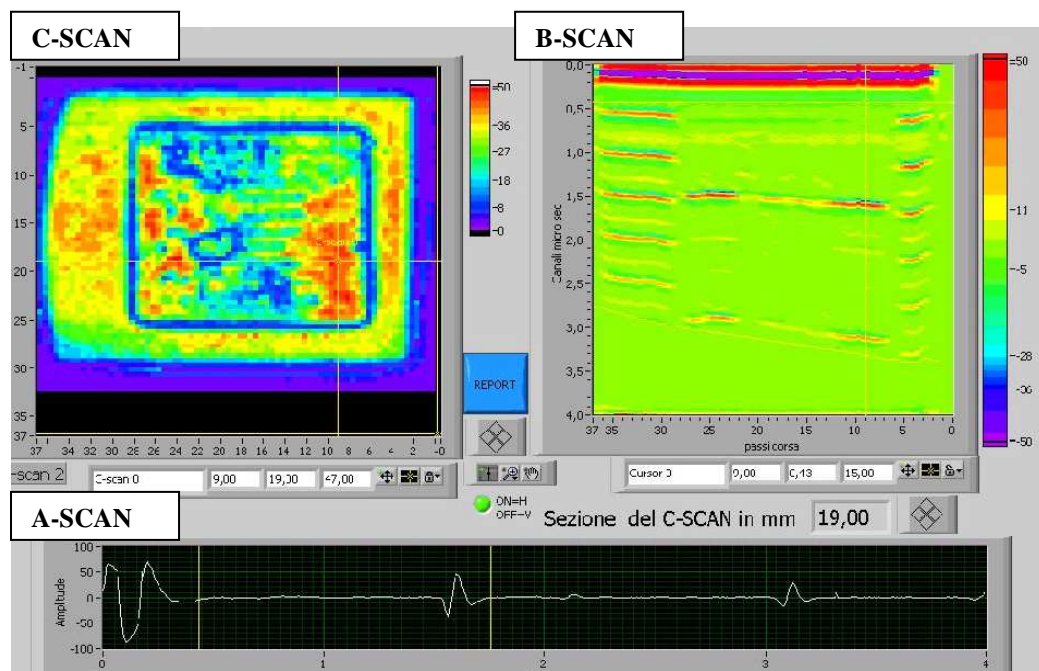
C-scan reported in figure 4 was obtained with an extended window over 3.5 mm in depth. Defects are localized on the left and on the right side of the sample at CFC/Cu interface (red areas). Blue areas show good joint interface (no defects).

Figure 4 Defects localization (red color on the C-scan) at Cu/CFC interface for sample K

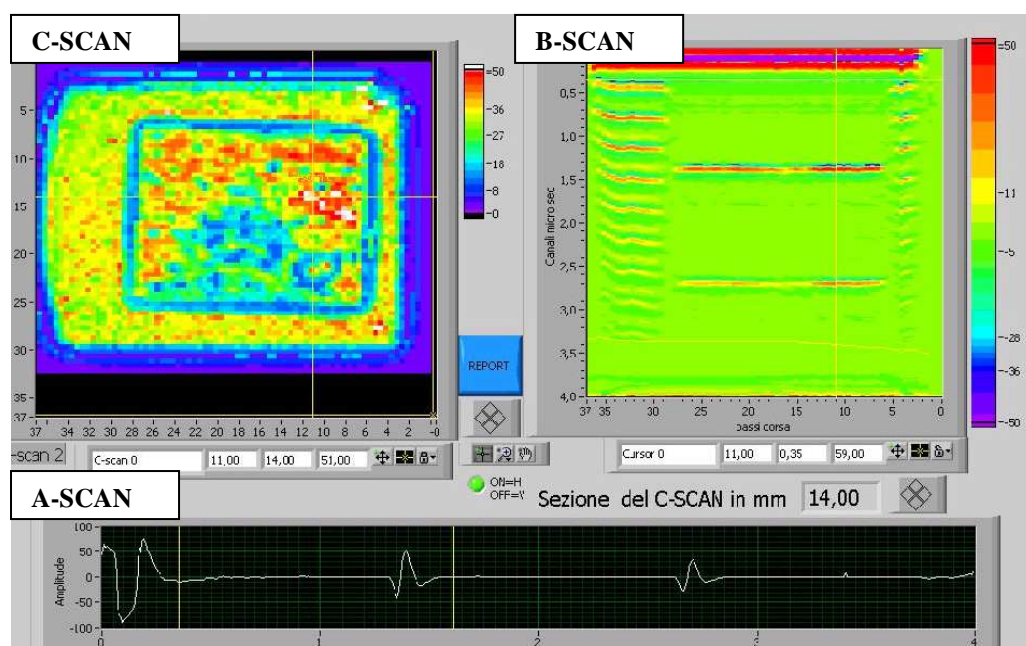
Concerning test on sample L, reference signals have been determined as for sample K (about 1 mm Cu/CuCrZr interface and about 3 mm Cu/CFC interface that correspond to $0.43\text{ }\mu\text{s}$ and $1.3\text{ }\mu\text{s}$ on time axis respectively). Figure 5 shows discontinuities at CFC/Cu interface. Cu/CuCrZr interface is quite continuous; only limited area (figure 6) indicates a defect.

Figure 5 CFC/Cu interface scan of sample L : defects are located in yellow-red areas

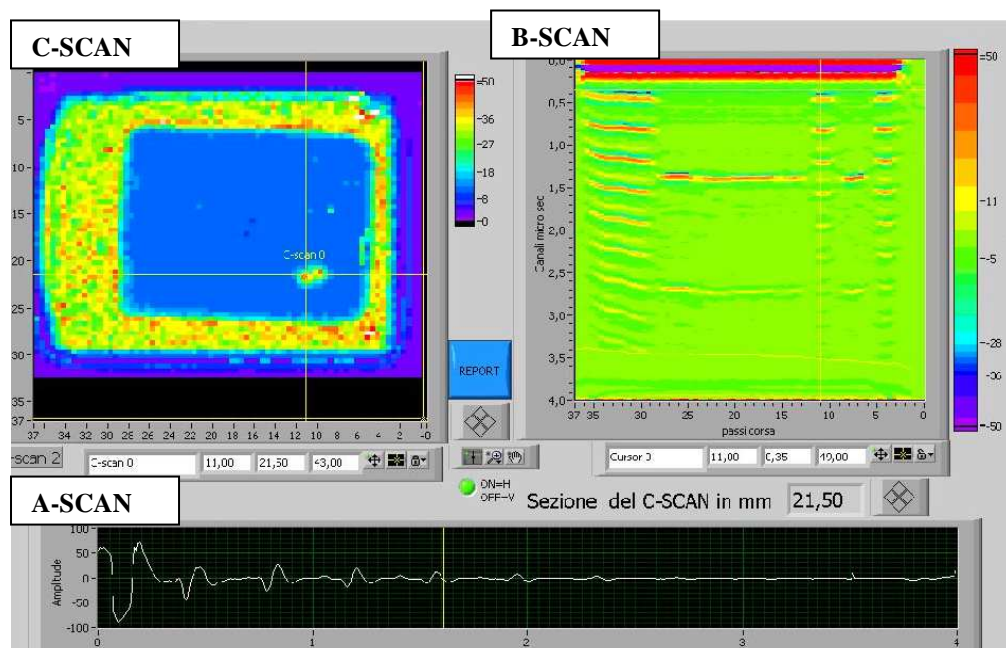
Figure 6 Defect at Cu/CuCrZr interface (yellow/red dot in blue area) in sample L

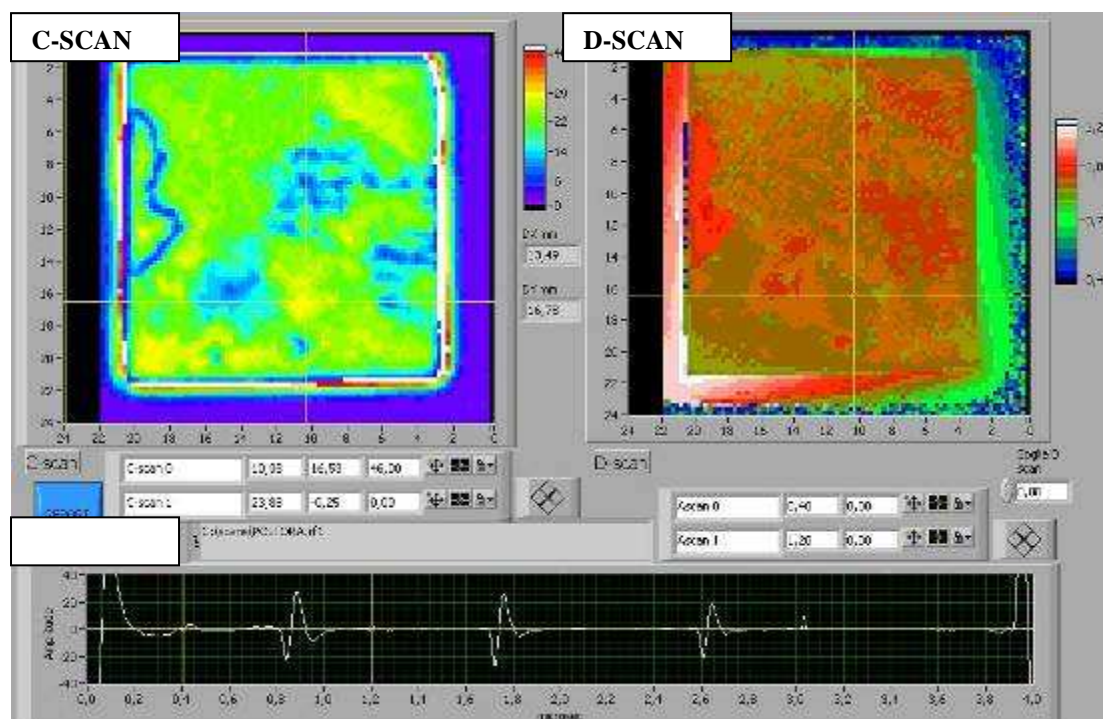
Figure 7 shows a comparison between C- and D-scan for sample D ; if the cursor is directed on yellow area, signal amplitude is more than 20 (relative amplitude); if it's directed on blue area, signal amplitude is significantly lower (less than 10); sample E shows the same behavior.

Typically, good joints show low echo values (relative amplitude below 8, showed in blue). As a consequence, samples D and E seem to be acceptable only in areas corresponding to blue zones on C-scans; since most of the maps are yellow-green, it could be concluded that samples quality is low. On the contrary, red areas are not present on the maps thus indicating that Cu and CFC are not detached.

Actually, the samples quality appears to be poor; this is probably due to weak interface but it cannot be excluded that some porosities in cast Cu are localized at the interface between copper and CFC and they act as a void at interface.

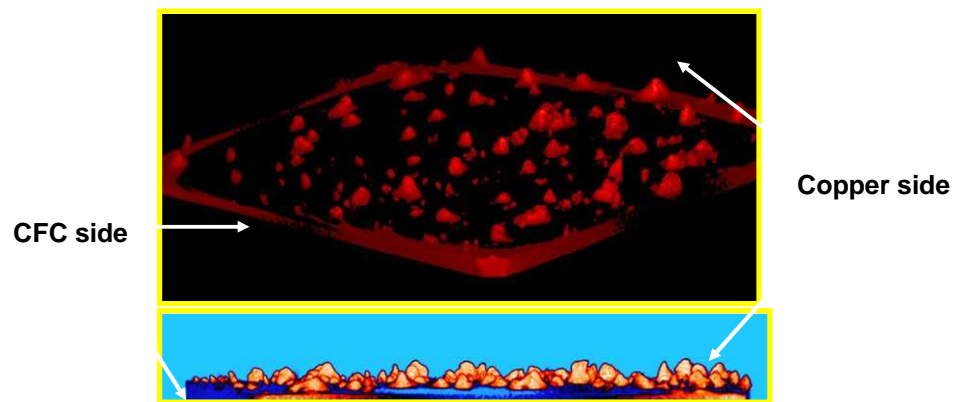
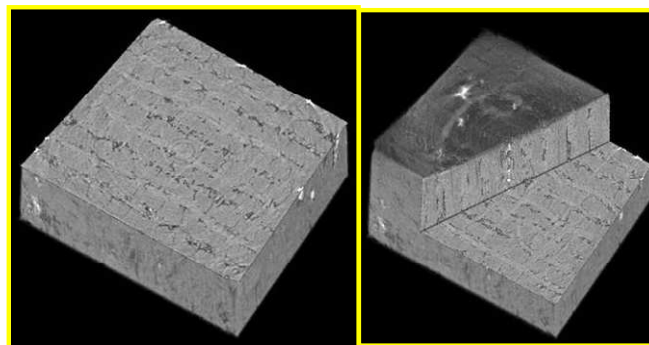
In figures 8 and 9 are shown some tomography of sample M achieved with 85 kV peak energy with 0.8 mm Cu filter and 45 kV without filter respectively. In the first one, the copper layer is clearly observable, where the copper “finger-like” pattern at CFC/Cu interface can be distinguished, while in the second one, the CFC structure is more evident.

The effects of highly absorbing materials on tomographic reconstruction could lead to some “star-artifacts” (white rays radiating away from a spot, a typical star-like pattern also known as metal-artifact.) on the surface of the analyzed sample; they correspond to “lack of information” zones (figure 10). These spots could be explained as voids at CFC/Cu interface but actually they are reconstruction artifacts.

In order to avoid these artifacts, X-ray energy should be enhanced; nevertheless, there will be a lack of information on CFC bulk, since it's less absorbent. In this case, the X-ray beam can penetrate the CFC bulk but there is not enough contrast to detect the CFC/Cu interface.

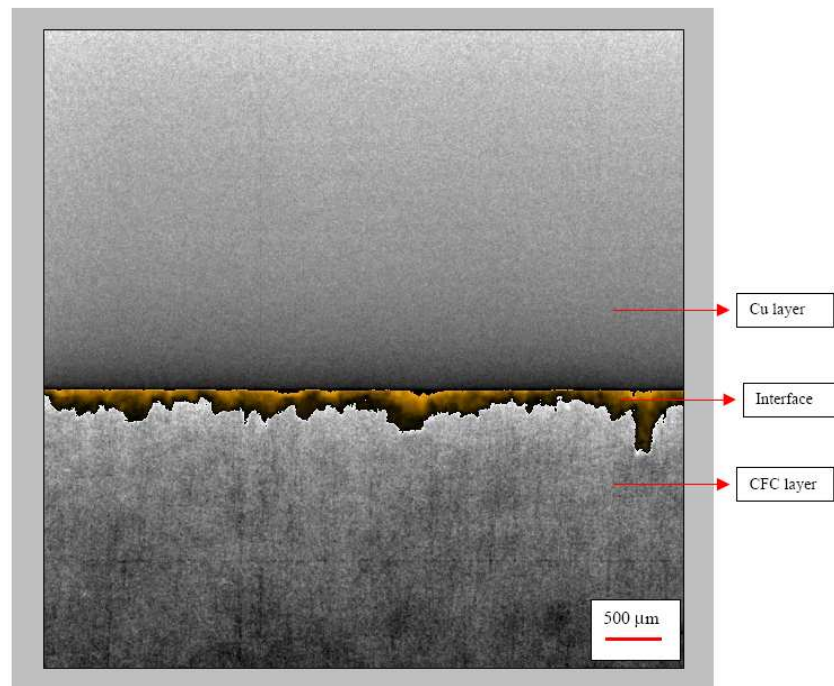
Figure 11

X-ray micro-radiography along the 19 mm side of the examined area (figure 11) shows the interface between CFC and copper; the structure suggests that molten Cu penetrates into CFC substrate in a “finger-like” pattern.

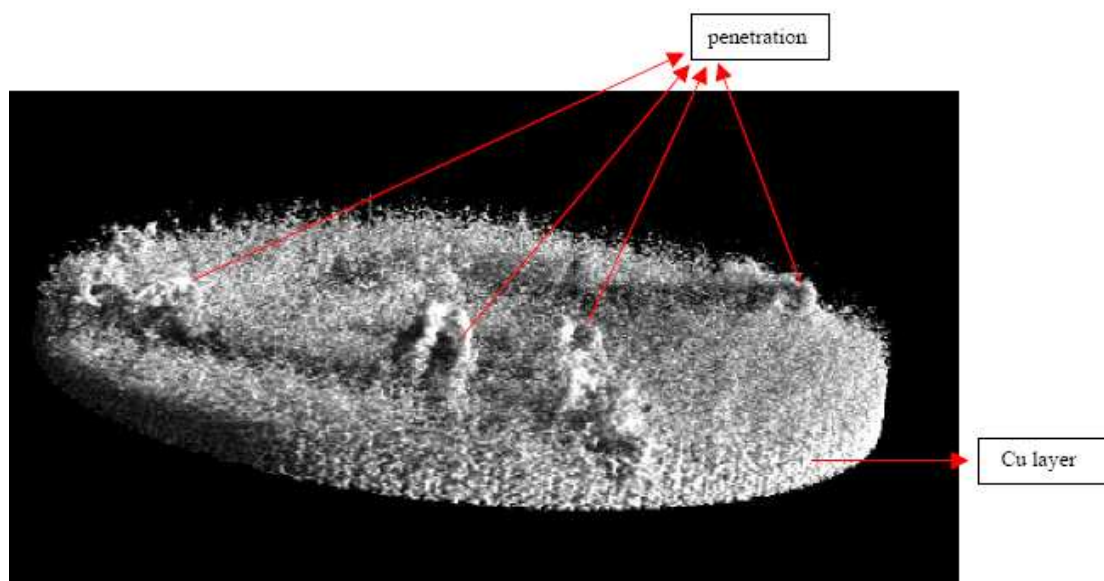
Figure 12 shows a tomographic reconstruction of the interface region, where CFC was intentionally removed by image processing; the “finger-like” penetration of Cu in CFC bulk is outlined.

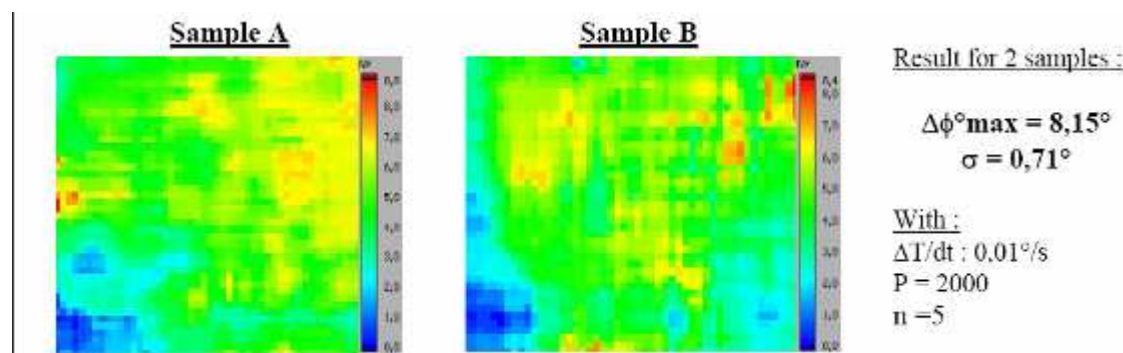
Figure 13

Phase contrast cartography was measured for samples K and L (figure 13); these phase contrast values are in the experimental noise.

The reduced heat transfer capability of some areas of the joined samples, in particular due to the presence of flaws at the interface CFC/Cu can be detected by this technique; not bonded areas indicated by non-homogeneity of the values of the phase contrast cannot be detected in figure 13. As a consequence no defects on K and L samples were detected by means of this technique, in contrast with results of ultrasonic tests.

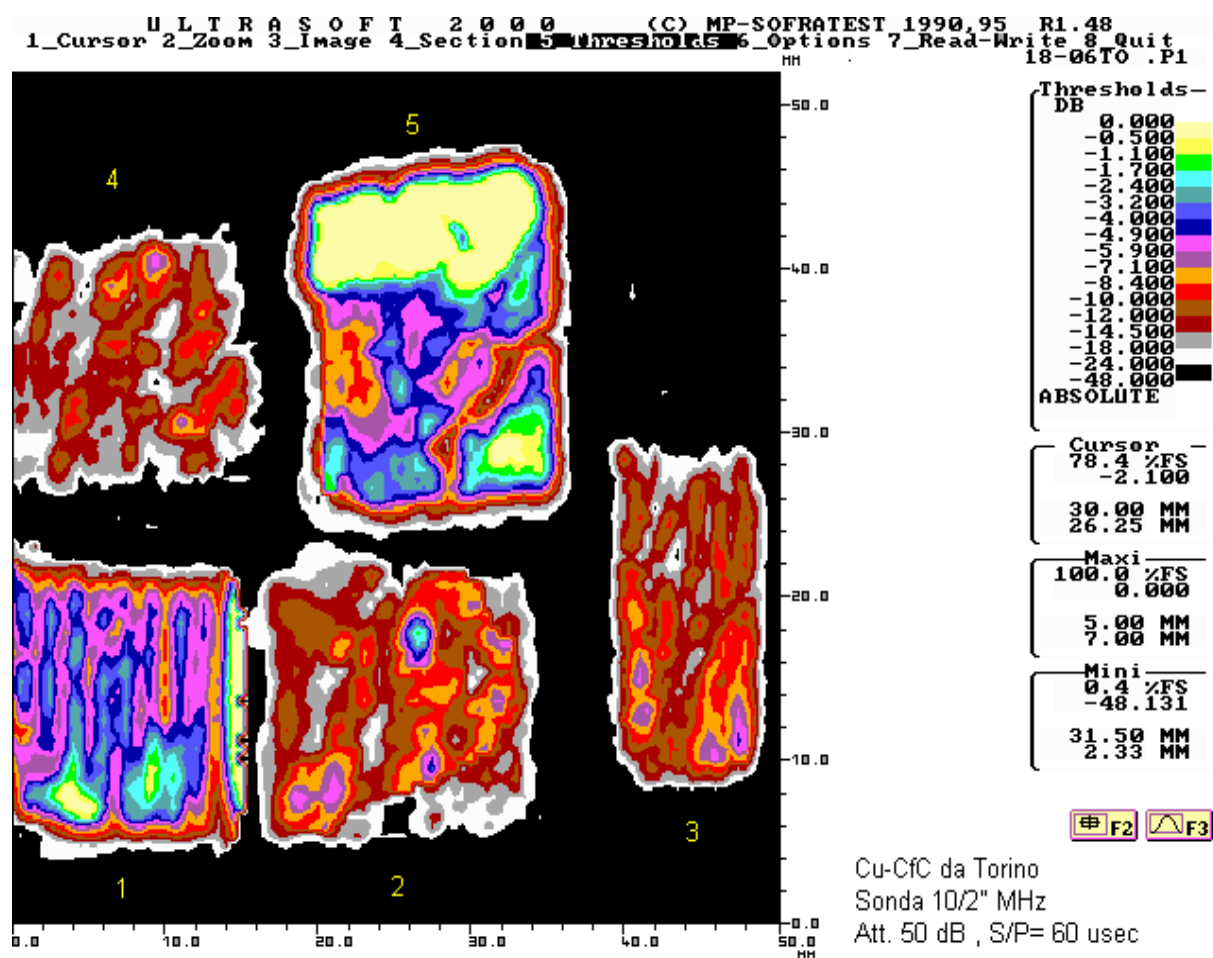
Figure 14

Ultrasonic inspection gave divergent results also for examination of CFC NS31 (silicon doped carbon-carbon) joined to Cu; 5 samples were tested before thermal fatigue test. Sample 1 and 5 (figure 14) showed many defects, especially sample 5 in the upper part (yellow area); these two samples sustained 30 cycles during thermal fatigue test and fracture surface analysis didn't reveal significant detached areas at interface.

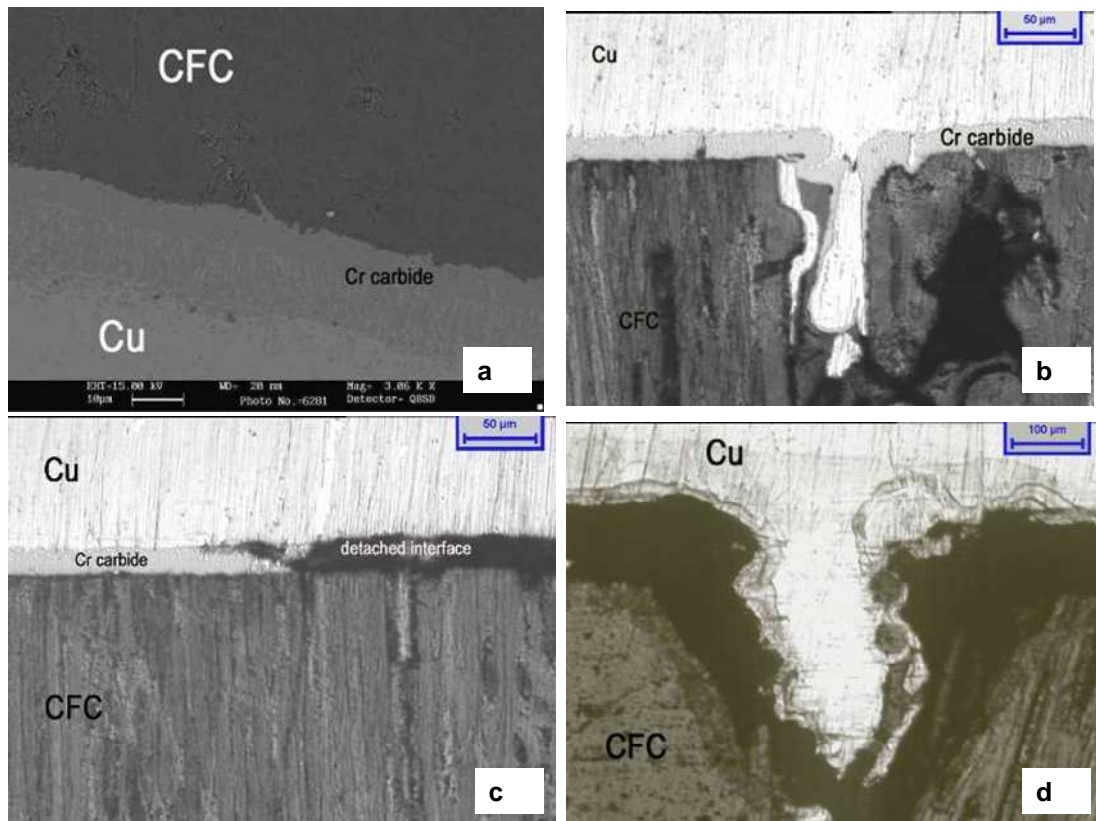
With regard to samples D and E (prepared with Ar overpressure, not subjected to thermal fatigue tests, tested as prepared) optical analysis of cross sections of the joints (figures 15 b,c,d) shows detached interfaces along some direction where defects were supposed to be, while CFC/Cu interface is continuous in some areas of the joint where the NDT saw large defects.

Results of metallographic inspection on samples D and E agree partially with ultrasonic inspection that foresaw a weak adhesion between CFC and copper; the CFC/Cu interface is partly detached. Conversely, some areas indicated as discontinuous by US analysis look sound (figure 15 b).

Figure 15 a) SEM magnification of CFC/Cr carbide/Cu interface of sample M; b) Optical micrograph showing defect-free cross section of sample D; on the right, it is possible to identify a pore in the carbon matrix; c) Optical micrograph of sample D showing detached interface between CFC and copper on the right, d) Image from optical microscopy characterization of sample E: there is a significant detach at CFC/Cu interface (about 600 μm)

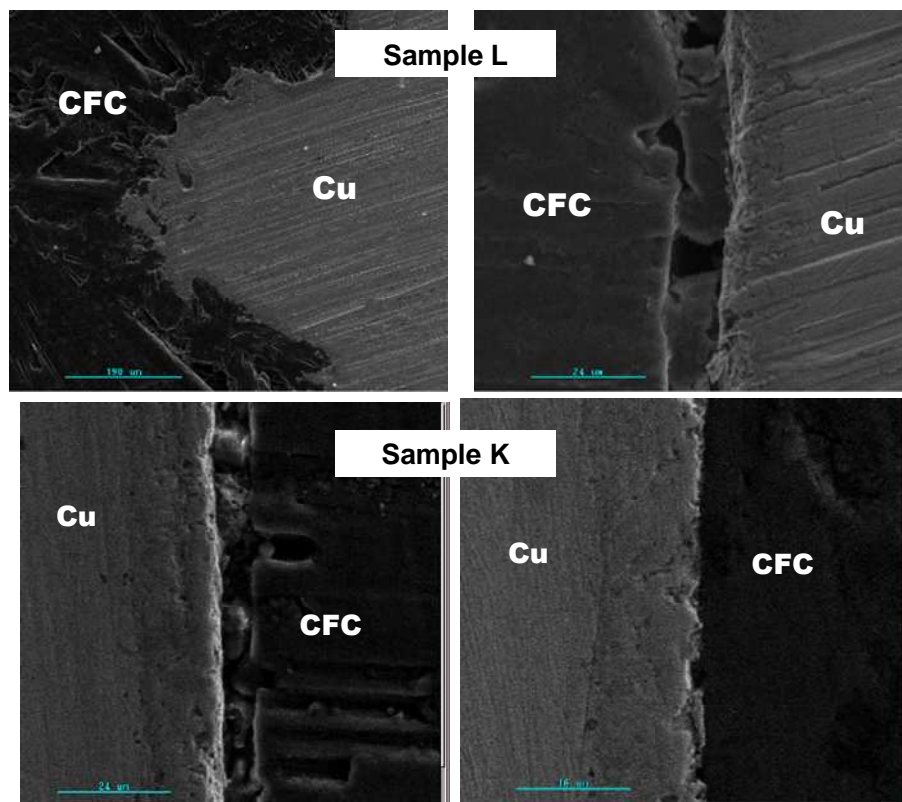
Figure 16

SEM and optical micrographs on samples K and L (figure 16) revealed some voids at CFC/Cu interface, but at the same time supposed detached areas are not confirmed by morphological inspection; as a consequence metallographic analysis doesn't agree completely with results from ultrasonic inspection and ultrasonic analysis disagrees with lock-in thermography.

It can be explained if discontinuities at CFC/Cu interface are small (reduced gap between CFC and Cu surfaces). In that sense, the thermography map can't point out discontinuity at the interface, since thermal response of the joint is quite good; on the contrary mechanical strength should be low.
