# **Large N.G. explosion and fire involving several buried utility networks**

N. Piccinini<sup>(1)</sup>, R. Tommasini<sup>(2)</sup>, E. Pons<sup>(2)</sup>

This paper describes an accident (explosion and natural gas fire) that occurred in Turin (Italy), in which power distribution cables, tramway network feeding cables and a gas pipe were involved.

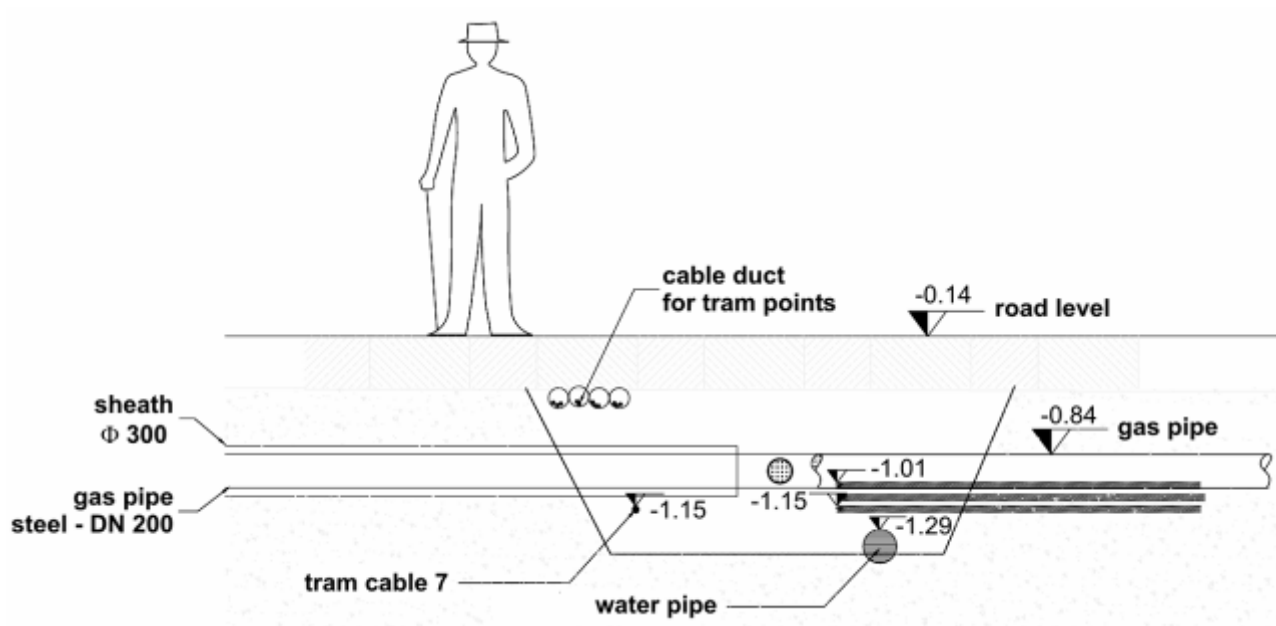
Fig. 1 – Depth survey

No trace of the gres pipe which protected tram cable n. 7 was found near the gas pipe. This was probably damaged and removed during previous works (perhaps when the old cast iron gas pipe was substituted by the steel pipe in 1980). Moreover, the space between the gas pipe, the water pipe and the tram cables 1-6 was not sufficient to allow the gres pipe to cross (see Fig. 1 for details).

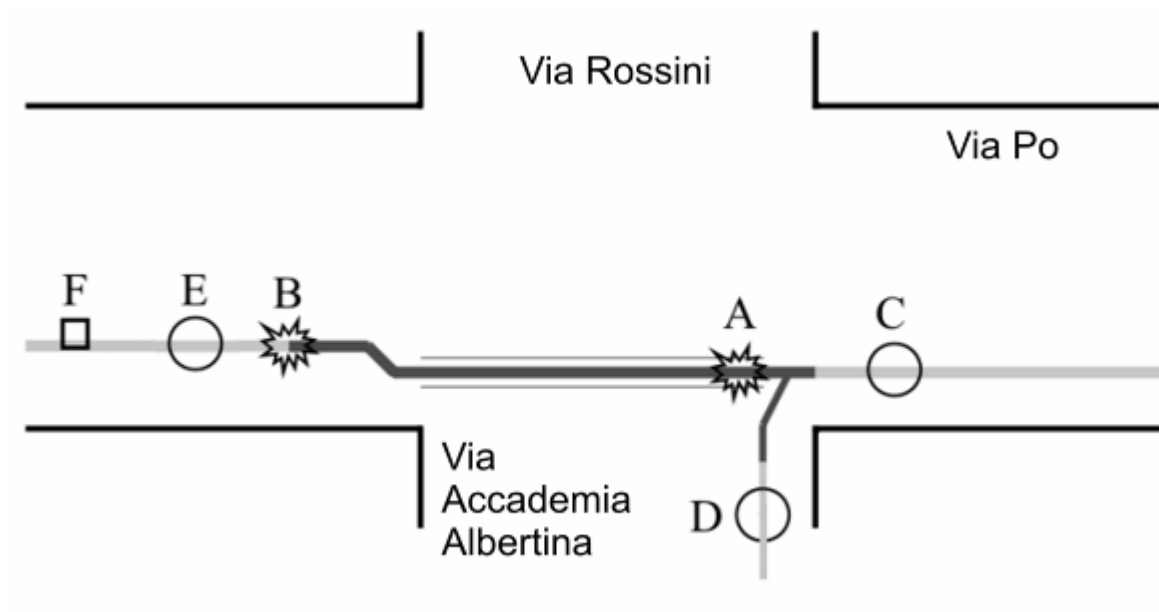
**Fig. 2 – Gas pipe damage**

Two damaged points, marked “A” and “B” in Fig. 2, were found along the gas pipe:

During the inspections after the accident, a water leak was found, at about 100 m from the crossroads where the accident happened; the water leak was caused by an old damaged lead pipe in the manhole marked with the letter “F” in Fig. 2. The street is slightly sloping, and the water therefore flowed through the PVC pipes of cables 1-6 and reached the accident area, where the terrain was flooded. This water flow accelerated the damage of cable 7, which started to leak current to the ground, through the gas and water pipes. In a vicious circle, the fault current produced heat, the heat accelerated the cable damage and the fault current increased.

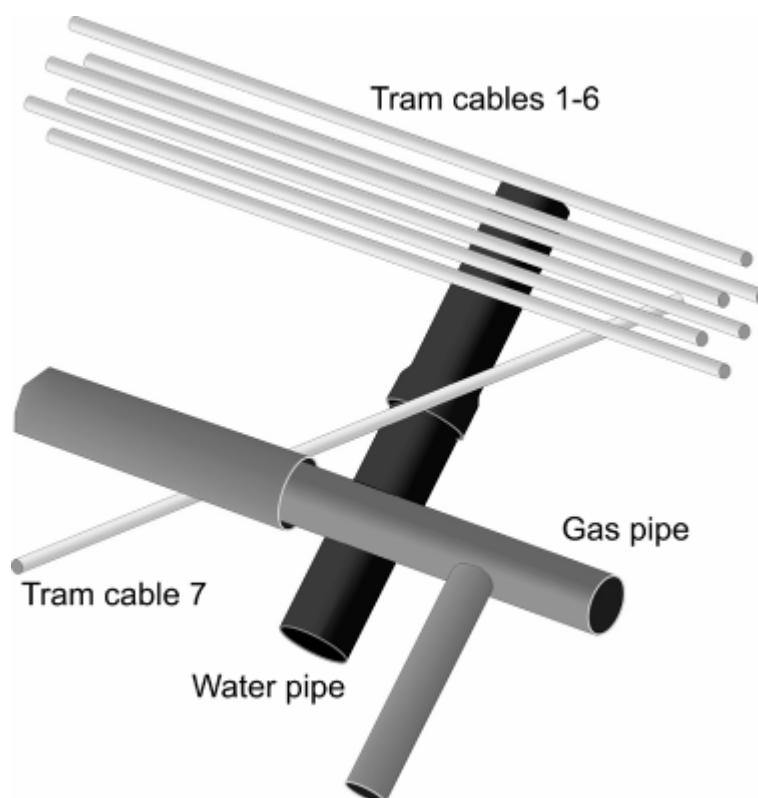
**Fig. 3 – Lower buried facilities**

There were many buried utilities below the road where the accident took place; from the ground surface and going downwards (for a detailed depth survey see Fig. 1) there were: traffic lights, tram points, public lighting, power distribution and tram network power cables, gas pipes and water pipes. The layout of the lower installations is described in Fig. 3.

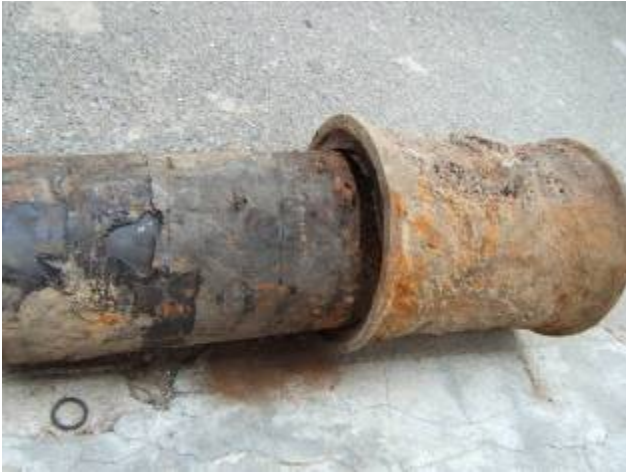
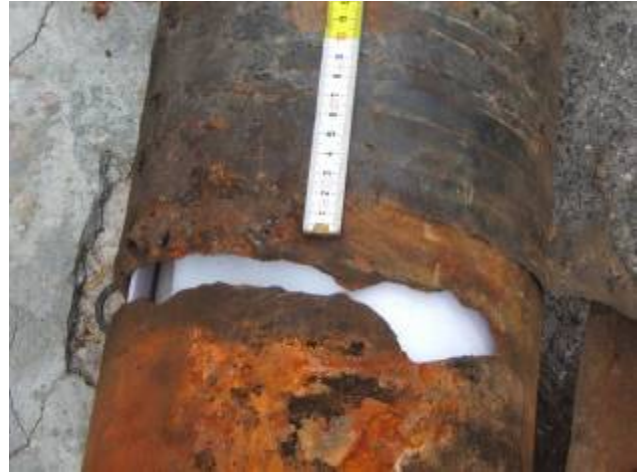
- damage point “B” was found at the junction between the steel pipe used to cross the road and the older cast iron pipe (see Fig. 4 and Fig. 5);
- damage point “A” was found where tram cable n.7 crossed the steel gas pipe (see Fig. 6).

**Fig. 4 – Gas pipe damage “B”**

**Fig. 5 – Gas pipe damage “B”**

Moreover, the current flowing through the gas pipe also caused damage (due to corrosion and/or arcing) to the junction between the cast iron pipe and the steel pipe.

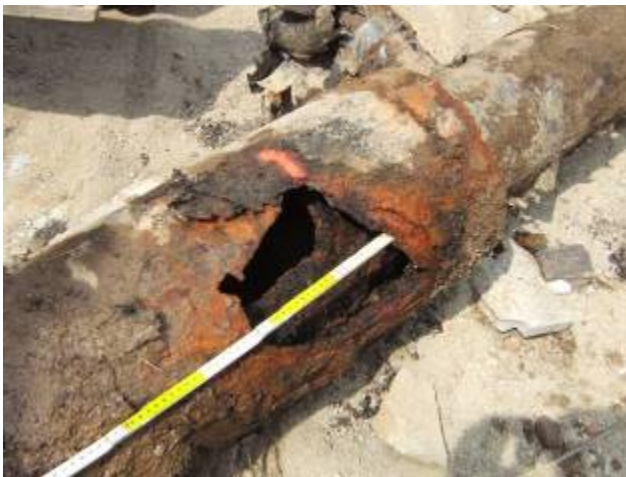
**Fig. 6 – Gas pipe damage “A”**

For the above mentioned reasons, tram cable n. 7 crossed the gas pipe and the water pipe without any protection and was almost in contact with them.

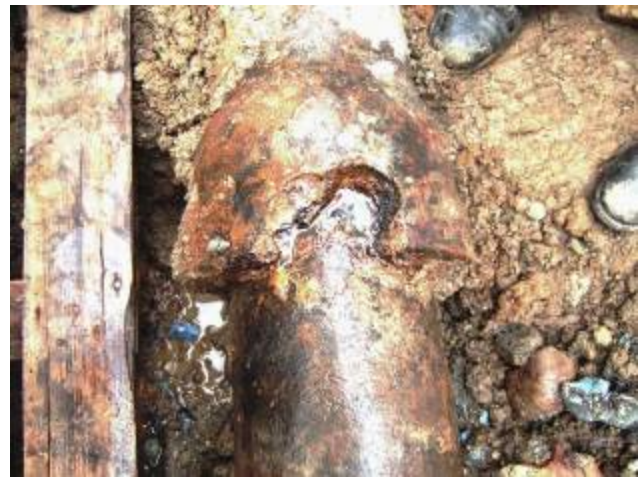
**Fig. 7 – Water pipe damage**

The water pipe, which crossed the other facilities at a greater depth, was made of cast iron and was damaged by an electric arc on a joint, where cable 7 crossed it (see Fig. 7). This pipe was not totally perforated, probably thanks to the cooling effect provided by the water flowing inside.

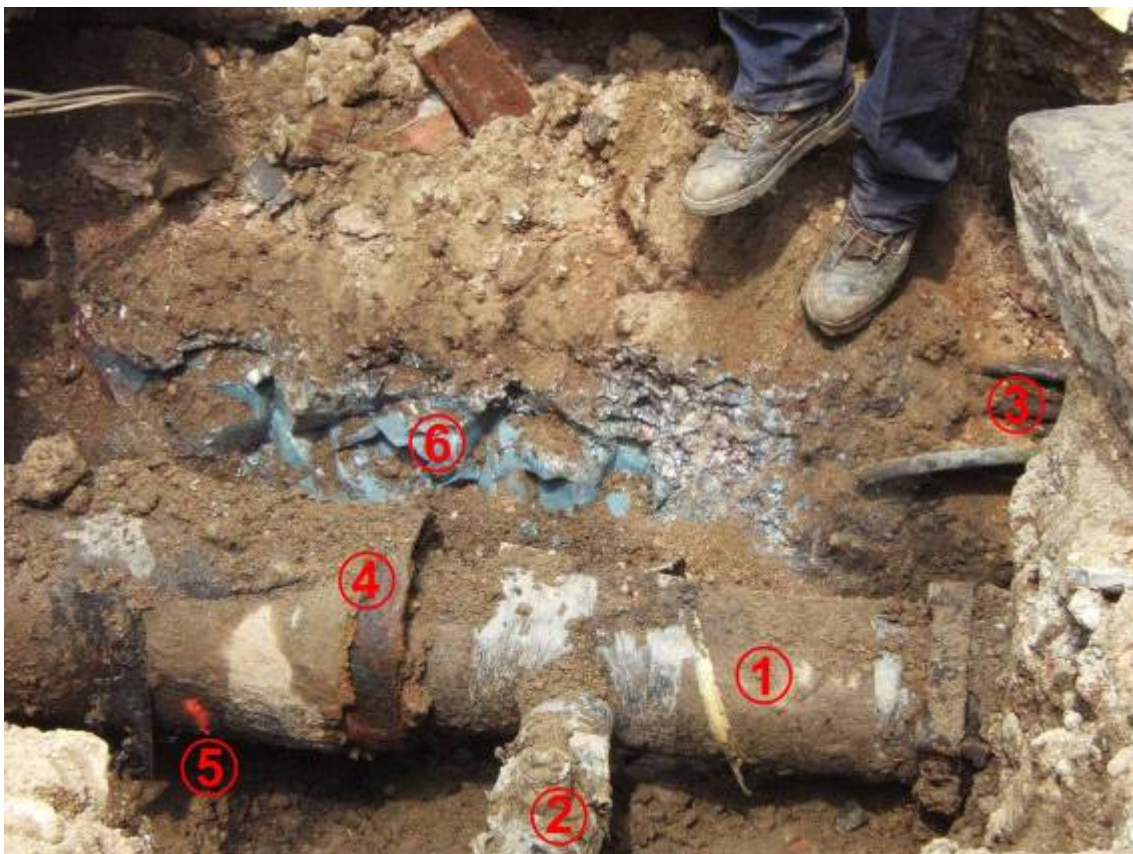
**Fig. 8 - Trench**

While digging the trench where damage “A” occurred (see Fig. 8), it was found that tram cables 1-6 were fused together with the soil, and formed a vitrified mass (n. 6 in Fig. 8).

The fused cable ends were also visible (n. 3 in Fig. 8).

- the gas pipe (n. 1, 2);
- the gas pipe sheath (n. 4);
- the damaged point “A” (n.5).

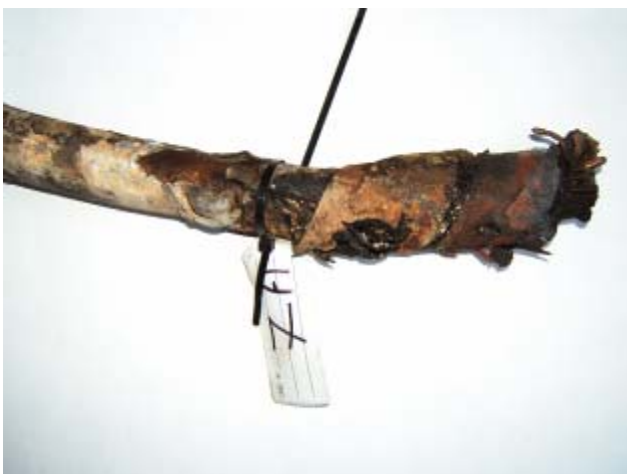
**Fig. 9 – Cable 7**

The gres protection, however, was not found in the zone in which cable 7 crossed the gas and water pipes. It had probably been broken or removed during previous maintenance works.

The damaged terminals of the cables are shown in Fig. 9 and Fig. 10.

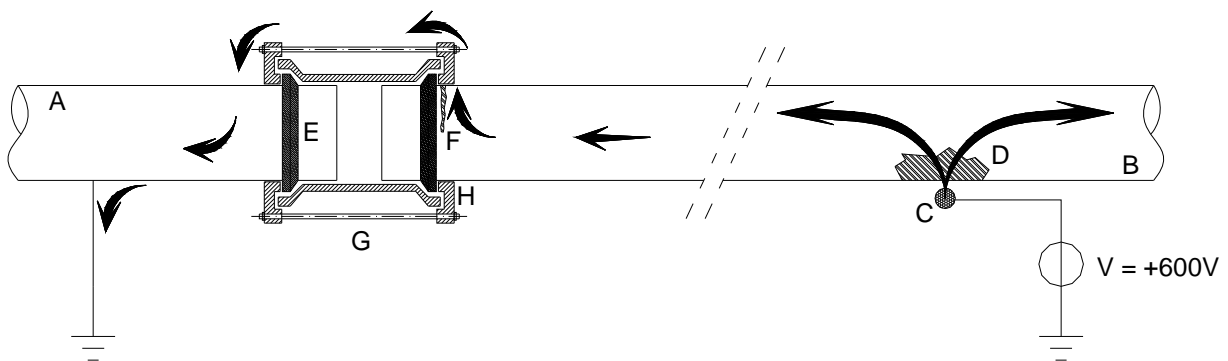
**Fig. 11 – Path followed by the electric current**

The damages to the gas and water pipes where GTT cable 7 was crossing are certainly not due to corrosion but to the high current flow because it was directed from the cable into the pipes. The path followed by the fault current is shown in Fig. 11, where:

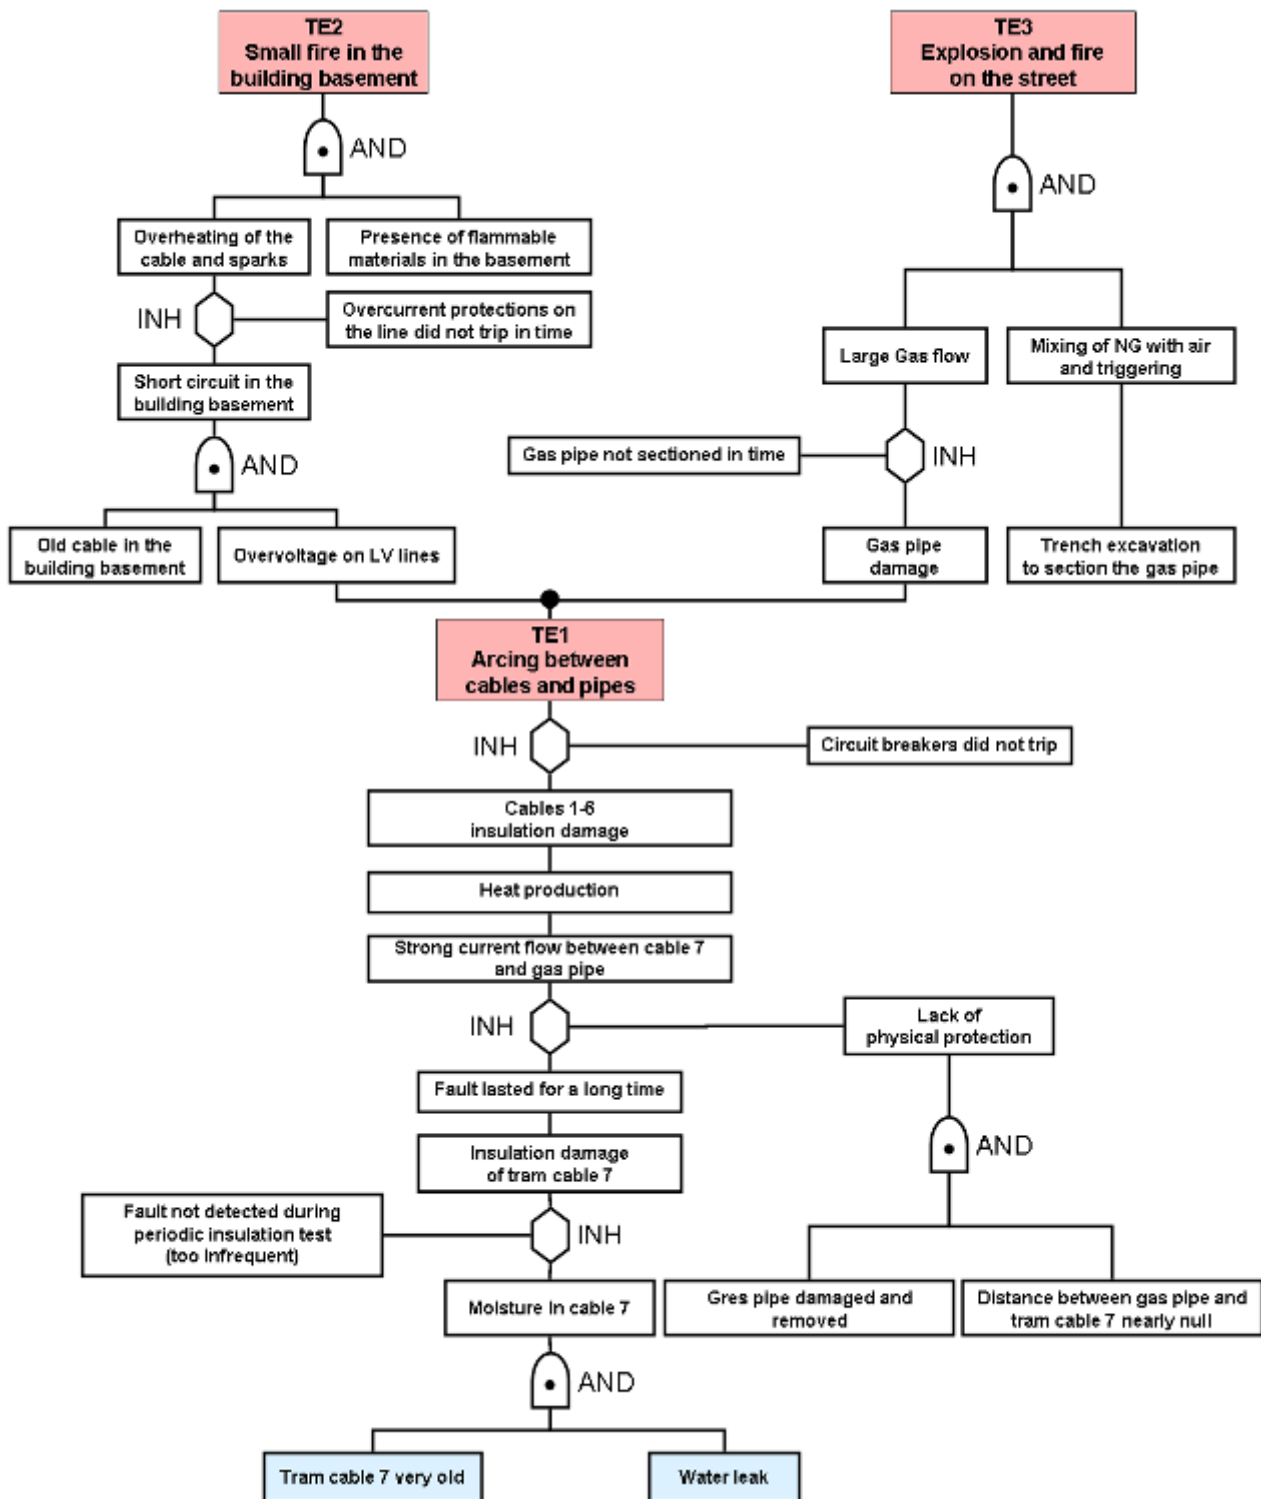
Fig. 12 – ISD presenting the domino effects and the failure of the protection systems

It is interesting to notice the domino effect which, from a small electric fault and despite the many protection levels, led to the natural gas explosion and fire. Actually, starting from a

modest event (600 V electric cable loss of insulation), which most likely lasted for months, the aforementioned accident was reached in a crescendo of domino effects. This sequence has been represented by an Incidental Sequences Diagram (ISD) (Fig. 12) in which the failure of the different protection systems is highlighted (Piccinini and Ciarambino, 1997). These protection systems were mostly based upon the strict respect of procedures both in the installation and in the following maintenance of the different utilities. In general the development of an accident or any undesired event (Top Event) can be ascribed to a process malfunction AND to the failure of both the automatic and manual protection systems; these may be due to different initiating events OR human errors of different kind. The representation of Fig. 12, which is called Incidental Sequences Diagram (ISD), is a causes/consequences logical graph similar to the better known Fault Tree representation. The construction of these graphs proceeds downwards with small logic steps from the Top Events to the Initiating Events, while their reading, or their numerical solution, proceeds in the opposite way: upward from the Primary Events towards the Top Event.

The accident was caused by the fact that many cables and pipes were buried at a limited distance from each other, without any proper protection. With reference to Fig. 12, the electric fault, involving tram cable n. 7, a water pipe and a gas pipe occurred because:

- the gres protection pipe was not present where the power cable crossed the two pipes;
- the distance between the two pipes and the cable was nearly null;
- the tram cable was quite old (installed in 1956).
