Seismic history of the church of San Pietro di Coppito in L'Aquila

Seismic History of the Church of San Pietro Di Coppito in L'Aquila

Renato Masiani, Department of Structural Engineering and Geotechnics, La Sapienza University of Rome, via Gramsci 53, Rome 00195, Italy

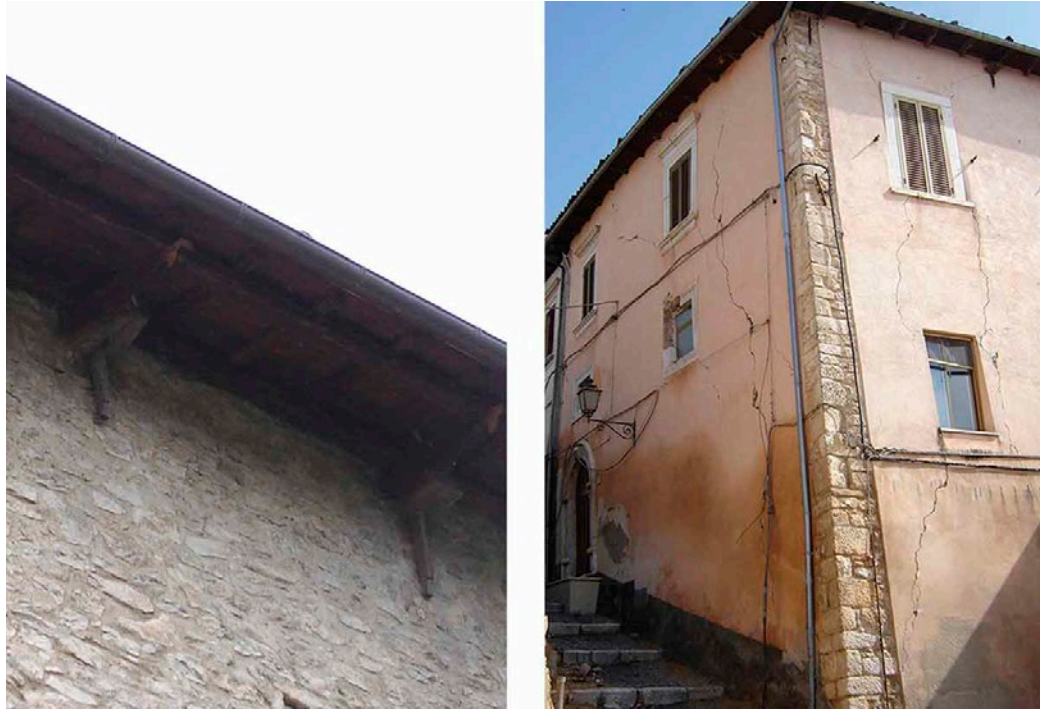
Fig. 3. Paganica (AQ): the tie-beams of the roof trusses of the nave are systematically anchored (pegged) to the outside part of side walls with wooden pegs (on the left). Poggio Picenze (AQ): the systematic use of metal tie-rods and wooden logs, and the wedge shape of the outside walls, prevented the out-of-plane collapse of the facing walls (and determined their in-plane cracking (on the right)).

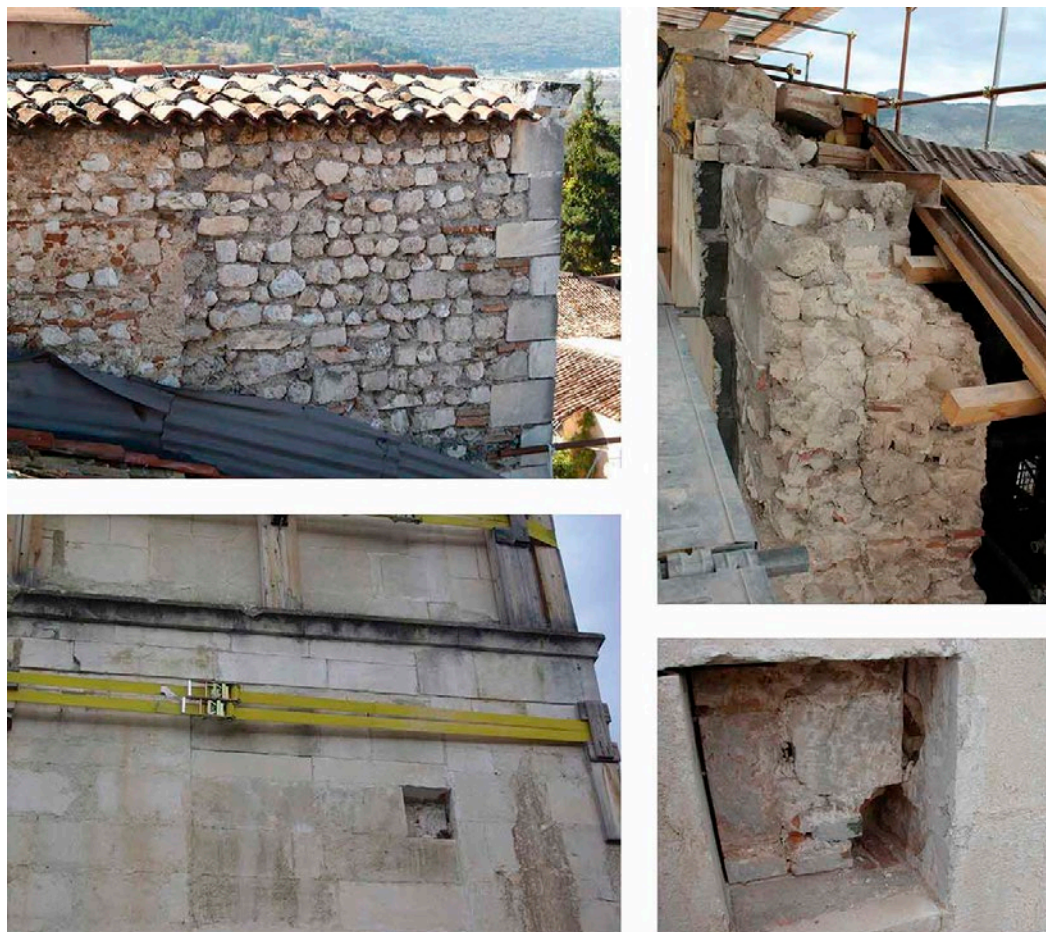
Fig. 10. Top: (on the left) the surviving false front of the façade (we can clearly see where the new masonry added by Moretti, rough stones laid on cement mortar, joins – without toothing out – to the original masonry, wedged with bricks and lime mortar, like the masonry visible on the façade wall inside the church); (on the right) the thickening of the nineteenth century façade obtained by Moretti by simply placing a new wall side by side with the existing one.

Bottom: direct survey of the stone facing in the façade by removing single stones from the cladding; on the right we can recognize the block bonding of the pilaster's ashlar in the rear masonry wall and the thick layer of cement mortar where big stone slabs are laid.

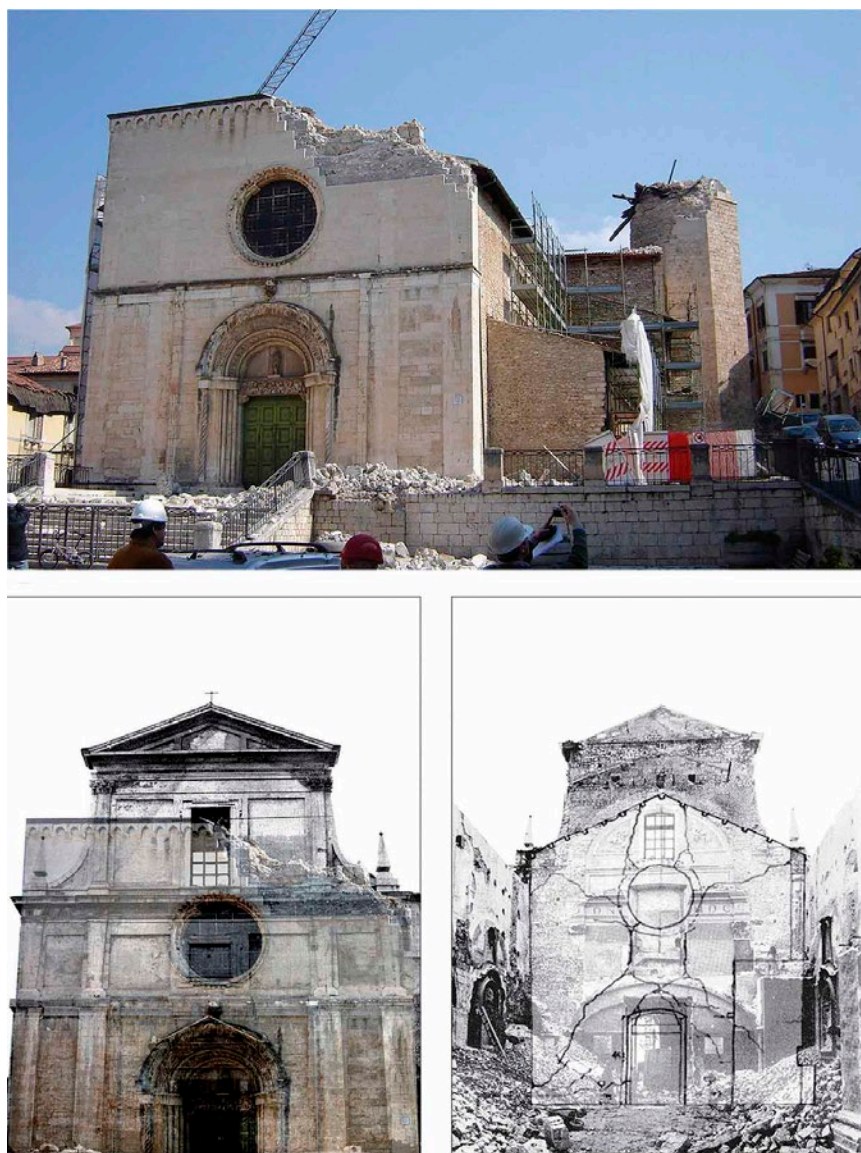
The longitudinal actions caused the damage to the bell tower and the upper part of the façade. The façade has come away from the two side walls of the church, with cracks along the previous crack lines which get bigger as they approach the top, where, in the remaining portion of the roof, the purlins of the rafters have partly (some completely) come out of their housings in the façade. The greater weakness of the right wall of the church, due to the three arches that drastically reduce the shear resistance area (limited, in fact, only to the solid part behind the façade), is consistent with the stronger longitudinal oscillations affecting the right side of the church and the consequent collapse of the upper part, not effectively held in place, of the façade (the part that collapsed was the one added by Moretti in order to create the squared shape) (fig. 12).

Fig. 12. Damage due to the earthquake of 6 April 2009. The right corner of the façade has collapsed, as also the top of the bell tower, which, falling, also badly damaged the roof of the transept. The collapse shows that the stone cladding consists of thin stone slabs stuck onto the wall; moreover, the first row of stone cladding, which remained in place, does not seem to extend beyond the part (trapezoidal pilasters) where Moretti reused the stones elements of the previous façade for his restoration (top and lower left). Inside the church, the cracks follow the lines of the Baroque façade (lower right).

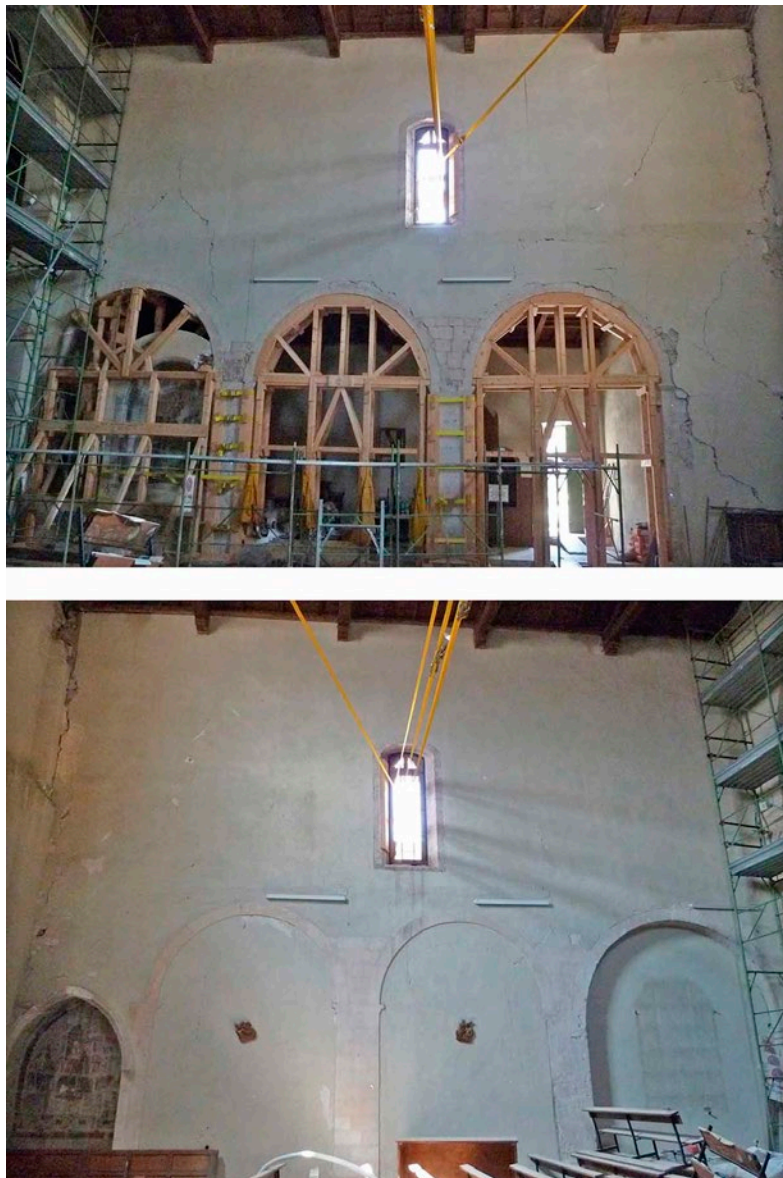
The masonry wall behind the façade, on the right, was badly damaged, as also the two pillars in which some ashlar were crushed by concentrations of load due to the oscillations. Moreover, the removal of the plaster from the masonry highlighted the extensive alterations made to the structure even before Moretti's interventions, and the consequent constructional weakness – in addition to geometric insufficiency – of the right wall (fig. 13, top).

The left wall, too, was more badly damaged near the façade, where the greater concentration of shear stresses was accompanied by a particular weakness of the wall in terms of both geometry (the wall is less thick because of a niche) and constructive quality (due to the presence of prior damage and consequent alterations to the masonry work) (fig. 13, bottom).

Fig. 13. Top: in-plane shear cracks in the right nave wall, in both the masonry structure behind the façade and the two pillars. The cracks are bigger than those in the left nave wall because of a smaller overall stiffness (due to the presence of the pillars); this in turn is responsible for the more pronounced movements seen in the right part of the façade and the consequent collapse of the top portion of the latter.

Bottom: in-plane shear cracks in the left nave wall. It should be noted, moreover, that the inner side of this wall is not perfectly vertical and was corrected by adding a substantially perpendicular external facing. This is an evident sign of prior damage repaired by external cladding.

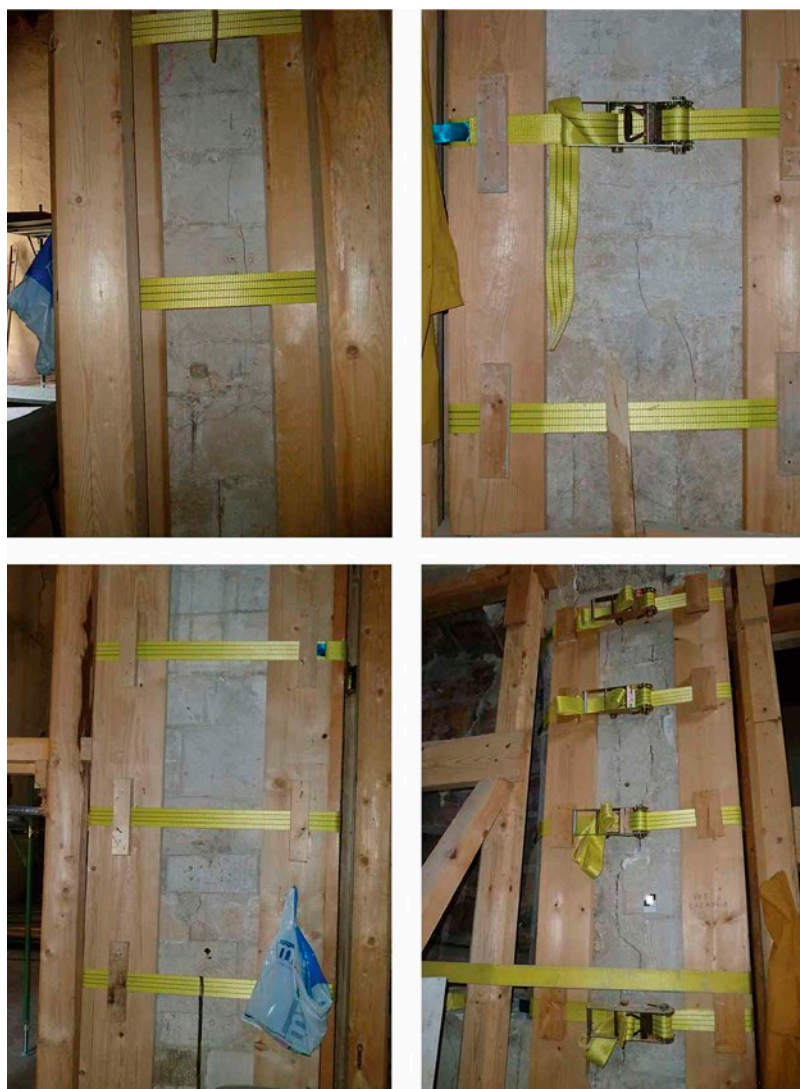
The cracks in the two pillars by the orthogonal faces of the nave, and the loosened stones in the second arch, show that there was also transverse movement (fig. 14). This is confirmed by cracks

Fig. 14. Top: the first pillar on the right of the nave. Cracks can be seen both in the face overlooking the aisle (on the right) and in the orthogonal face (on the left) and reveal both longitudinal and transverse movements (in line with the damage found on the facade and the triumphal arch of the transept). On a corner (towards the aisle and towards the transept), the stones were crushed by the longitudinal and transverse oscillations of the pillar.

Bottom: the second pillar on the right of the nave. Cracks can be seen in the surfaces that face (on the right) and are orthogonal (on the left) to the nave, revealing both longitudinal and transverse movements. Previous cracks, some of them big, have been plastered. The damage in this pillar is much more serious than in the other since it had already suffered previous damage.

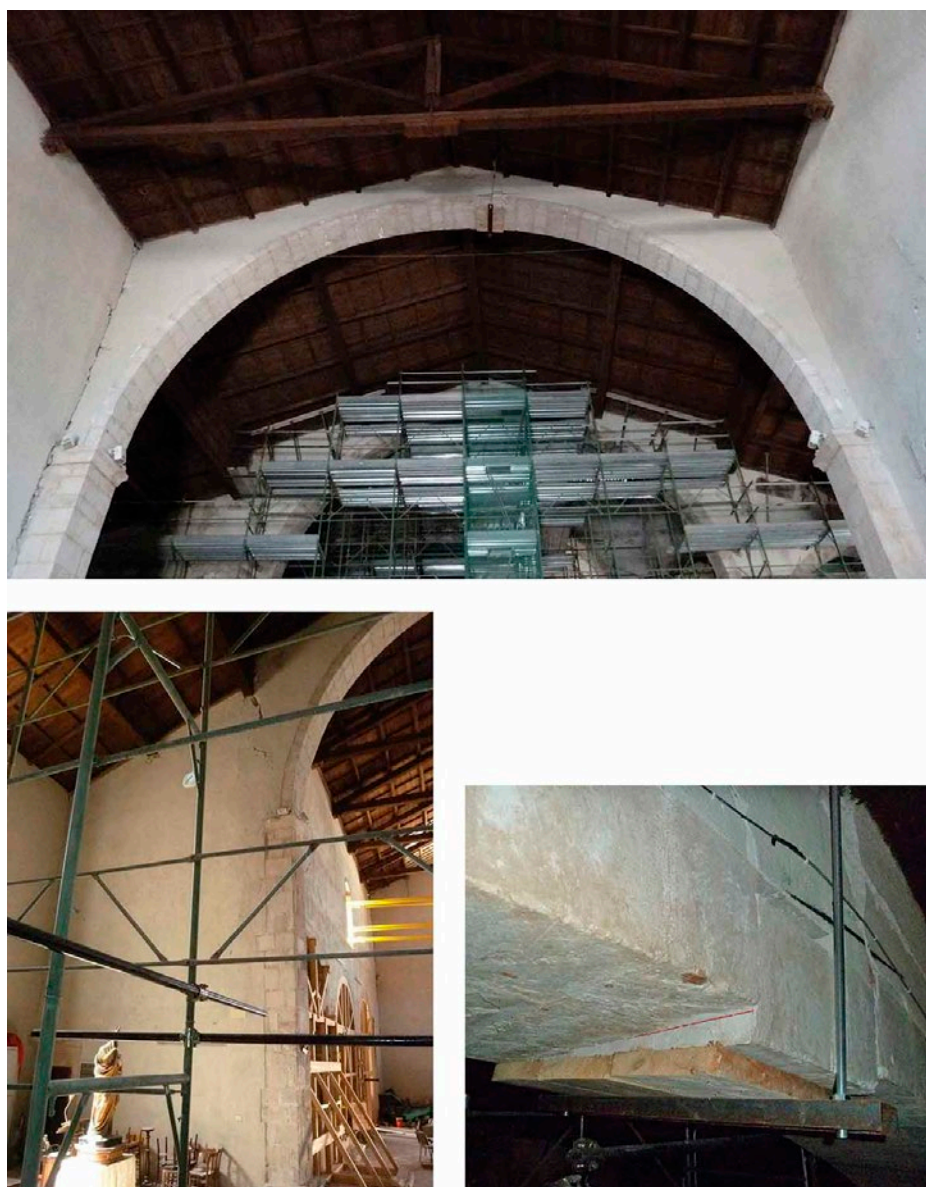
Transverse movement also triggered the damage to the triumphal arch of the transept and its left pier. The arch was affected by the classic mechanism known in the literature as bending mechanism, in which cracks appear at the top of the intrados and at the bottom of the extrados, while the pier on the left has clearly visible shear cracks on the external surface and less clear ones on the inside, due to the extensive alterations it underwent, highlighted by the effects of the last earthquake.

Moreover, the dislodgment of the key stones and the cracks in the stones next to both abutments, nave side, reveal the out of plane rotation of the arch and confirm the strong longitudinal seismic movement (fig. 15).

Fig. 15. The triumphal arch between the nave and the transept has cracks consistent with a classic flexural mechanism, at the top of the intrados and at the bottom of the extrados (top and lower left); the diagonal cracks in the left pier of the arch are consistent with an in-plane action. The dislodgment of the key stones (lower right) and the cracks in the stones next to both abutments, nave side, reveal the out of plane rotation of the arch and confirm the strong longitudinal seismic movement.

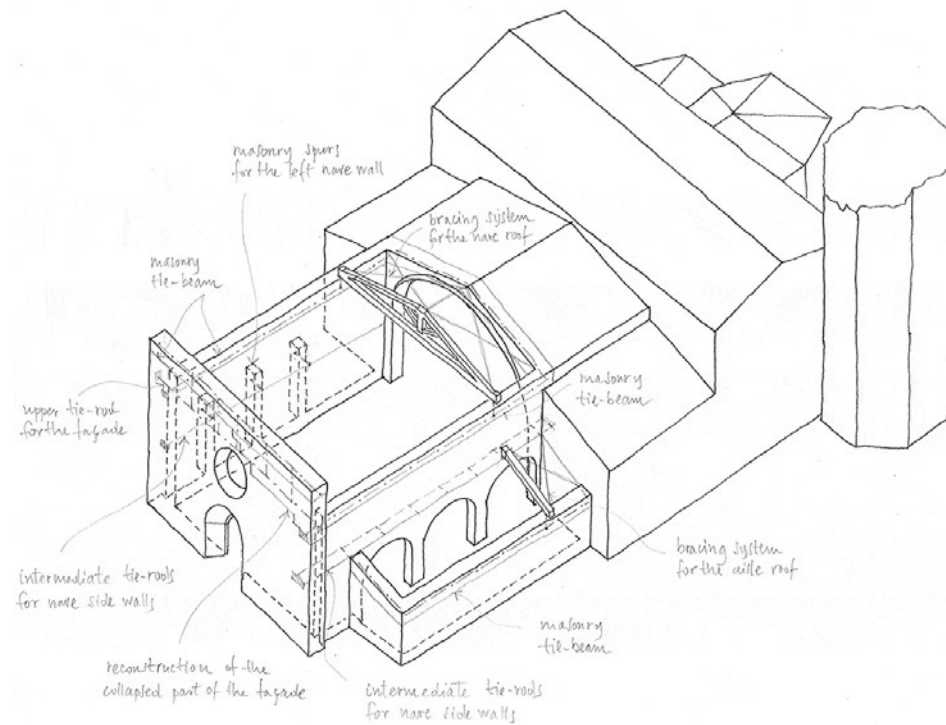
Fig. 16. Overall view of the connections designed for the nave.

From this point of view, and with reference to the nave, which the improvement project was limited to, the major problem is poor containment in both planimetric directions which is a consequence of Moretti's improper interventions and, on the contrary, had been one of the most serious concerns of the baroque builders, as it clearly arises from the historical research. An effective seismic improvement strategy would thus require, recalling the anti-seismic configuration of the eighteenth century church, the systematic introduction of connections to hold together the different structural elements, so that they act as a whole, with the introduction

of additional buttresses where defects in the layout are such that they cannot be realistically remedied by the simple use of tie-rods (fig. 16).
