Seismic History of the Church of San Pietro Di Coppito in L'Aquila

Renato Masiani, Department of Structural Engineering and Geotechnics, La Sapienza University of Rome, via Gramsci 53, Rome 00195, Italy

Art of building, early earthquake engineering, masonry structures, L'Aquila earthquake, seismic improvement, static restoration.

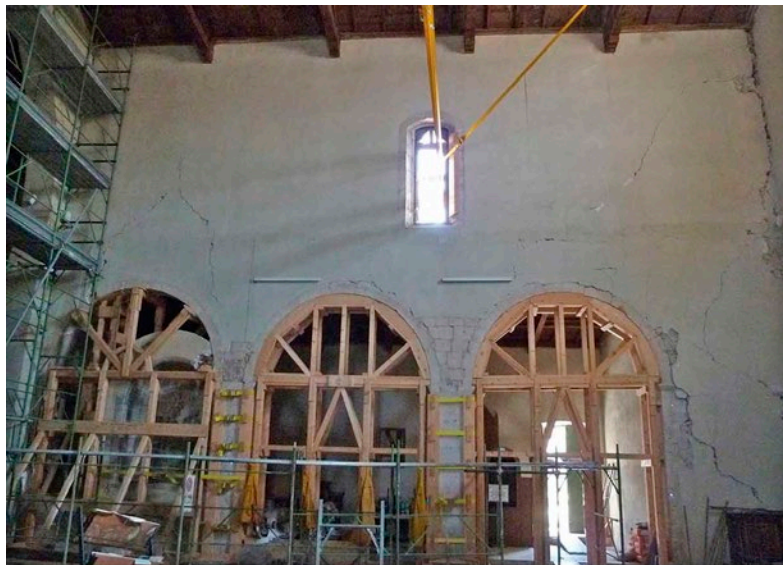
The masonry wall behind the façade, on the right, was badly damaged, as also the two pillars in which some ashlar were crushed by concentrations of load due to the oscillations. Moreover, the removal of the plaster from the masonry highlighted the extensive alterations made to the structure even before Moretti's interventions, and the consequent constructional weakness – in addition to geometric insufficiency – of the right wall (fig. 13, top).

Fig. 13. Top: in-plane shear cracks in the right nave wall, in both the masonry structure behind the façade and the two pillars. The cracks are bigger than those in the left nave wall because of a smaller overall stiffness (due to the presence of the pillars); this in turn is responsible for the more pronounced movements seen in the right part of the façade and the consequent collapse of the top portion of the latter.

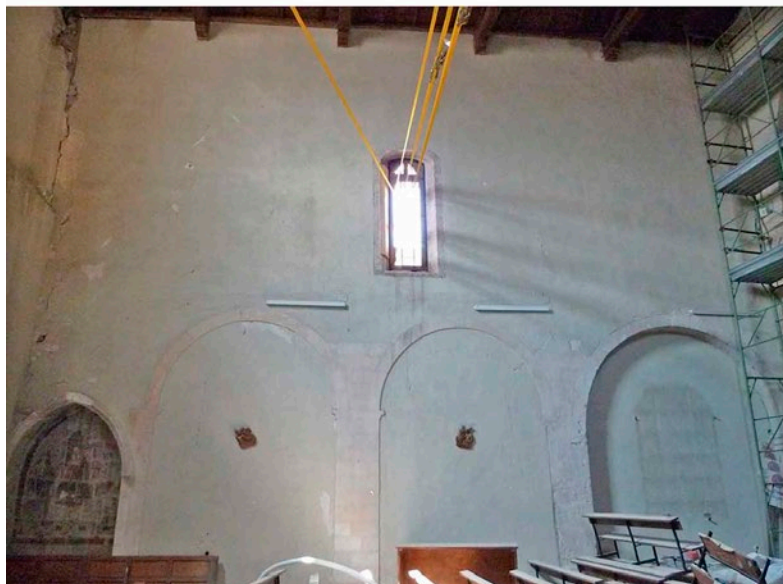
The left wall, too, was more badly damaged near the façade, where the greater concentration of shear stresses was accompanied by a particular weakness of the wall in terms of both geometry (the wall is less thick because of a niche) and constructive quality (due to the presence of prior damage and consequent alterations to the masonry work) (fig. 13, bottom).

Bottom: in-plane shear cracks in the left nave wall. It should be noted, moreover, that the inner side of this wall is not perfectly vertical and was corrected by adding a substantially perpendicular external facing. This is an evident sign of prior damage repaired by external cladding.
