# The anatomy of a collapse: forensic analyses, monitoring and restoration attempts of the Fossano Bridge

F. Bazzucchi & G. A. Ferro

*Department of Structural, Building and Geotechnical Engineering  
Politecnico di Torino, Torino, Italy*

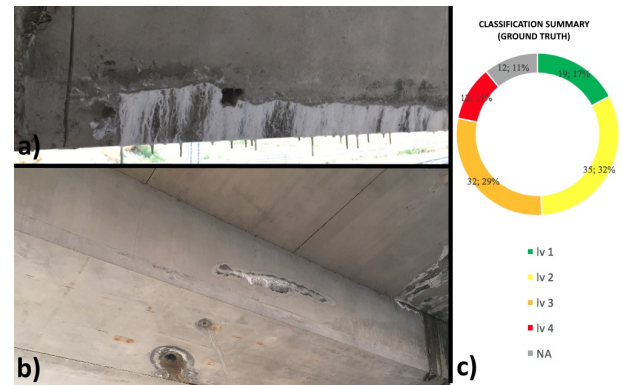
The forensic investigations evidenced a concise correlation between the external presence of a pattern of superficial stains and the expected level of damage of the cables. As evidenced in Figure 4a, crystallized matter accumulated along the cable trajectory by the absolving action affecting the grout of the infiltrated and pressurized water in the sheatings. Depending on the extension and the dimension of these superficial stains, two ascending levels of damage have been established (lv. 2 and lv. 3). A maximum level of damage (lv. 4, Figure 4b) has been created for red-brown stains along the cable trajectory, meaning that the oxidation is acting without any presence of the grout (unbonded cables). Obviously, no evident sign of degradation has been classified as level 1. Results of this preliminary classification are reported in Figure 4c. These results have been used as ground truth for the building of the image layer of a Deep Convolutional

Figure 4: a,b) lv. 3 and lv. 4 stains classification standards. c) Entire classification summary.
