The anatomy of a collapse: forensic analyses, monitoring and restoration attempts of the Fossano Bridge

F. Bazzucchi & G. A. Ferro

*Department of Structural, Building and Geotechnical Engineering
Politecnico di Torino, Torino, Italy*

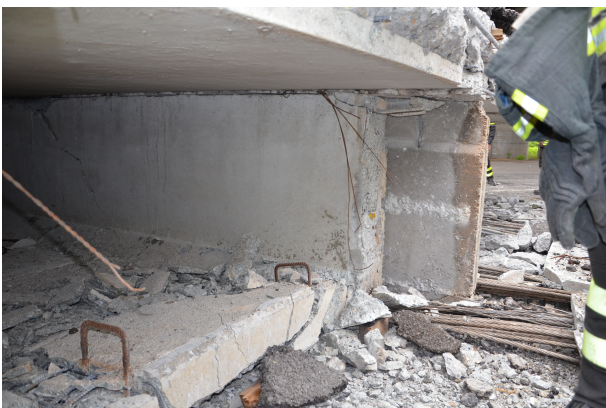
Figure 2: Collapsed joint.

Visual inspections consented to affirm that the collapse mechanism was triggered by a shear failure in one of the joint due to the absence of the equilibrating action of the prestressing. Same inspections immediately evidenced the lacking of the sufficient grout protection in the opened joint area (Figure 2). Corresponding level of cable oxidation was not compatible with such a *young* structure (20 years old) concrete

structure damage scenario, where, above all the external overall condition appeared healthy. The collapse had a sudden and fragile nature, with an insignificant process zone and volume of debris. The kinematic was practically vertical with no out-of-plane displacements. Only a modest slip in the longitudinal axis direction occurred in the pinned bearings side.
