Engineering Reconnaissance of the 24 August 2016 Central Italy Earthquake. Version 2

Geotechnical Extreme Events Reconnaissance Association

Report No. GEER-050B

22 November 2016

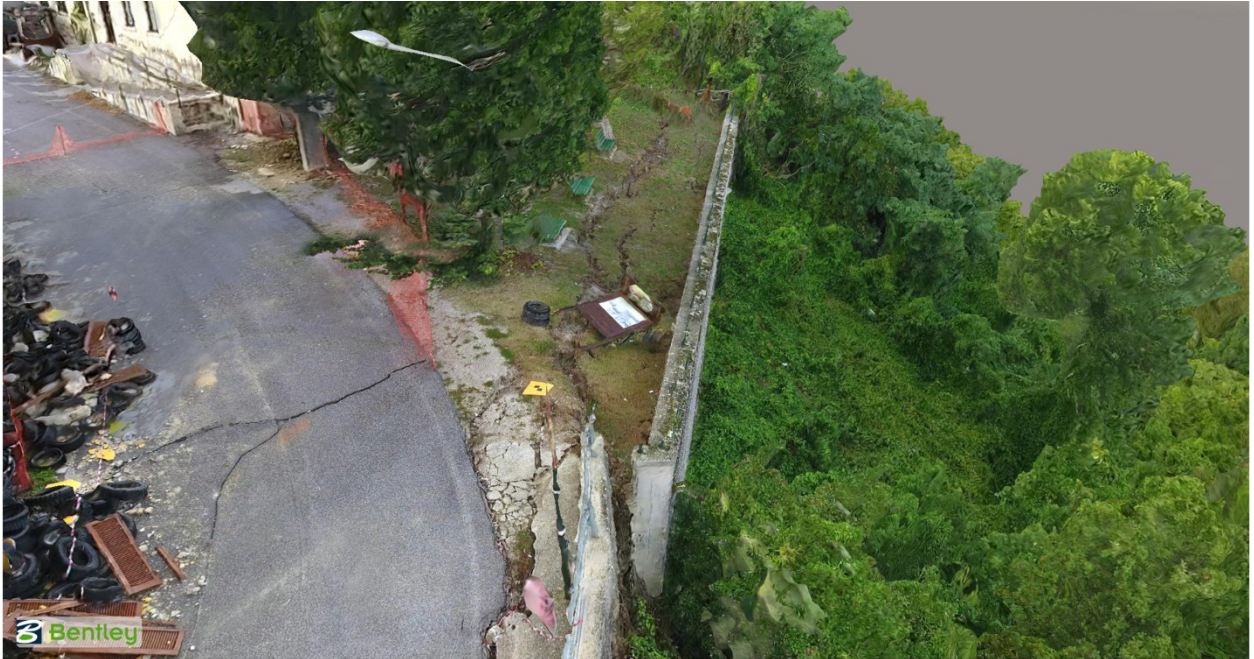
Figure 4.43. Rotated retaining wall and subsequent graben behind the wall. Soil settlement between 45-50 cm behind the wall, and formed cracks up to 45 cm in width (42.69446 N 13.24980 E).

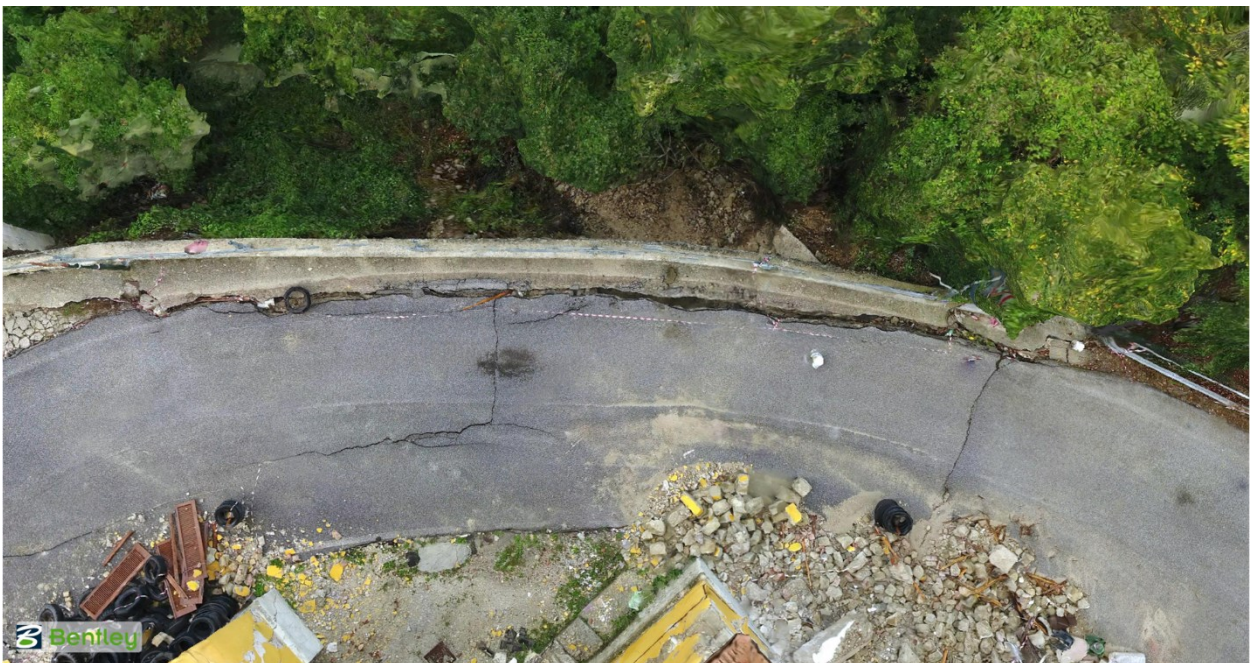
Figure 4.44. Rotated retaining wall below the road Frazione Fonte del Campo and subsequent cracks up to 25 cm in width (42.69438 N 13.24995 E).

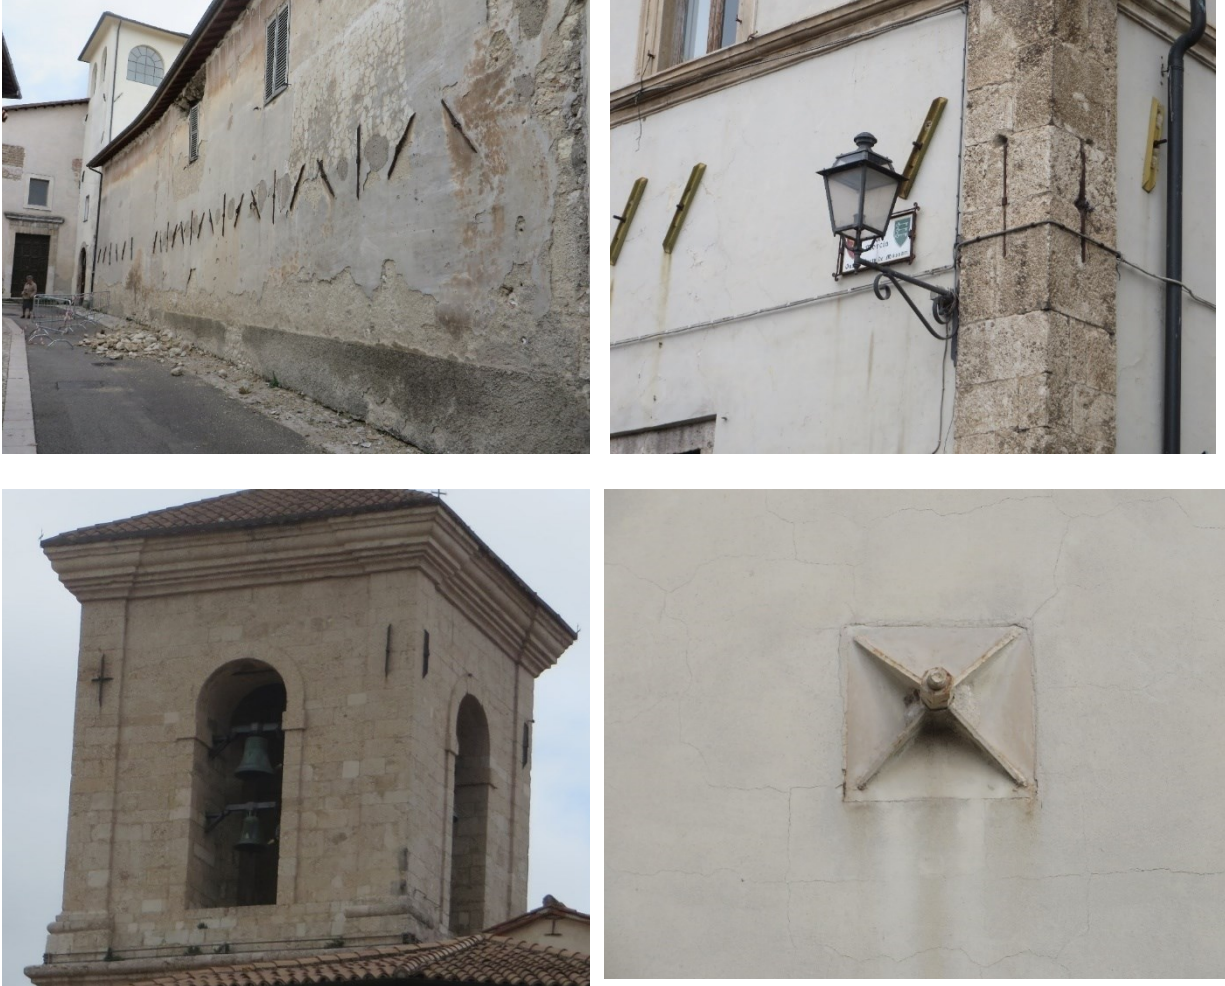
Figure 5.35. Buildings and towers retrofitted with cross-ties in Norcia.
