Corrosion assessment of a bronze equestrian statue exposed to urban environment

Corrosion assessment of a bronze equestrian statue exposed to urban environment / Es Sebar, L.; Iannucci, L.; Grassini, S.; Angelini, E.; Parvis, M.; Antonino, R.; Quaranta, G.; Giani, C.; Boassa, M.; Nicola, M.. - In: KOROZE A OCHRANA MATERIALU. - ISSN 1804-1213. - ELETTRONICO. - 66:1(2022), pp. 50-55. [10.2478/kom-2022-0008]

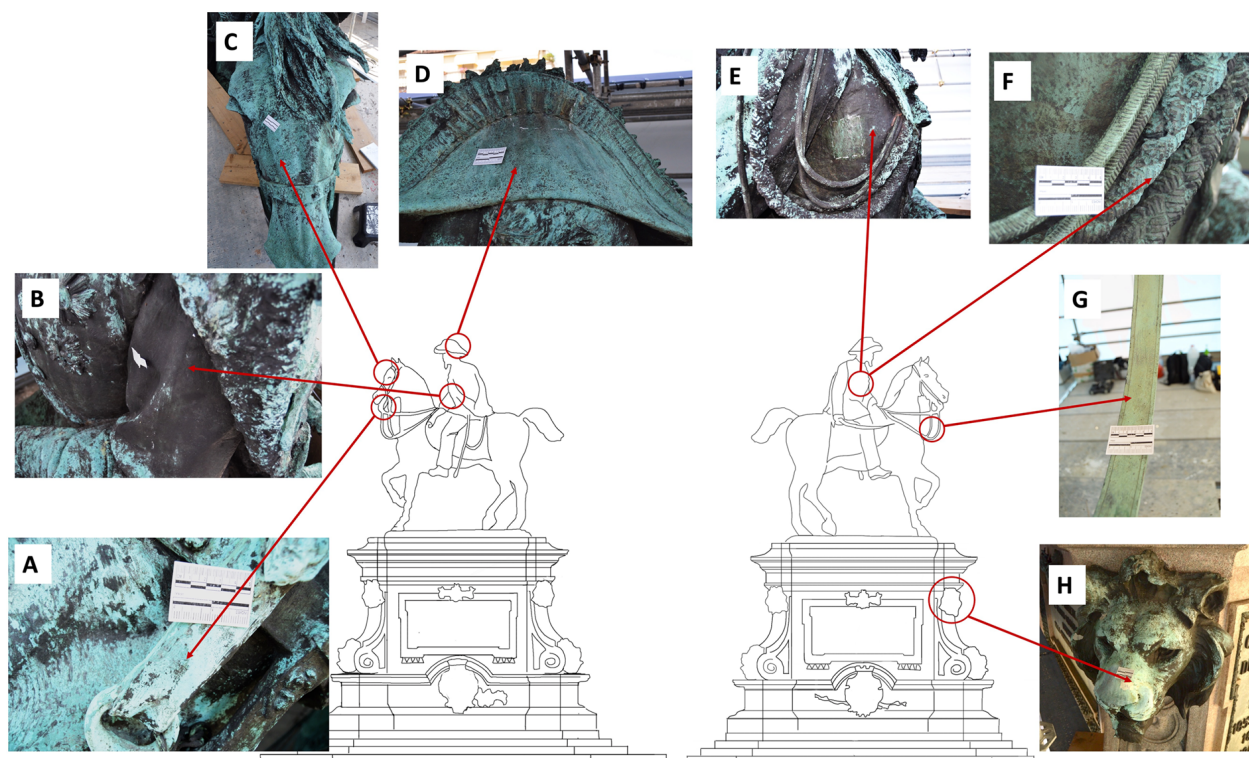
At visual inspection, the monument was characterized by the presence of patinas having different colours and aesthetical appearance, presumably corresponding to different conservation states. Colours ranged from light to dark green and some areas were covered by a blackish patina, presumably due to smog and particulate deposits. The initial survey was performed using XRF, in order to understand if the statue had been made from a single material or if different copper-based alloys were present. In some of the points, chosen considering the patina visual appearance, EIS and RS measurements were performed too, in order to have a complete characterization of the superficial layers. About 180 areas were analysed by means of XRF, and about 20 of them were also analysed using EIS and RS; the most significant ones are reported in Figure 2.

Fig. 2. Photographs of the most significant analysed areas, representative of the different colours and morphologies of the corrosion products, and their position on the statue

It is worth to notice that it was possible to correlate the impedance spectra collected in the different areas of the statue with the colour of the patina and its exposure to the environment. Actually, areas with a high impedance module had a blackish or dark brown appearance, while those with a low impedance module had a bright green appearance. Moreover, in virtually all cases, areas characterized by high impedance module were vertically oriented or in sheltered positions. On the other hand, patinas with bright green appearance were found in areas more exposed to rain washout, such as the bicorn, the horse head and the bridles. So, the formulated hypothesis was that in areas exposed to intense rain the protective layers had been washed out during the years, exposing the bronze corrosion products to the environment (this explains the lower impedance modulus). Instead, sheltered or vertically oriented areas, preserved the applied protective layers, keeping a lower corrosion rate. Actually, impedance moduli in the range of $10^6 \Omega \cdot \text{cm}^2$ or above are characteristic of organic coatings with high protective capability, while these values are too high to be attributed to a corrosion products layer naturally grown on the bronze surface.

The performed measuring campaign allowed the restorers to assess the quality of the intervention carried out about a decade before. Actually, even though rain washout removed part of the applied organic protective layers, critical situations could not be found, and the corrosion phenomena were under control in all areas of the monument. Chlorides-containing compounds could not be found in any of the analysed corrosion patina, further highlighting the good conservation state of the artefact. Based on these conclusions, only a soft intervention was necessary for the monument. Restorers performed a light cleaning of the entire surface of the statue by means of organic solvents to remove wax layers and then applied the new protective coating based on acrylic varnishes and microcrystalline wax.

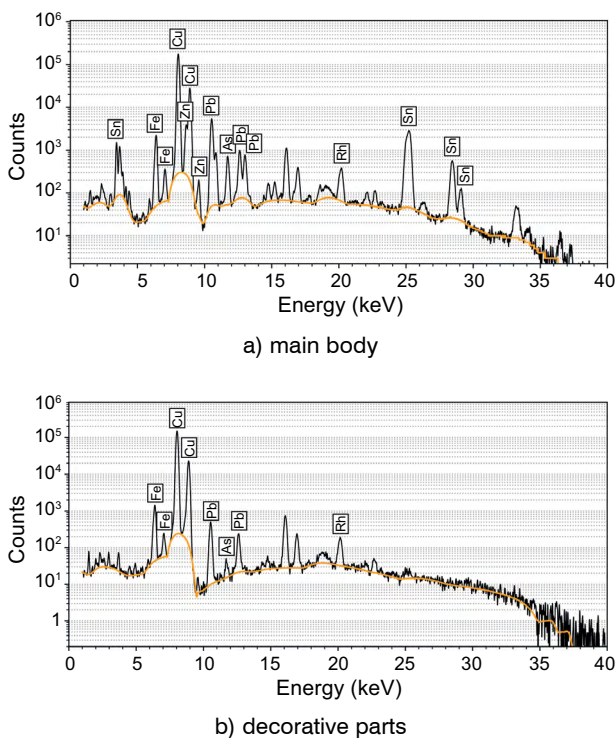
Results from XRF measurements showed that there are two main alloys used for the realization of the monument. The first one, whose characteristic XRF spectrum is reported in Figure 3a, was employed for the main body of the statue, namely for the horse and for the knight body (areas A, B, C, D, E, and H in Figure 2). The alloy is characterized by the presence of copper, tin, zinc, iron, lead, and arsenic, which are common elements in bronzes composition for artistic foundry; meanwhile rhodium characteristic lines at 20.22 keV are related to the anode material of the spectrometer. This finding is in agreement with the analyses performed during the previous restoration intervention which identified a ternary bronze constituted by copper, tin and zinc (90 wt%, 6 wt% and 4 wt%, respectively). In the 2006 campaign, the bronze composition was identified by means of EDS (Energy Dispersive X-ray Spectrometry) after a micro-sampling of the material. On the contrary, the experimental approach presented in this paper and based on XRF in-situ measurements, allowed analysing many different areas of the statue, thus highlighting the homogeneity in the alloy composition. As a matter of facts, the obtained results confirmed that the entire knight statue was made of the same bronze alloy. Moreover, it is important to underline that the discrepancies between these new data and the previous ones can be attributed to the fact that the EDS sampling was necessarily performed by

A second alloy was then identified in the decorative parts of the monument, namely the horse bridles and the decorations on the La Marmora blouse (areas F and G in Figure 2). Also this alloy is a bronze, characterized by the presence of copper, iron, lead and arsenic, as can be seen from the XRF spectrum reported in Figure 3b. PCA was also used in order to check if additional alloys could be discriminated among the acquired spectra, but only the two reported groups were identified.

Fig. 3. XRF spectra of the two alloys constituting the equestrian statue: a) main body (i.e. area C in Figure 2), b) decorative parts (i.e. area G in Figure 2) – in yellow the spectrum baseline

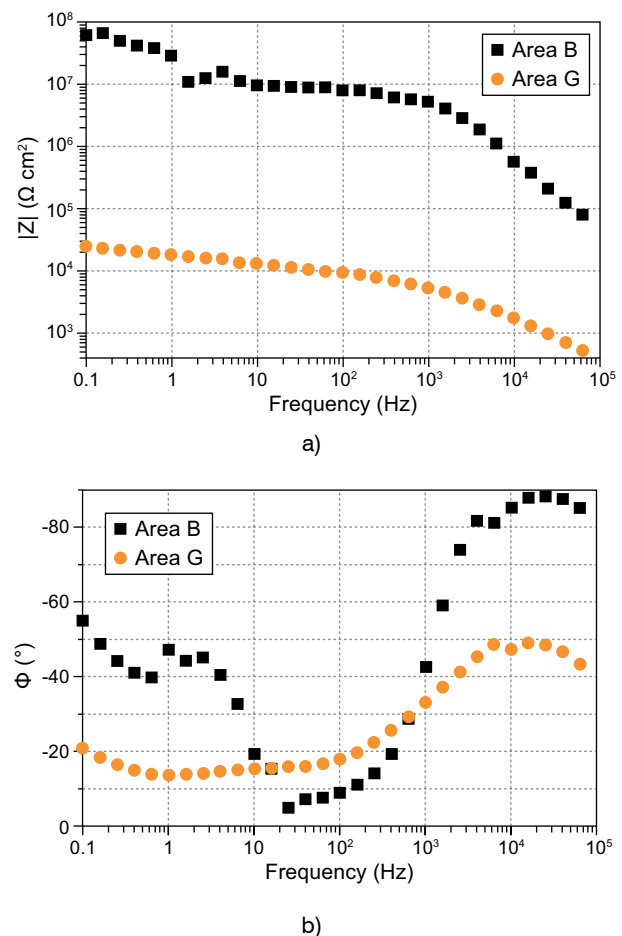
Two main cases were identified, based on the different trends in the impedance spectrum. The first one, reported in Figure 4 (area B in Figure 2), regards the areas with values of the impedance module above

Fig. 4. Impedance spectra acquired in different areas of the statue: area B – dark brown patina; area G – bright green patina (as shown in Figure 2)

$10^6 \Omega \cdot \text{cm}^2$ at low frequencies and phase values of about -90° at high frequencies. These areas are characterized by a good protective effectiveness of the surface layers and thus by a low corrosion rate for the metal substrate (areas B and E in Figure 2). The second case, reported in Figure 4 (area G in Figure 2), is related to the areas with lower impedance module values (about $10^4 \Omega \cdot \text{cm}^2$) at low frequencies and phase values which remained below -50° in the whole analysed frequency range and reached a value of about -10° at low frequencies. So, these points are characterized by a higher corrosion rate (as can be deduced from the absolute impedance value) and are presumably no longer protected by any organic layer applied during the previous restorations (areas A, C, D, G, and H in Figure 2).

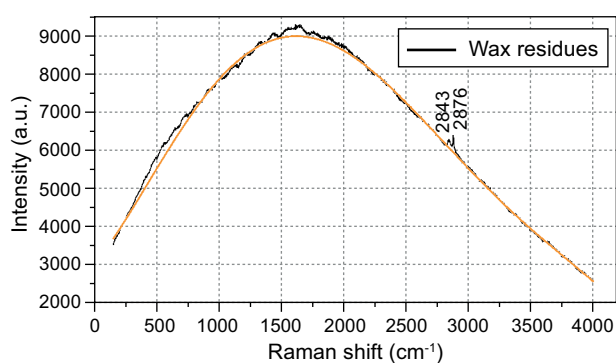
Fig. 5. Raman spectrum acquired in one of the 'blackish' areas in the statue (area E in Figure 2) – in black the acquired spectrum, in yellow the baseline (peaks, at 2843 cm^{-1} and 2876 cm^{-1} are characteristic of aliphatic chains)

In order to validate this hypothesis, RS measurements were carried out in most of the areas that were previously analysed by means of EIS. The results showed that wax residues were present in areas characterized by high impedance moduli. Actually, as can be seen from Figure 5, the Raman spectrum is composed by an intense fluorescence signal and two peaks, namely at 2843 cm^{-1} and 2876 cm^{-1} , characteristic of aliphatic chains and thus of organic material such as wax.

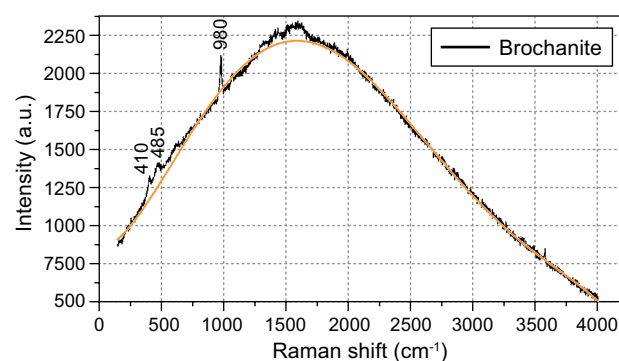
In areas with low impedance values at low frequencies, i.e. with low protective capability and bright green colour, the collected Raman spectra showed the characteristic peaks of sulphate-based corrosion products and the absence of peaks related to wax. As an example, in Figure 6 one of these spectra is shown, where the peaks at 410 cm^{-1} , 485 cm^{-1} , and 980 cm^{-1} , generally attributed to brochantite, are present [20,21]. The presence of this compound in the bronze patina is characteristic of copper alloys exposed to atmosphere in non-aggressive conditions and confirms the stable behaviour of the material as far as the corrosion processes are concerned [22].

Fig. 6. Raman spectrum, identified as brochantite (characteristic peaks at 410 cm^{-1} , 485 cm^{-1} , and 980 cm^{-1}), acquired in correspondence to the 'bright green' areas in the statue (area G in Figure 2) – in black the acquired spectrum, in yellow the baseline)
