Path of Knowledge for the Assessment of Structural Safety of the Pisan Tower of the Royal Palace of Palermo in Italy

Abstract: This paper presents the path of knowledge developed for assessing the structural safety of the Norman-age Pisan Tower, which is mostly incorporated into the Royal Palace in Palermo, Italy. Historical, geomatic, and mechanical investigations were conducted and the most relevant results are herein collected and presented. The research path was addressed to specific tasks: identification of the building, geometric surveys, recognition of the sequence of phases of building transformation, detection of the components of the load-bearing structure, structural diagnostic surveys, and investigation of the subsoil and foundations. The explicit vulnerabilities found were mostly confined to the Piazza library floor, while implicit vulnerabilities were identified in the presence of false walls and in high loads and fillings on the vaults of the last levels. The results of the analyses allowed the individuation of the confidence factors to use in structural analysis models aimed at the assessment of the seismic safety of the building.

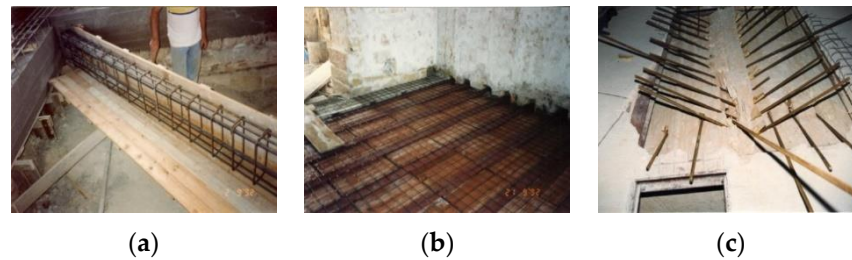
Boscarino and Cottone's intervention in the 1990s was performed after the damage due to the 1968 earthquake. In particular, the floor of the President's Room is still severely damaged, as well as the room with the Piazzoli Library, which is even more damaged, with a strongly cracked vault, shored up in a currently visible safety intervention, which should have been provisional.

Figure 11. Details of the execution of the Boscarino–Cottone intervention (1990s): (a,b) photos related to the floor slab of the room on the left of the gallery, showing the diagonal crossbeam and the electro-welded mesh above hollow blocks; (c) reinforcement of the central vault for the sustainment of the steel reticular column which supports Mertz's equatorial telescope.

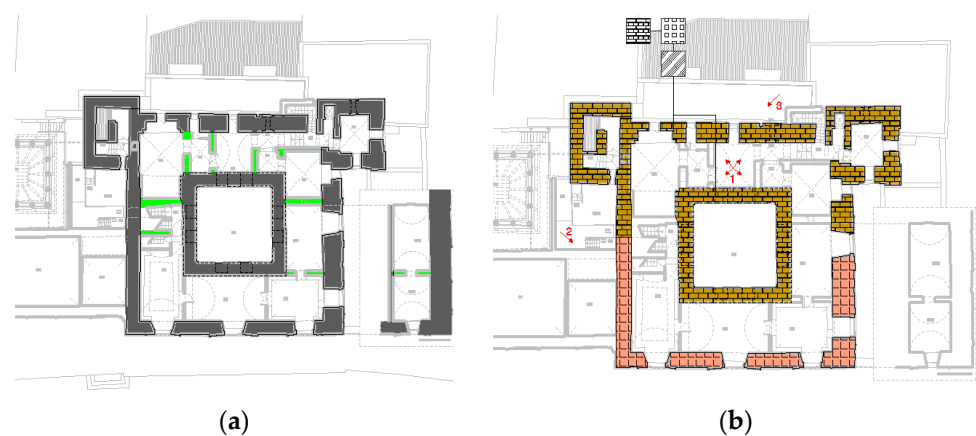
At the level of the Piazzini Library (level H), which hosts rooms of both the Astronomical Observatory and the ARS, the load-bearing structure provides the layout with concentric quadrilaterals (Figure 21a). The compactness and rigidity of the system are notably reduced by the narrow width of the walls, and by the numerous openings. As discussed in the previous paragraphs, the east side of the Tower probably represents an addition from the period of the Spanish Viceroyalty. Hence, techniques and materials differ significantly from the Norman construction (Figure 21b). This circumstance was also confirmed by the mechanical characteristics surveyed in the Spanish masonry, which was characterized by low values of compression strength as compared to those of the Norman masonry and to the suggested values for masonry walls in soft stone ashlars. These intrinsic flaws in the masonry, together with the presence of many transfer walls between the two squares in the load-bearing structure of the Tower, have certainly led to a relevant vulnerability. The effects of the 1968 earthquake and the constant and abundant infiltrations from the terrace of the upper level have produced several instability phenomena, including diffuse—and worrisome—cracks in both vertical and horizontal structural components. Following these damages, the rooms of the Observatory were shored up and made inaccessible. The cracks in the floor slabs are often extended in the walls, hence disrupting the wall structure and leading to additional vulnerability.

Figure 21. Identification of the structure of the Tower on level H (height 28.70 m): (a) hypothesized vertical load-bearing structure; (b) hypothesized materials.
