II Fabre Conference – Existing bridges, viaducts and tunnels: research, innovation and applications (FABRE24)

Preliminary Insights from Surveys of Bridges at High Scouring Risk in West Piedmont

Mauro Aimar^a, Marco Civera^{a*}, Sebastiano Foti^a, and Bernardino Chiaia^a

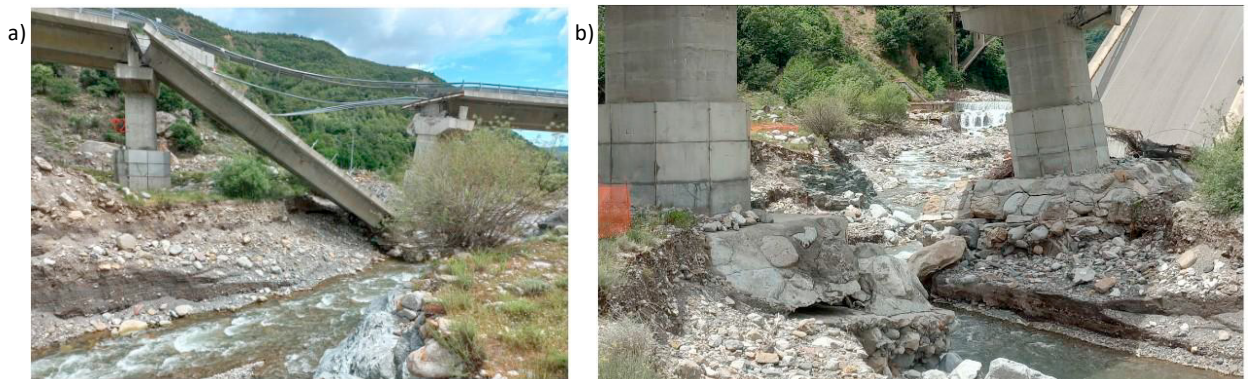
Figure 1. Collapse of the Longobucco bridge, near Cosenza: a) Collapsed deck span and rotated pier; b) Detailed view of the foundation of the rotated pier.

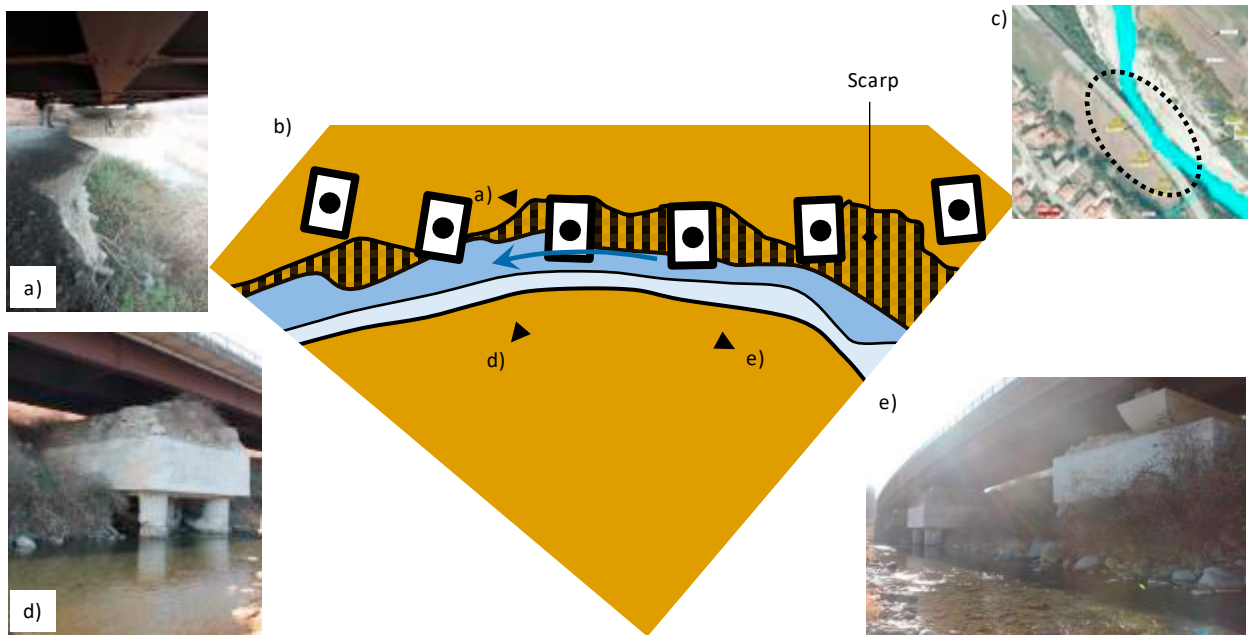
On the one hand, the Inverso Pinasca bridge (PIP) is part of a thalweg road running parallel to the Chisone river, in the Western part of the Metropolitan City of Turin. The superstructure is characterized by a continuous, composite steel-concrete deck with excellent conditions, also due to the relative short age of this structure – the construction year is 2005. However, the river main channel has gradually shifted towards the road axis, thus inducing significant lateral scouring on the foundations of part of the piers (Fig. 4). As each pier is supported by deep, large-diameter piles, foundation scour should not dramatically affect the safety conditions of the bridge, in this case. On the other hand, the different entity of erosion from pier to pier may induce some asymmetry in the structural response. To avoid further extension of the erosion, the infrastructure manager planned a retrofit intervention, consisting in a restoration of the original morphology, soil improvement through jet grouting injections and protection through rock walls. For this reason, this bridge will be further investigated to better understand its behaviour and have an insight into the effects of such an intervention.

Figure 4. Plane view of the portion of the Inverso Pinasca (PIP) bridge affected by foundation scour (c, d). For simplicity, in (c) only the piers and the foundation pads are represented. The sketch is integrated with photos taken below the deck (a) and from the other side of the river (d, e).
