Investigation of the failure behavior of fiber-reinforced patches in the repair of locally damaged steel pipes

Keywords: fiber-reinforced patch, structural repair, acoustic emission, hydrostatic test.

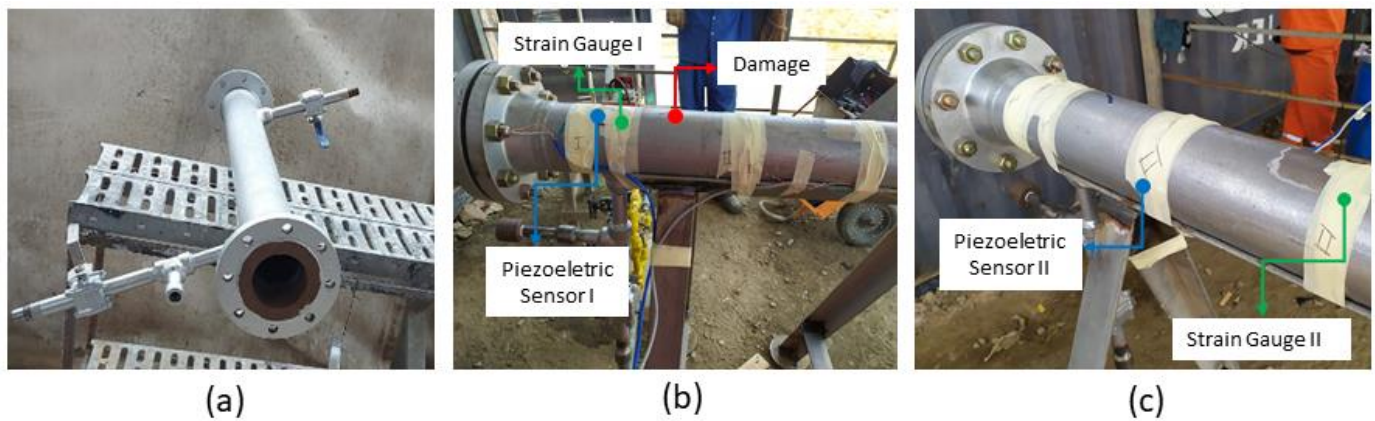
To access the efficiency of repair patches with minimal surface extension, and, consequently, minimal stiffness/inertia modification of the substrate, a stepped repair patch was designed to repair a steel pipe. The specimen consisted of a segment of hydrocarbon pipeline, in accordance with specifications from [5], with a nominal diameter equal to 101.60mm. The pipe length was defined as 1.50m and a wall thickness of 6.02mm. The specimen was prepared for hydrostatic tests, as defined by [6] and [7]. The specimen is presented in Fig.1(a) prior to the damage, Figs. 1(b) and 1(c) detail the pipe instrumentation, which will be better discussed henceforward.

Fig. 1. Specimen prepared to field tests: (a) pipeline segment prior to damage; (b) instrumentation attached to the pipe; and (c) sensors positioning and identification.

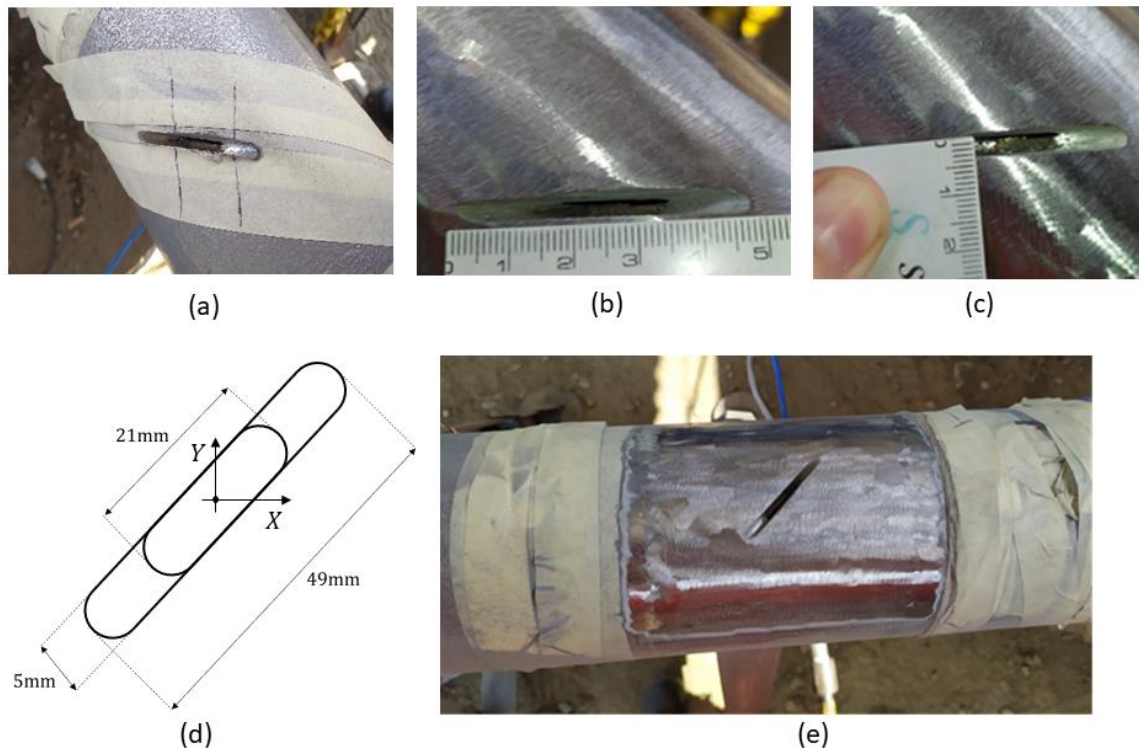
The damaged component is presented in detail in Fig.2(a), which illustrates the through-thickness cut diagonally to the pipe axis. Figs.2(b) to 2(c) show the crack-like damage dimensions, which are given by the schematic of Fig. 2(d): 49mm x 5mm on the outer surface and 21mm x 5mm on the inner surface. The pipe surface was cleaned with acetone

and sanded (#400 grit) to remove irregularities produced during the cutting operation. Fig.2(e) presents the damaged region previously to the patching operation.

Fig. 2. Crack-like, through-thickness cut, damage: (a) overall view; (b) length in detail; (c) crack opening in detail; (d) crack schematic; and (e) region prepared to receive the repair patch.

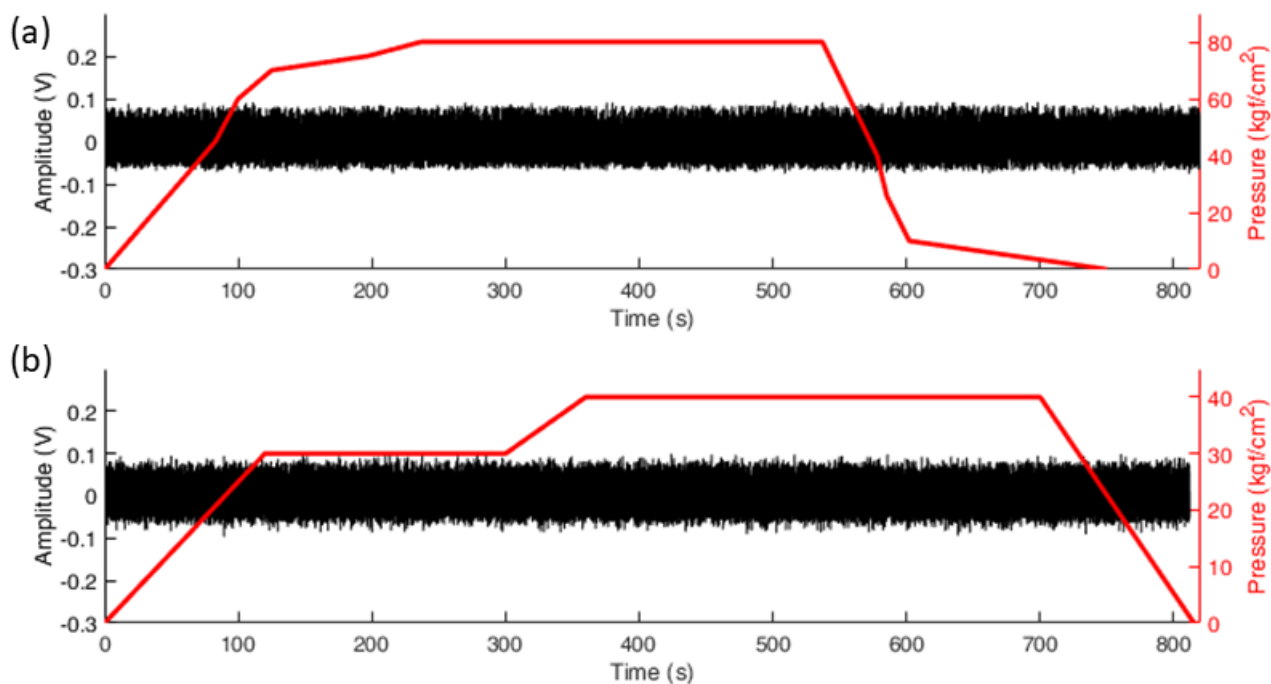
After the 2nd HT test, the repair patch surface was degraded after each testing regime. The specimen and the repair patch remained intact and without any deformation behavior suggesting internal crack/failure, this statement is true even after the 3rd test, at which only 75% of the patch's layers were resisting load. The patch only failed during the 4th HT, at a pressure equal to $\cong 3.5\text{MPa}$. It is very important to stress that even after the patch was reduced to half its design thickness and 40% of its original area, it resisted the maximum allowable working pressure. Fig. 4 presents the signal obtained using AE at two distinct conditions. Fig. 4(a) presents the signal at the maximum pressure of 7.84MPa during the 1st HT. Fig. 4(b) shows the same result, but now for the 3rd HT.

Fig. 4. AE signal at peak testing pressures: (a) 1st HT and (b) 3rd HT.

Even under extreme conditions, the signal response of the specimen, with a repair patch degraded to 75% of its original thickness, showed no significant events. This lack of events indicating internal crack/failure of the patch supports the efficiency of the technique adopted to repair the locally damaged pipe. Furthermore, the patch failure, during 4th HT, and the failure region was only visible after using penetrating fluid.
