Investigation of the Failure Behavior of Fiber-Reinforced Patches in the Repair of Locally Damaged Steel Pipes

Proceedings of the  
**6<sup>th</sup> Brazilian Conference on Composite Materials**

## Investigation of the failure behavior of fiber-reinforced patches in the repair of locally damaged steel pipes

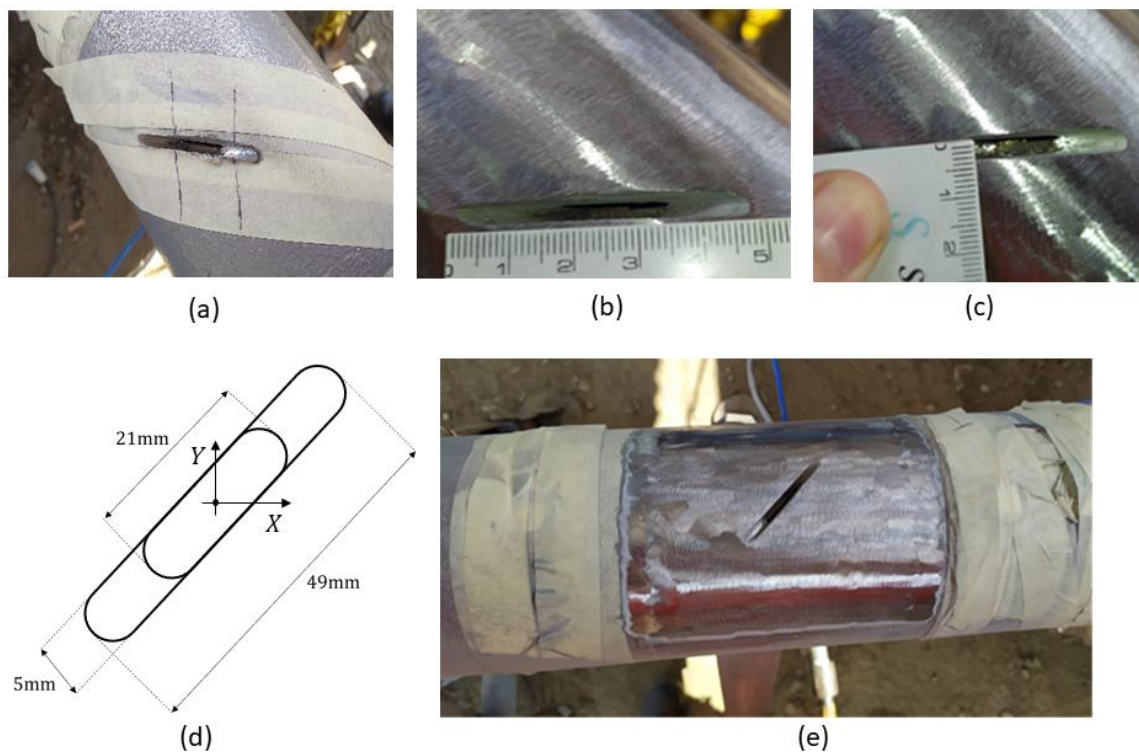
The damaged component is presented in detail in Fig.2(a), which illustrates the through-thickness cut diagonally to the pipe axis. Figs.2(b) to 2(c) show the crack-like damage dimensions, which are given by the schematic of Fig. 2(d): 49mm x 5mm on the outer surface and 21mm x 5mm on the inner surface. The pipe surface was cleaned with acetone

and sanded (#400 grit) to remove irregularities produced during the cutting operation. Fig.2(e) presents the damaged region previously to the patching operation.

**Fig. 2.** Crack-like, through-thickness cut, damage: (a) overall view; (b) length in detail; (c) crack opening in detail; (d) crack schematic; and (e) region prepared to receive the repair patch.

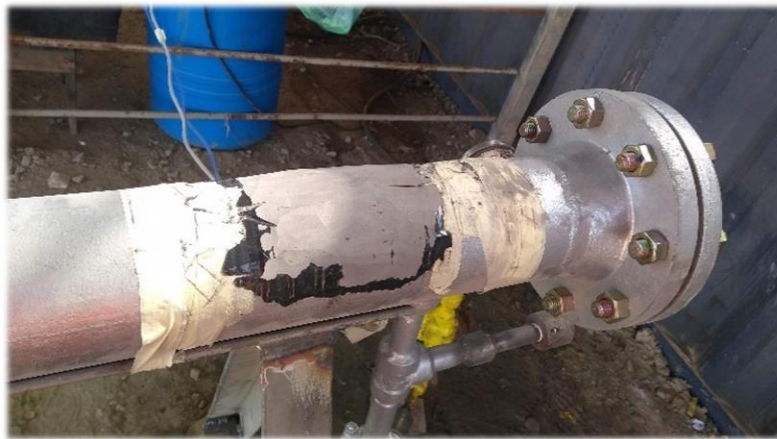
Fig. 4 presents the specimen after the repairing operation. The patch was constituted of a plain weave fiberglass fabric ( $200 \frac{g}{m^2}$ ) and an epoxy resin with micro-steel particulate reinforcement (4:1 mixture ratio). This type of resin [8] was selected due to its fast curing characteristics, i.e., the whole curing process took twelve hours at room temperature ( $\approx 23^\circ\text{C}$ ). The patching process was defined in a similar manner to the suggested by [9].

**Fig. 3.** Repaired region after the patch cure.

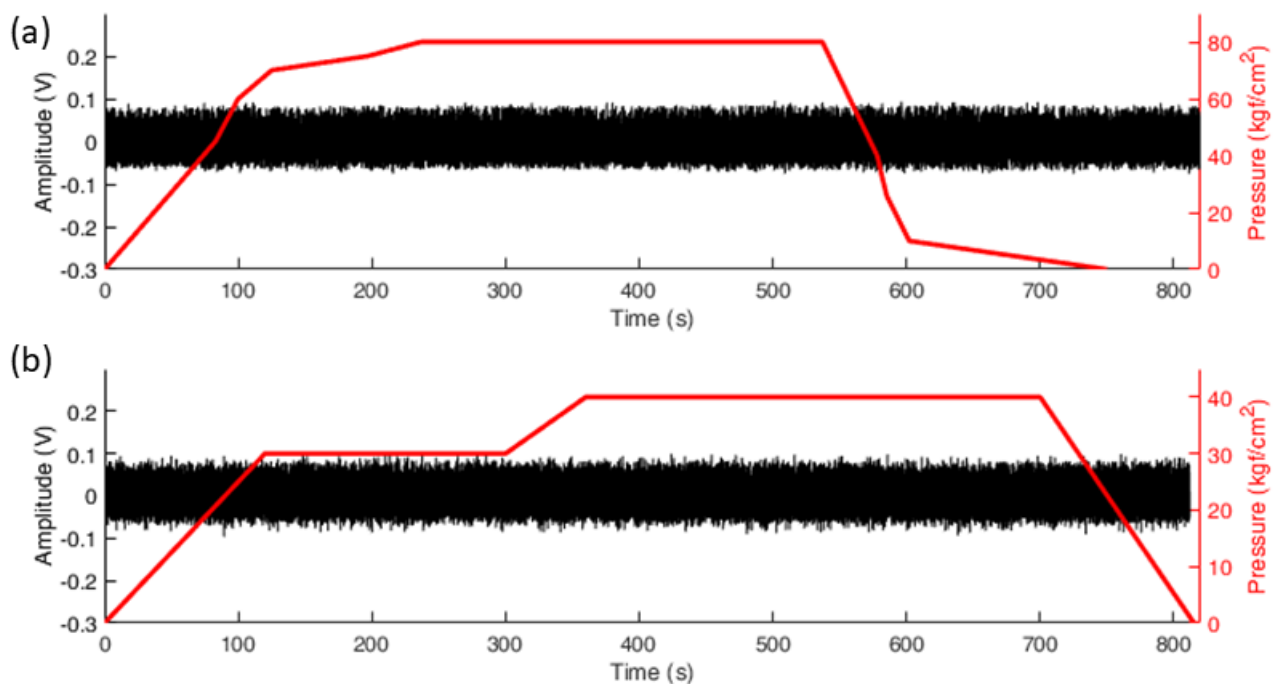
After the 2<sup>nd</sup> HT test, the repair patch surface was degraded after each testing regime. The specimen and the repair patch remained intact and without any deformation behavior suggesting internal crack/failure, this statement is true even after the 3<sup>rd</sup> test, at which only 75% of the patch's layers were resisting load. The patch only failed during the 4<sup>th</sup> HT, at a pressure equal to  $\cong 3.5\text{MPa}$ . It is very important to stress that even after the patch was reduced to half its design thickness and 40% of its original area, it resisted the maximum allowable working pressure. Fig. 4 presents the signal obtained using AE at two distinct conditions. Fig. 4(a) presents the signal at the maximum pressure of 7.84MPa during the 1<sup>st</sup> HT. Fig. 4(b) shows the same result, but now for the 3<sup>rd</sup> HT.

**Fig. 4.** AE signal at peak testing pressures: (a) 1<sup>st</sup> HT and (b) 3<sup>rd</sup> HT.

Even under extreme conditions, the signal response of the specimen, with a repair patch degraded to 75% of its original thickness, showed no significant events. This lack of events indicating internal crack/failure of the patch supports the efficiency of the technique adopted to repair the locally damaged pipe. Furthermore, the patch failure, during 4<sup>th</sup> HT, and the failure region was only visible after using penetrating fluid.
