Path of Knowledge for the Assessment of Structural Safety of the Pisan Tower of the Royal Palace of Palermo in Italy

# Path of Knowledge for the Assessment of Structural Safety of the Pisan Tower of the Royal Palace of Palermo in Italy

**Abstract:** This paper presents the path of knowledge developed for assessing the structural safety of the Norman-age Pisan Tower, which is mostly incorporated into the Royal Palace in Palermo, Italy. Historical, geomatic, and mechanical investigations were conducted and the most relevant results are herein collected and presented. The research path was addressed to specific tasks: identification of the building, geometric surveys, recognition of the sequence of phases of building transformation, detection of the components of the load-bearing structure, structural diagnostic surveys, and investigation of the subsoil and foundations. The explicit vulnerabilities found were mostly confined to the Piazzali library floor, while implicit vulnerabilities were identified in the presence of false walls and in high loads and fillings on the vaults of the last levels. The results of the analyses allowed the individuation of the confidence factors to use i

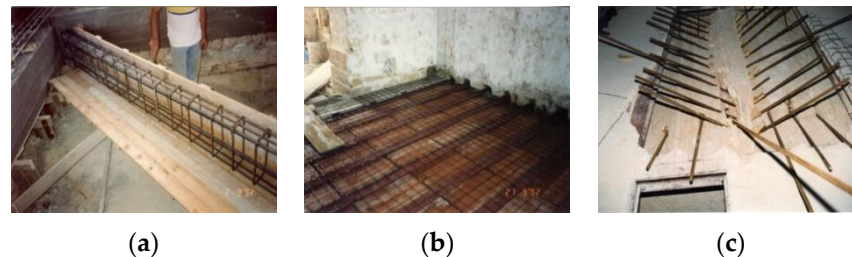
Boscarino and Cottone's intervention in the 1990s was performed after the damage due to the 1968 earthquake. In particular, the floor of the President's Room is still severely damaged, as well as the room with the Piazzzi Library, which is even more damaged, with a strongly cracked vault, shored up in a currently visible safety intervention, which should have been provisional.

**Figure 11.** Details of the execution of the Boscarino–Cottone intervention (1990s): (a,b) photos related to the floor slab of the room on the left of the gallery, showing the diagonal crossbeam and the electro-welded mesh above hollow blocks; (c) reinforcement of the central vault for the sustainment of the steel reticular column which supports Mertz's equatorial telescope.

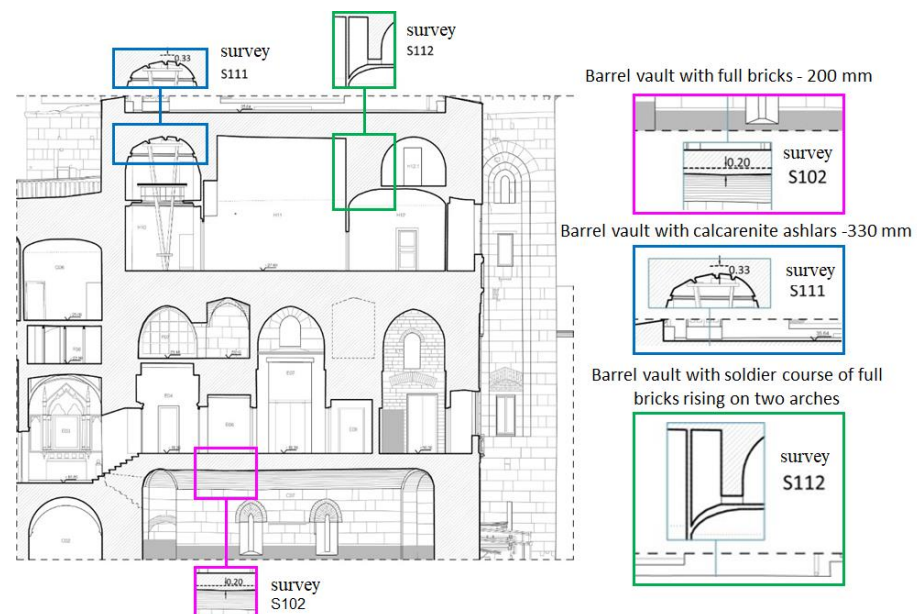
tower on the same level (sample S104), and in the Director's Office on level H (samples S109 and S110). The width of the barrel vault of the ambulatory surrounding the Treasure Room (sample S102) and of the barrel vault above the Piazzzi Library (sample S111) were surveyed. Despite the latter being currently covered by plaster, the constituting material was determined to be calcarenite ashlar. Finally, the real current structural configuration of the vault on the passageway between the Piazzzi Library and the Observatory Director's Study was obtained, as it is hidden by partition walls and false ceilings. Horizontal sampling on a wall (sample S112) highlighted that the barrel vault had actually been realized with a soldier course of full bricks and that it rises on two arches: one of them is visible, while the other one is hidden by the abovementioned partition walls. Figure 13 shows the locations of samples S102, S111, and S112, which provided these results.

**Figure 13.** Results of endoscopic surveys S102, S111, and S112.

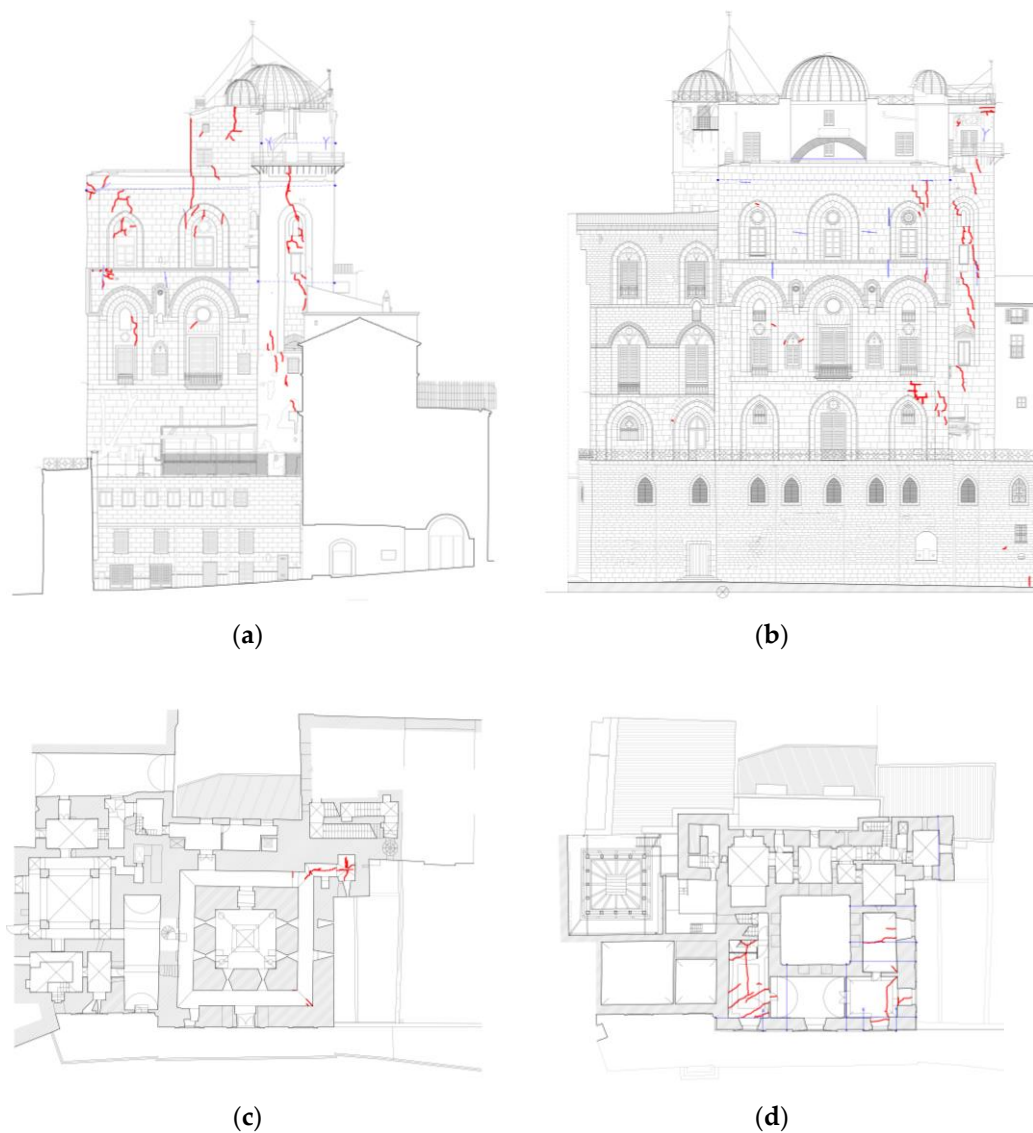
During the long life of the Royal Palace, many significant seismic events have occurred, and these have produced damage, which has been documented since 1693 [22] because of the various architectural modifications and the proximity of the Kemonia creek, which had a higher flow at that time. In particular, the Pisan Tower suffered significant damage during the 1968 earthquake, leading to the unavailability of some rooms on the level of the Observatory, with severe cracks in the vault of the Piazzzi Library, which is currently still shored up for safety reasons. Comparison should be made of the current crack pattern—possibly worsened by the recent earthquake on 6 September 2002—with surveys of previous cracks; however, there was no available documentation for this purpose. Figure 14 shows some of the technical drawings by Officina per le Arti Opera, which illustrate the crack patterns.

**Figure 14.** Crack patterns (in red) and steel ties (in blue) (from the drawings of the Officina per le Arti Opera company): (a) on the north side; (b) on the east side; (c) on the floor plan at the height of 13.00 m; (d) on the floor plan at the height of 28.70 m.

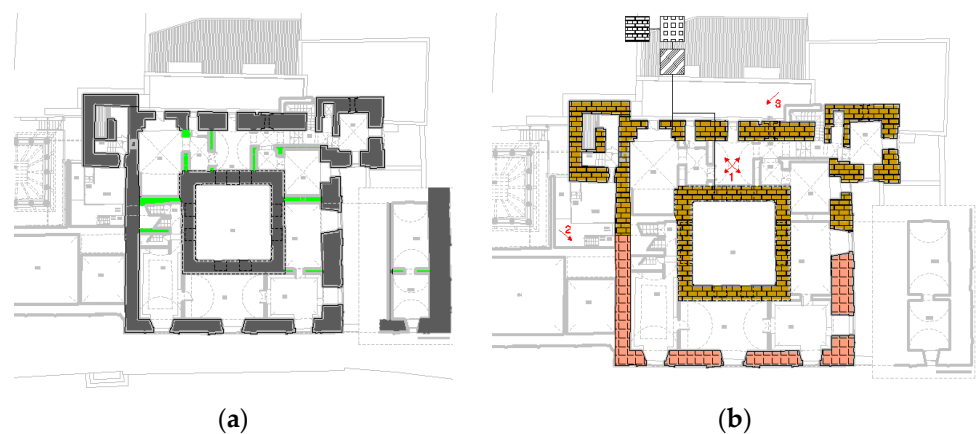
At the level of the Piazzzi Library (level H), which hosts rooms of both the Astronomical Observatory and the ARS, the load-bearing structure provides the layout with concentric quadrilaterals (Figure 21a). The compactness and rigidity of the system are notably reduced by the narrow width of the walls, and by the numerous openings. As discussed in the previous paragraphs, the east side of the Tower probably represents an addition from the period of the Spanish Viceroyalty. Hence, techniques and materials differ significantly from the Norman construction (Figure 21b). This circumstance was also confirmed by the mechanical characteristics surveyed in the Spanish masonry, which was characterized by low values of compression strength as compared to those of the Norman masonry and to the suggested values for masonry walls in soft stone ashlars. These intrinsic flaws in the masonry, together with the presence of many transfer walls between the two squares in the load-bearing structure of the Tower, have certainly led to a relevant vulnerability. The effects of the 1968 earthquake and the constant and abundant infiltrations from the terrace of the upper level have produced several instability phenomena, including diffuse—and worrisome—cracks in both vertical and horizontal structural components. Following these damages, the rooms of the Observatory were shored up and made inaccessible. The cracks in the floor slabs are often extended in the walls, hence disrupting the wall structure and leading to additional vulnerability.

**Figure 21.** Identification of the structure of the Tower on level H (height 28.70 m): (a) hypothesized vertical load-bearing structure; (b) hypothesized materials.

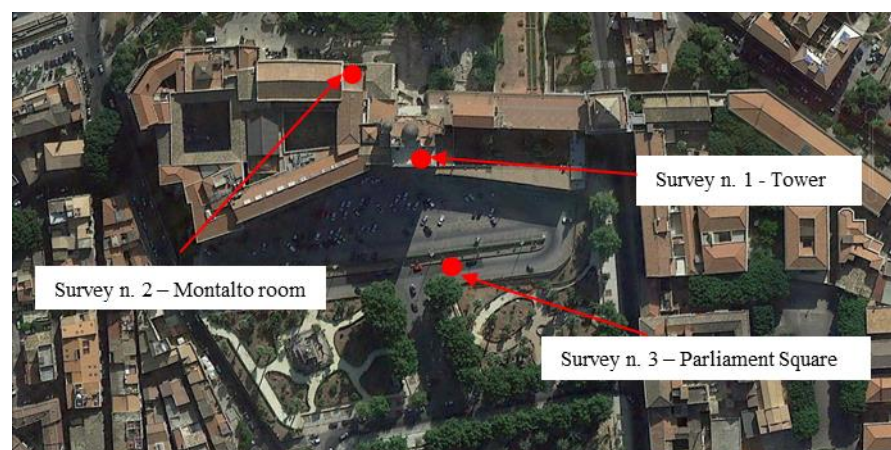
The surveys were performed at the points shown on the planimetry in Figure 27; the first one was inside the Tower at the lowest height (n. 1), the second one was outside the Tower, but at a lower height corresponding to the Montalto Room (n. 2), and the third one was in Parliament Square (n. 3), just beyond the caretaker’s office at the entrance. Survey n. 1, named “Tower”, obtained a value of  $V_{S,30} = 342 \text{ m/s}$  and a width of 8 m for landfill on the sandy–calcarenite complex. Survey n. 2, named “Montalto room”, obtained a value of  $V_{S,30} = 345 \text{ m/s}$  and a width of 5 m for landfill on the sandy–calcarenite complex. Survey n. 3, named “Parliament Square”, obtained a value of  $V_{S,30} = 352 \text{ m/s}$  and a width of 5 m for landfill on the sandy–calcarenite complex.

**Figure 27.** Planimetry with the location of the surveys.

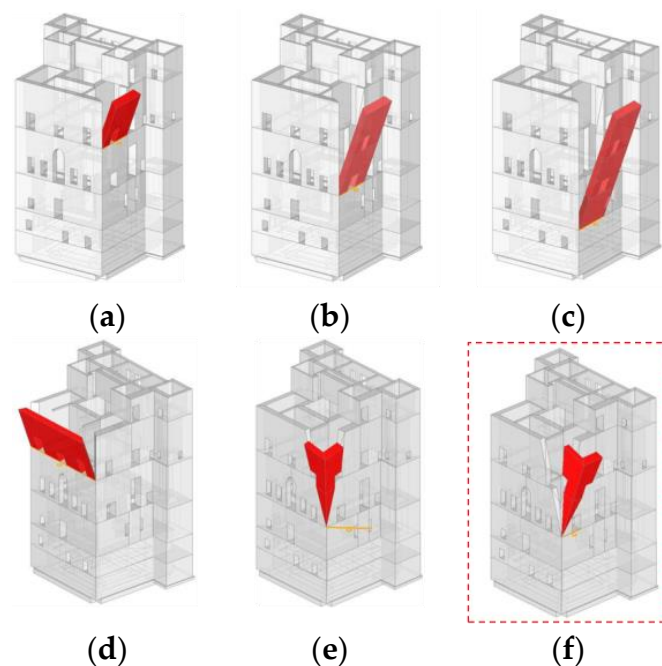
**Figure 29.** Axonometric views of the theoretical local collapse mechanisms: (a–c) rotation of the north wall at different levels; (d) rotation of the east wall; (e) rotation of the north-east corner area; (f) most probable simple overturning of the north wall (angle  $\gamma = 0$ ) and a portion of masonry in the east wall.

The obtained results show that the most likely failure mechanism involves the simple overturning of the north wall (angle  $\gamma = 0$ ) and a portion of masonry in the east wall.
