Path of Knowledge for the Assessment of Structural Safety of the Pisan Tower of the Royal Palace of Palermo in Italy

# Path of Knowledge for the Assessment of Structural Safety of the Pisan Tower of the Royal Palace of Palermo in Italy

**Abstract:** This paper presents the path of knowledge developed for assessing the structural safety of the Norman-age Pisan Tower, which is mostly incorporated into the Royal Palace in Palermo, Italy. Historical, geomatic, and mechanical investigations were conducted and the most relevant results are herein collected and presented. The research path was addressed to specific tasks: identification of the building, geometric surveys, recognition of the sequence of phases of building transformation, detection of the components of the load-bearing structure, structural diagnostic surveys, and investigation of the subsoil and foundations. The explicit vulnerabilities found were mostly confined to the Piazza library floor, while implicit vulnerabilities were identified in the presence of false walls and in high loads and fillings on the vaults of the last levels. The results of the analyses allowed the individuation of the confidence factors to use in

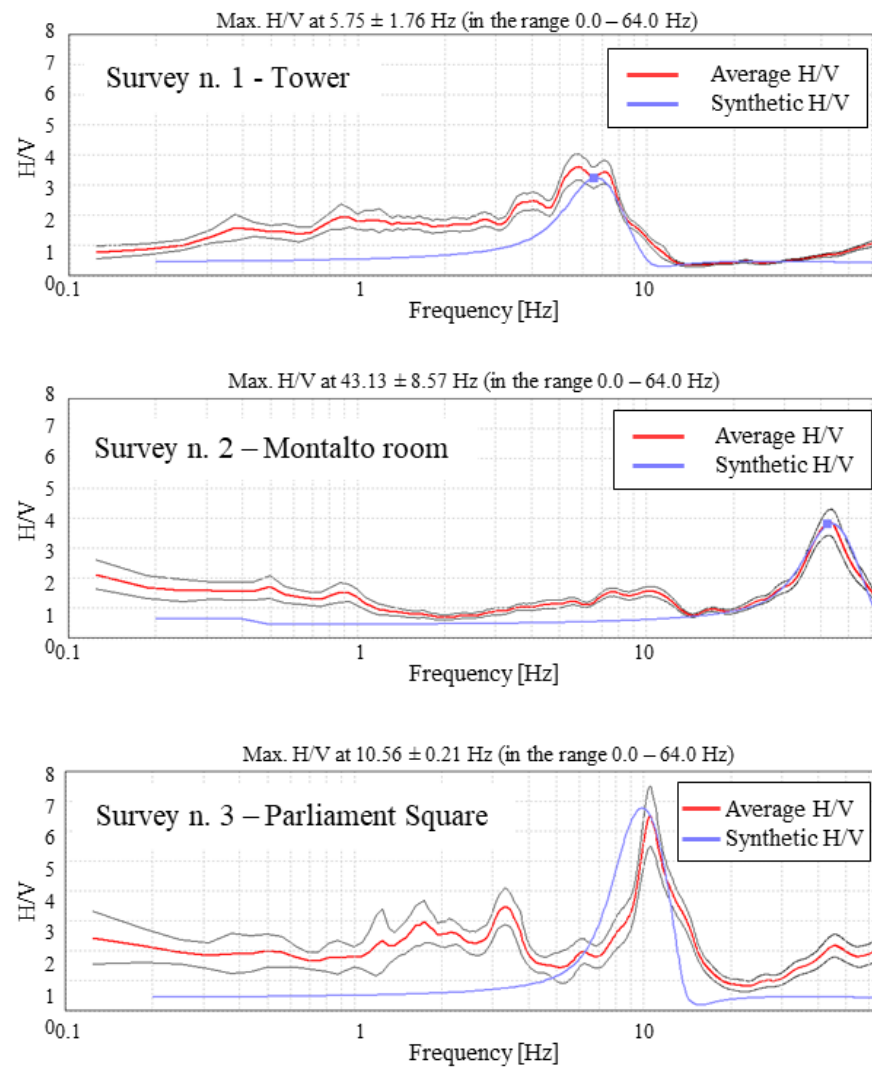
In accordance with chapter 3 of *Guidelines*, which defines seismic action with reference to Section 3.2.2 of NTC2018, and hence according to the value of  $V_{S,30}$  obtained in the three tests, the soil class to be assumed for the definition of the response spectra was Class C—coarse-grained, medium-dense soil deposits or fine-grained soils with a medium consistency, thicker than 30 m, characterized by a gradual improvement of mechanical properties along with the depth, and by values for  $V_{S,30}$  between 180 m/s and 360 m/s (that is,  $15 < N_{SPT,30} < 50$  in coarse-grained soils and  $70 < c_{u,30} < 250 \text{ kPa}$  in fine-grained soils). Figure 28 shows the details of the interpretations of the experimental data obtained.

Depth [m]	Thickness [m]	$V_s$ [m/s]	Poisson's Ratio
<b>Survey n. 1 – Tower</b>			
8.00	8.00	209	0.40
inf.	inf.	445	0.35
<b>Survey n. 2 – Montalto room</b>			
1.00	1.00	168	0.40
inf.	inf.	358	0.35
<b>Survey n. 3 – Parliament Square</b>			
5.00	5.00	180	0.42
inf.	inf.	436	0.35

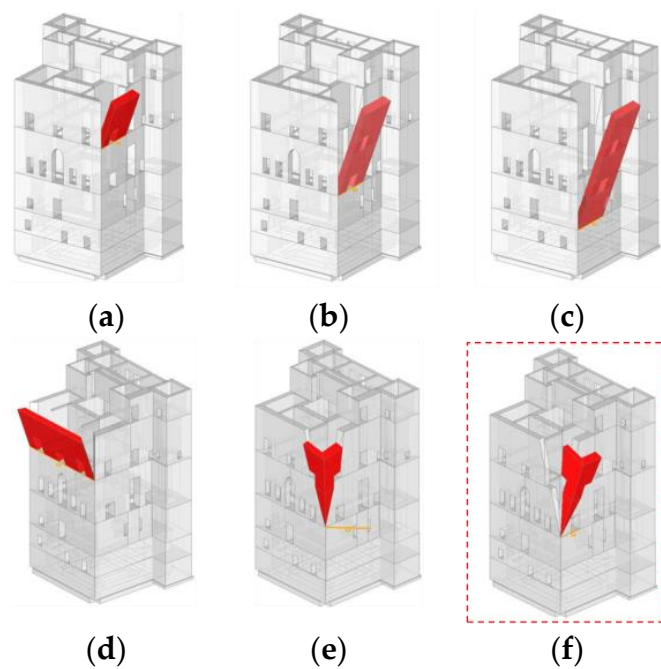
Among the vulnerabilities examined, particular attention is required for the recent rupture of the bolt and consequent unthreading of the contrasting chain of the roof vault that insists on the north-east cantonal. This may lead to a local mechanism associated with a rotation of the north wall of the Tower, the east wall, or the corner area. The parts of masonry involved in the local mechanism have been determined according to the existing crack pattern, and the mechanisms indicated in Figure 29 have been studied with a cinematic linear analysis.

**Figure 29.** Axonometric views of the theoretical local collapse mechanisms: (a–c) rotation of the north wall at different levels; (d) rotation of the east wall; (e) rotation of the north-east corner area; (f) most probable simple overturning of the north wall (angle  $\gamma = 0$ ) and a portion of masonry in the east wall.

The obtained results show that the most likely failure mechanism involves the simple overturning of the north wall (angle  $\gamma = 0$ ) and a portion of masonry in the east wall.
