## Plasma impact on diagnostic mirrors in JET

# Modification of diagnostic mirrors in current and next-step fusion devices

**Modification of diagnostic mirrors in JET**

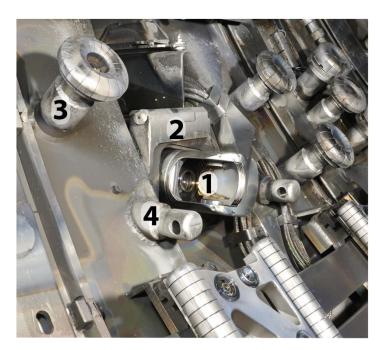
Figure 1: Top of the JET vessel: 1) mirror, 2) periscope head, 3) castellated mushroom roof limiter, 4) crane rail.

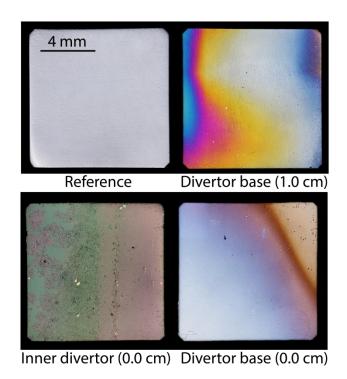
Visual inspection revealed that all divertor mirrors were covered with smooth-looking layers displaying a variety of colourful patterns thus indicating inhomogeneous material deposition. The appearance of several surfaces is presented in Figure 2. The total reflectivity was degraded by 50 - 80 % regardless of the substrate material or the location in the carrier. Plots in Figure 3 show the reflectivity for the outer divertor mirrors before and after the exposure to plasma. The distances in the legend refer to the depth of the mirror in the channel of the

Figure 2: Visual inspection of divertor mirrors after exposure to plasma.

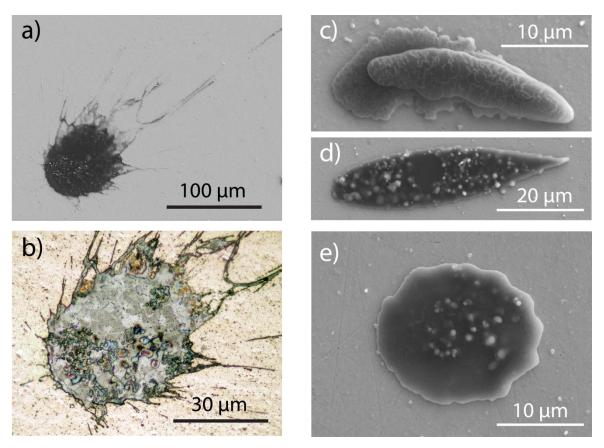
Surface composition of the mirrors is presented in Table 2. There is a significant difference between the specimen at the carrier entrance and those located deeper. In the latter case the concentrations of D, Be, C, N and O impurities are at the level of about  $1-3x10^{16}$  cm<sup>-2</sup>, while tungsten is below the detection limit of  $5x10^{13}$  cm<sup>-2</sup>. On the contrary, the mirror at the entrance (position 0 cm) is coated by a layer of 600 nm composed mainly of beryllium. Photographic survey performed during the shut-down showed melting of beryllium limiters in the vicinity of the mirror carrier. The fairly thick beryllium layer was most probably deposited on the mirror surface during such off-normal events.

Results of detailed topographical studies performed with SEM and EDS on the mirror at position 0 cm are shown in Figure 6 and 7. On top of the fairly uniform co-deposits there are numerous macroscopic particles of various shape and size: from 3 µm to over 100 µm. These are elongated splashes (Fig. 6 (a-d)), flat splashes (Fig. 6 (e)) and spherical droplets (Fig. 7(a)). The variety of objects gives strong indication that they were deposited at different events. The elongation proves that splashing occurred under strong magnetic field. The splashes cannot be associated with a single disruption because they have different orientations. A common feature of all these objects is the presence of beryllium as the main component. The other detected elements in all particles are: C, N, O and traces of steel and Inconel alloy constituents. The spherical droplet shown in Fig. 7(a) is not splashed and its composition is complex (see EDS spectrum in Fig. 7(b)). Besides light elements there are also heavy species: W, Mo, Ni, Cu and Fe. It gives a fairly strong indication that the origin of such particle(s) is not associated with melting and splashing of the limiter material. One may suggest that it is most probably a W-Mo or W-Ni particle formed earlier in another region of the machine and then transported, for instance, during a disruption. The deposition of other species (Be, C, N) occurred when the droplet was already residing on the mirror surface. This statement regarding the droplet composition and the sequence of events is justified by the detection of beryllium on the surface. The energy of  $Be(K_{\alpha})$  radiation is only 108 eV and would not have been detected if it was a Be droplet coated with high-Z species.

Figure 6: Images of beryllium splashes on the surface of the mirror at position 0 cm. The splashes have elongated (a-d) or flat (e) shapes. Images (a) and (b) show the same particle under electron and optical microscopy respectively.

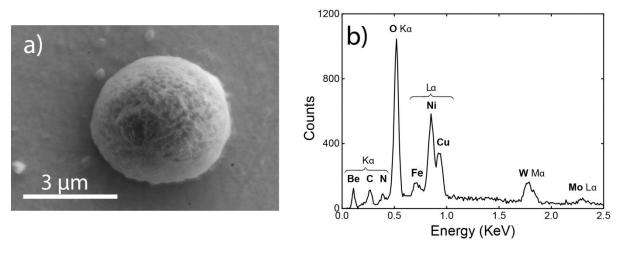
Figure 7: (a) spherical droplet on the surface of the mirror at position 0 cm, (b) EDS spectrum of the spherical droplet.

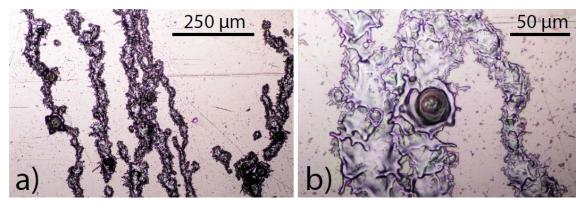
Li-beam diagnostic mirrors were retrieved after the 2011-2012 and 2013-2014 campaigns. Images in Figure 8 show the appearance of those mirrors. In both cases, significant areas of their surfaces were damaged. The topography of the damaged area, as recorded by optical microscopy in Figure 9, clearly proves melting of the surface layer (Au coating and the

stainless steel substrate) by arcing. Arcing is a well-known erosion process in fusion devices [18-21]. The main conditions to form electric arcs are a sufficiently high potential and an electron-emission spot such as a small surface protrusion (for instance, a beryllium droplet). In the presence of magnetic fields, the cathode spot moves across the material in the direction perpendicular to the magnetic field. This effect is known as retrograde motion and it produces characteristic dendrite-like tracks, as those observed in the mirror [22].

Figure 9: Optical microscopy pictures of the surface of the Li-beam diagnostic mirror: a) arc traces along the mirror surface, b) detail of material melting produced by arcing.
