II Fabre Conference – Existing bridges, viaducts and tunnels: research, innovation and applications (FABRE24)

Preliminary Insights from Surveys of Bridges at High Scouring Risk in West Piedmont

Mauro Aimar^a, Marco Civera^{a*}, Sebastiano Foti^a, and Bernardino Chiaia^a

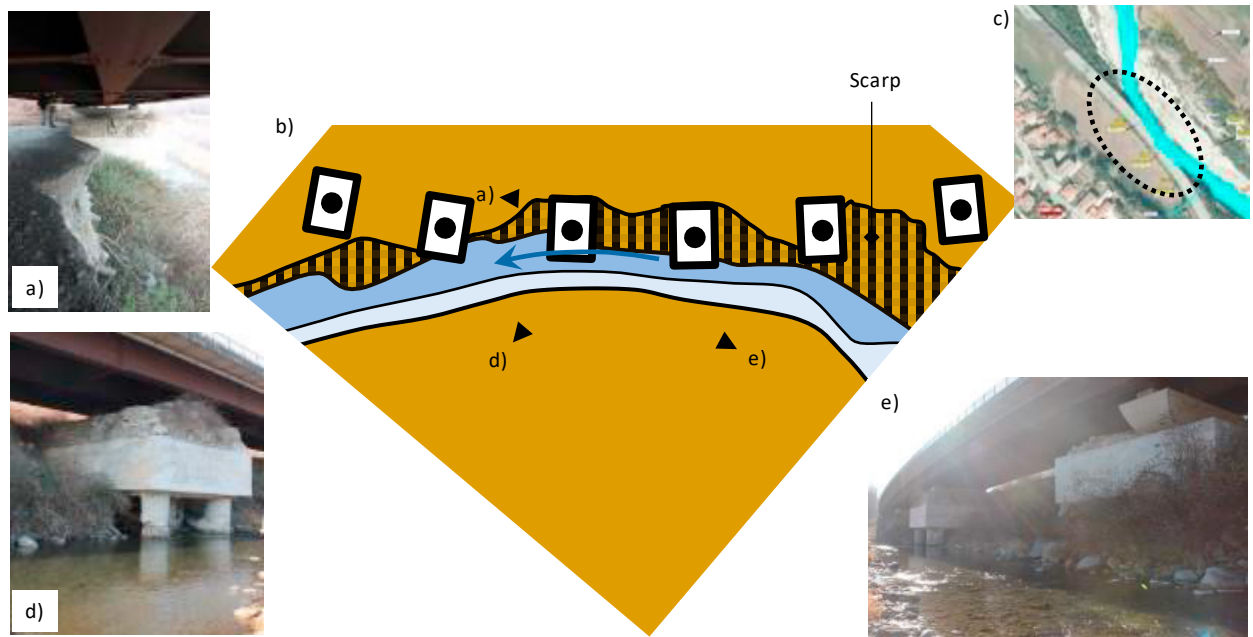
On the one hand, the Inverso Pinasca bridge (PIP) is part of a thalweg road running parallel to the Chisone river, in the Western part of the Metropolitan City of Turin. The superstructure is characterized by a continuous, composite steel-concrete deck with excellent conditions, also due to the relative short age of this structure – the construction year is 2005. However, the river main channel has gradually shifted towards the road axis, thus inducing significant lateral scouring on the foundations of part of the piers (Fig. 4). As each pier is supported by deep, large-diameter piles, foundation scour should not dramatically affect the safety conditions of the bridge, in this case. On the other hand, the different entity of erosion from pier to pier may induce some asymmetry in the structural response. To avoid further extension of the erosion, the infrastructure manager planned a retrofit intervention, consisting in a restoration of the original morphology, soil improvement through jet grouting injections and protection through rock walls. For this reason, this bridge will be further investigated to better understand its behaviour and have an insight into the effects of such an intervention.

Figure 4. Plane view of the portion of the Inverso Pinasca (PIP) bridge affected by foundation scour (c, d). For simplicity, in (c) only the piers and the foundation pads are represented. The sketch is integrated with photos taken below the deck (a) and from the other side of the river (d, e).

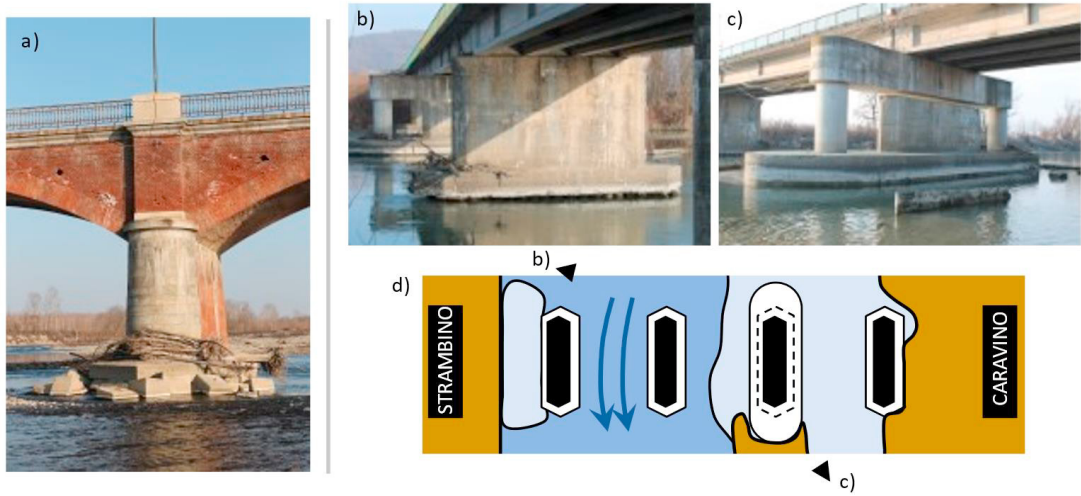
As stated above, also other bridges are affected by foundation scour, whereas the structural conditions are excellent. For instance, the Crescentino bridge (PCR in Fig. 2) is a multi-span masonry bridge crossing the Po river, where the spans crossing the main river channel are quite significantly scoured (Fig. 5a). Nonetheless, no damage was observed on the superstructure. Similarly, scouring is relevant at the Strambino bridge (PST in Fig. 2), on the Dora Baltea river (Fig. 5b-d). This case study is peculiar because it was retrofitted after the 2003 survey (specifically, in 2004). Indeed, the strong erosion induced by the 2000 flood urged for a reinforcement of the foundations of one of the central piers (Fig. 5c). This intervention and its effectiveness were addressed in detail (Nemry & Demirel, 2012). As shown in Fig. 5d, the 2023 survey highlighted a migration of the main river channel towards the Strambino side, worsening the foundation conditions of part of the remaining piers. Instead, the retrofitted pier seems not to be any longer affected by the main river flow. Therefore, the benefit of the retrofit intervention has been counterbalanced by the increased erosion on other piers due to river migration.

Figure 5. a) Photo of a pier at the Crescentino (PCT) bridge. The presence of concrete blocks indicates that the pier is affected by foundation scour; b-d) Survey results for the Strambino (PST) bridge: photos of original piers (b) and of the retrofitted one (c) and plane view of the piers with the location of the main river channel (d).
