## **Non- destructive characterization of carbon fiber composite/Cu joints for nuclear fusion applications**

## **Abstract**

Several non-destructive testing methods, lock-in thermography, ultrasonic inspection, microtomography and microradiography, were used to assess the manufacturing quality of joints between carbon fiber reinforced carbon composites and Cu/ CuCrZr.

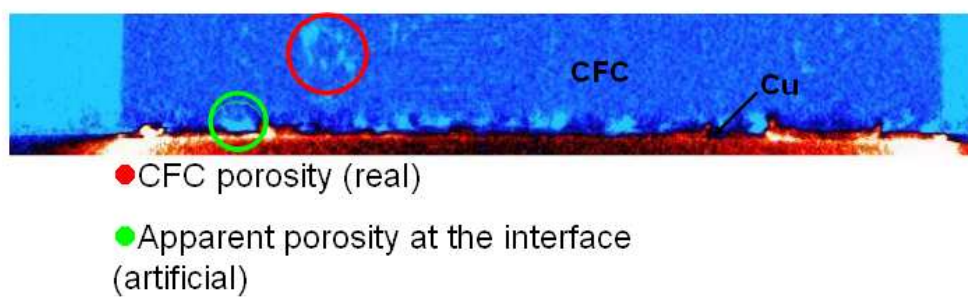
Figure 10

The effects of highly absorbing materials on tomographic reconstruction could lead to some “star-artifacts” (white rays radiating away from a spot, a typical star-like pattern also known as metal-artifact.) on the surface of the analyzed sample; they correspond to “lack of information” zones (figure 10). These spots could be explained as voids at CFC/Cu interface but actually they are reconstruction artifacts.

**Figure 10** Artifacts at the CFC/Cu interface

In order to avoid these artifacts, X-ray energy should be enhanced; nevertheless, there will be a lack of information on CFC bulk, since it's less absorbent. In this case, the X-ray beam can penetrate the CFC bulk but there is not enough contrast to detect the CFC/Cu interface.

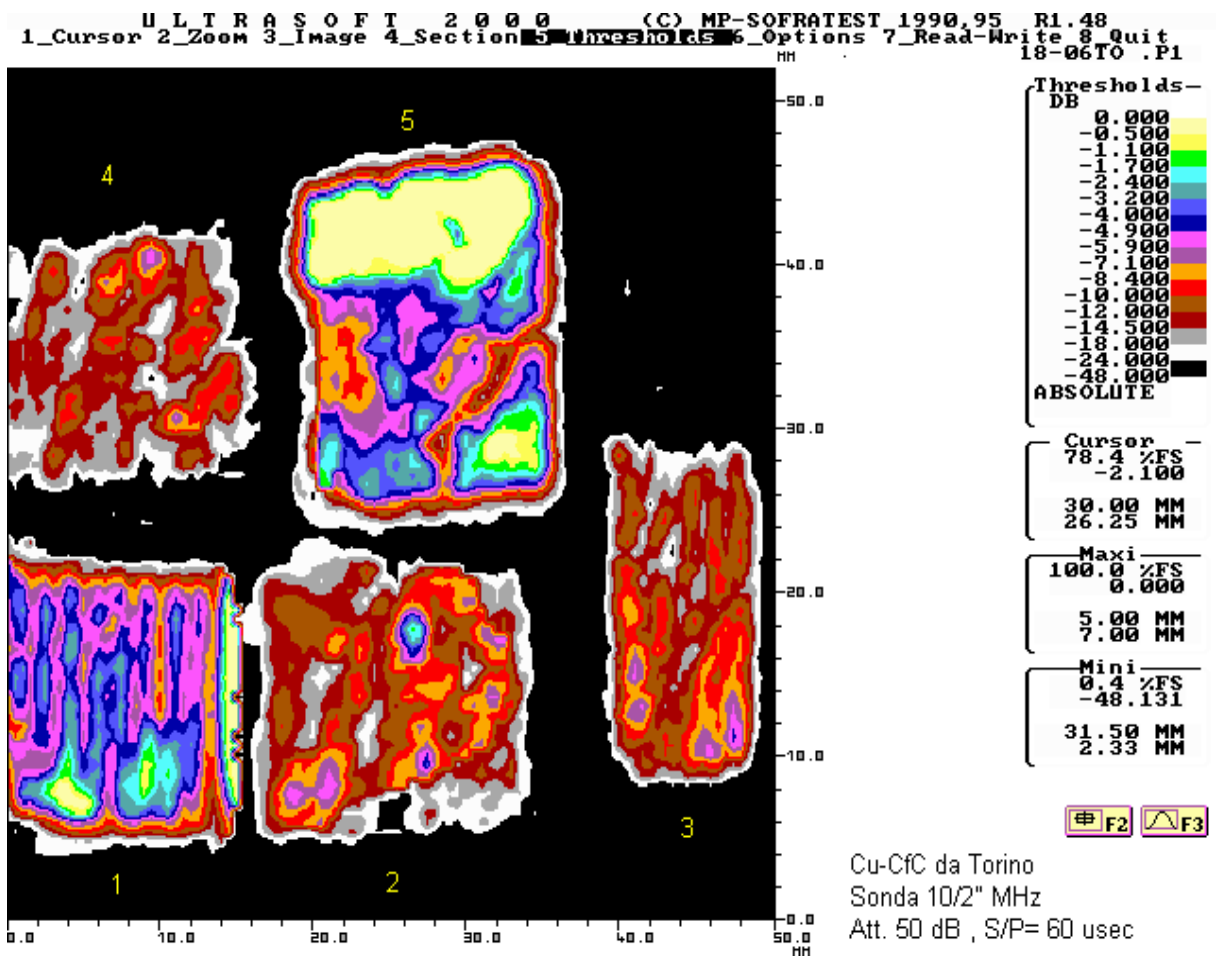
Figure 14

Ultrasonic inspection gave divergent results also for examination of CFC NS31 (silicon doped carbon-carbon) joined to Cu; 5 samples were tested before thermal fatigue test. Sample 1 and 5 (figure 14) showed many defects, especially sample 5 in the upper part (yellow area); these two samples sustained 30 cycles during thermal fatigue test and fracture surface analysis didn't reveal significant detached areas at interface.
