Large N.G. explosion and fire involving several buried utility networks

N. Piccinini⁽¹⁾, R. Tommasini⁽²⁾, E. Pons⁽²⁾

Abstract

This paper describes an accident (explosion and natural gas fire) that occurred in Turin (Italy), in which power distribution cables, tramway network feeding cables and a gas pipe were involved.

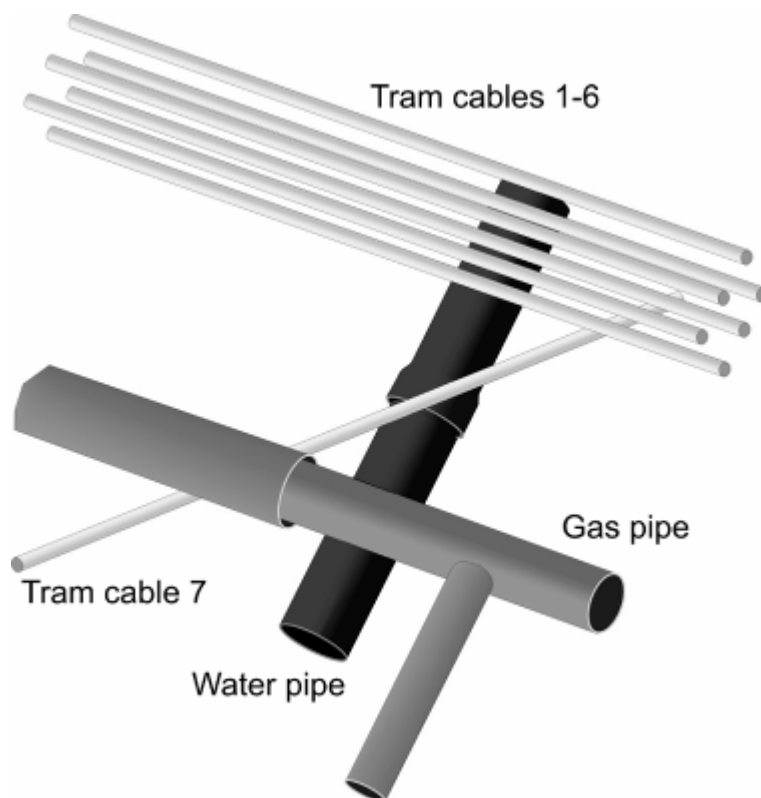
Fig. 3 – Lower buried facilities

There were many buried utilities below the road where the accident took place; from the ground surface and going downwards (for a detailed depth survey see Fig. 1) there were: traffic lights, tram points, public lighting, power distribution and tram network power cables, gas pipes and water pipes. The layout of the lower installations is described in Fig. 3.
