## Considerations over the Italian road bridge infrastructure safety after the Polcevera viaduct collapse: past errors and future perspectives

Fabio Bazzucchi, Luciana Restuccia, Giuseppe Andrea Ferro

**ABSTRACT.** In the last four years, Italy experienced the collapse of five road bridge: Petrulla viaduct (2014), Annone (2016) and Ancona (2017) overpasses, Fossano viaduct (2017) and Polcevera (2018) bridge.

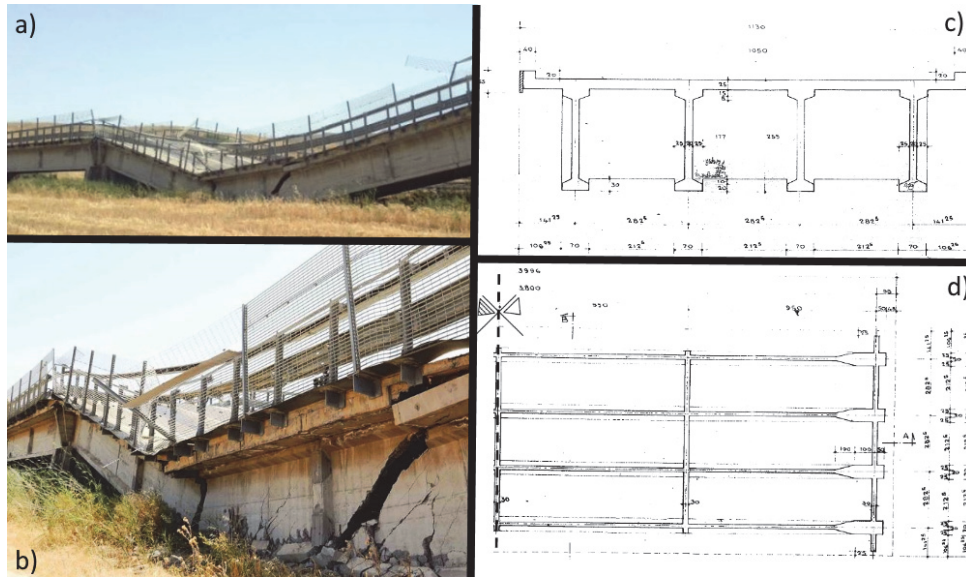
The Petrulla viaduct is situated along the S.S. 626 "Valle del Salso", at km 4+500, in Sicily. The viaduct consists in a series of 12 simply supported beams, each of them with a 40 m span (Fig. 1(a)). On July 7, 2014, one span collapsed, injuring 4 persons. The breakage occurred in mid-span circa, and then, shear failure occurred where the deck impacted ground (Fig. 1(b)). The deck, 11.30 m wide, was made of 4 precast and prestressed concrete I-beams equally spaced by 2.850 m. Five transverse beams realized the girder that supported the pavement slab (Fig. 1(c)). The investigation, conducted after the collapse, evidenced an exceeding state of material decay for the steel components: diffused oxidation in the prestressing cables, severe corrosions of the metallic sheathing and large absence of the protective grout inside the cables (Fig. 2(a), Fig. 2(b)). Since the bridge was built in the mid-80s, this degradation pattern was not compatible with 30 years of service life, especially because the concrete exhibited good signs preservation (Fig. 2(c)). The investigations have evidenced several construction flaws, in particular related to finishing operations of the prestressing. The grout injection was superficially carried out and the vent pipes were not accurately sealed (Fig. 2(d)). Under these circumstances, humidity found a preferential way into the cables, and its continuous content variation generated an aggressive environment for steel oxidation. Other additional deficiencies for this particular degradation scenario were addressed to:

- not sufficient cover due to malposition of the prestressing cables;
- not adequate workability and fluidity of the concrete;

- inadequate waterproofing covering of the joints.

Figure 1: Overview of the Petrulla viaduct (a); collapsed structure (b); original design of the deck (c,d).

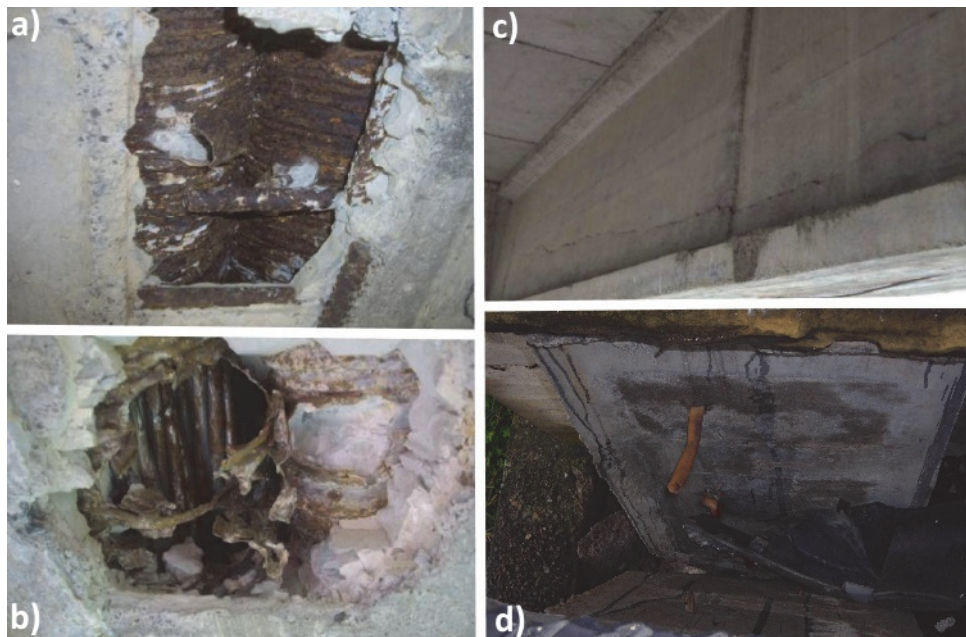
Figure 2: Steel components corrosion, strands (a), metallic sheathing (b); concrete condition (c); unsealed vent pipes (d).

Petrulla Viaduct characteristics have been discussed in section 1. The oxidation of the reinforcing and of the prestressing cables (Fig. 2(a), Fig. 2(b)) occurred due to an inadequate protection by carbonation and water seepage. Through the results of the vulnerabilities, four different restoration interventions have been proposed, corresponding to the observe damage degree (Fig. 3(a), Fig 3(b)). For the level one (G), the removal of the actual concrete coverage and corroded bars, followed by their complete refurbishment, was suggested (Fig. 15(a)). Considering the second level (Y), to assure the adequate safety factor, the installment of a metallic plate was suggested to reinstate the base of the I-beam. This plate was supposed to be connected to the web through two lateral bolts and a glued to the base of the I, previously abrase. The injection of epoxy resins realized the final sealing and the protection from further corrosion. For the third level (B), the intervention is the same of the discussed previous one with the additional injection into the prestressing cables with low-viscosity epoxy (Fig. 15(c)). Concerning the worst damage case (R), the corroded section area of the strand must be recovered to fulfill the safety factor. In order to do so, an external prestressing was suggested, connected to the sealing steel plates and the cable header (Fig. 15(d)).

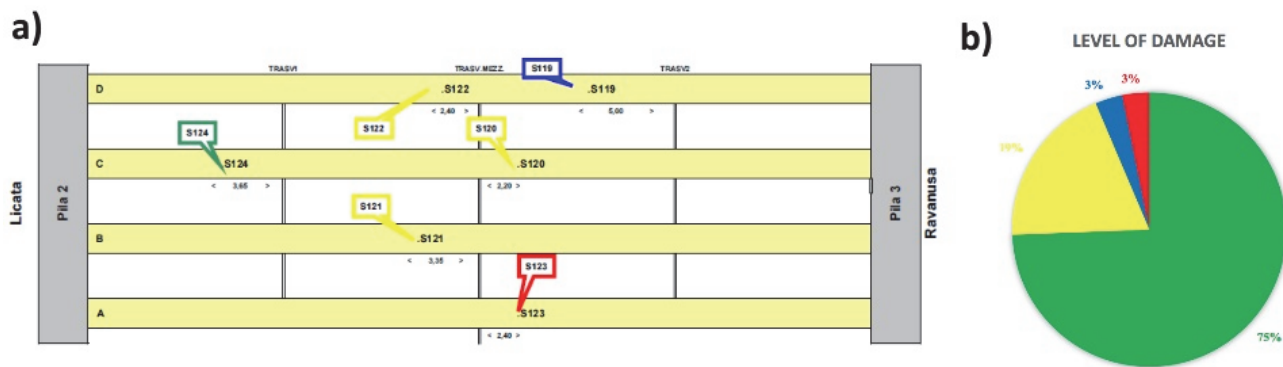
A visual inspection campaign was carried out for all the others remaining beams that constituted the Petrulla viaduct. Four level of damage degree were defined, from no noticeable damage (green) to exposed prestressing cables with visible signs of oxidation (red). In Fig. 3(a), the visual inspection location with its relative degree of damage for the bridge n. 2 has been reported. In Fig. 3(b), results for the entire viaduct have been summarized. It is worth to note that, even if less than 7% of the cases had a high degree of damage (blue and red), they represented 8 different visual inspections, which meant 8 possible beams with no active prestressing forces. This viaduct has been object of reparation and after four years has become operative again. It is reasonable to say that the investigation, repair, and public costs due to the inoperable structure are significantly higher than the ones associated with careful construction procedures. The adopted safety solutions are discussed in the next section (par 6).

Figure 3: Example of the deck visual inspections (a); damage degree results survey (b).

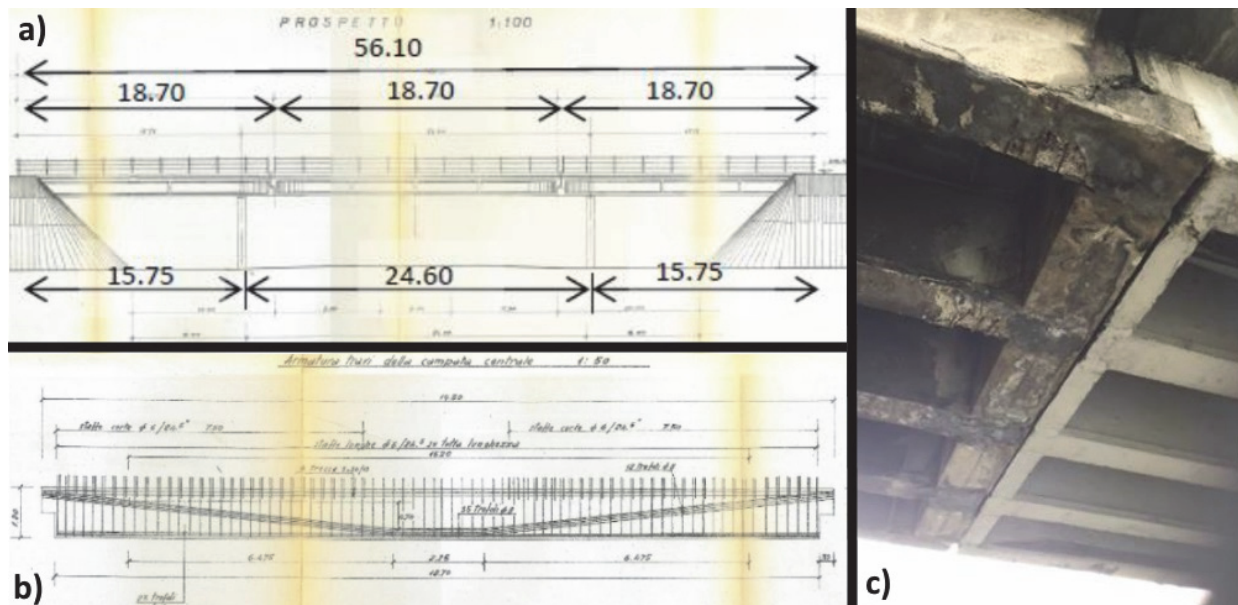
The collapse of the Annone overpass, Lecco, at km 42.000 along the S.S. 36 “del Lago di Como e dello Spluga”, occurred on October 18, 2016. The failure had a high impact on the Italian society since it caused the death of a car driver and several wounded. The bridge was built between the 1960 and 1962, with a Gerber scheme deployed over 4 supports (Fig. 4(a)). The central deck, 24.60 m long and 4.40 m wide, was constituted by 5 precast and prestressed I-beams. Gerber supports were 0.575 m high, with and ordinary reinforcement as shown in Fig. 4(b) and Fig. 4(c). Before the collapse, the bridge was subjected to several impacts by underlying moving vehicles [1]. This was due a non-adequate free height of the overpass ( $< 5$  m). After these events, the saddle was repaired with rebars and CFRP installments (Fig. 5(a)). However, those interventions could not renovate the shear fracture propagated over the saddle and significant presence of humidity was often detected when inspected (Fig. 5(b)). This was mainly due to the produced misalignment in the dapped-end (2.5 cm) due to the repairs, which constituted a stagnation point for running water [2].

Figure 4: Overview of the Annone overpass [1] (a); Geber support reinforcement, design (b) and investigation (c).

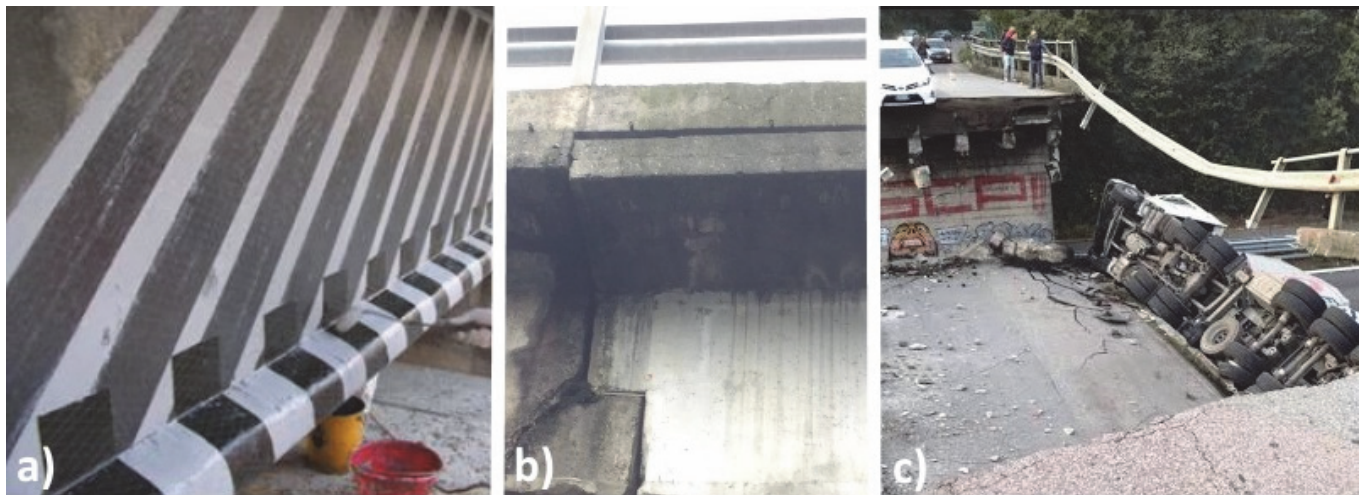
The collapse occurred when a 107.6 t heavy 8-axels truck went across the deck with a low moving speed (Fig. 5(c)). Once the load was carried entirely by the central beam, the external repaired dapped end corbel collapsed due to the vertical reaction established for supporting the beam. Total weight on the structure was approximately 172 t, which is 10 % higher than the maximum design load adopted equal to 155 t. However, this excess should have been overcome in the safety factor. This bridge was catalogued as category II by Italian Building Codes [3], but the safety requirements were not fulfilled by the structural properties. Investigation [1] have demonstrated that this failure was compromised by:

- an initial design flaws in the dapped-end corbel that significantly reduced the ultimate load;

- reinforcement in the precast beams was not enough to ensure a category II bridge classification;
- the presence of a shear fracture along the dapped end corbel promoted the oxidation of the reinforcement bars in the joint;
- the passage of II category loads (more than 100 per year) puts frequently the structure close to its ultimate bearing capacity.
- the eccentricity produced by a transit misaligned by the carriageway central line significantly increased the loading in the external dapped end joint.

Figure 5: Dapped end corbel conditions before the collapse (a); humidity presence and water stagnation (b); failure loading configuration (c) [1].

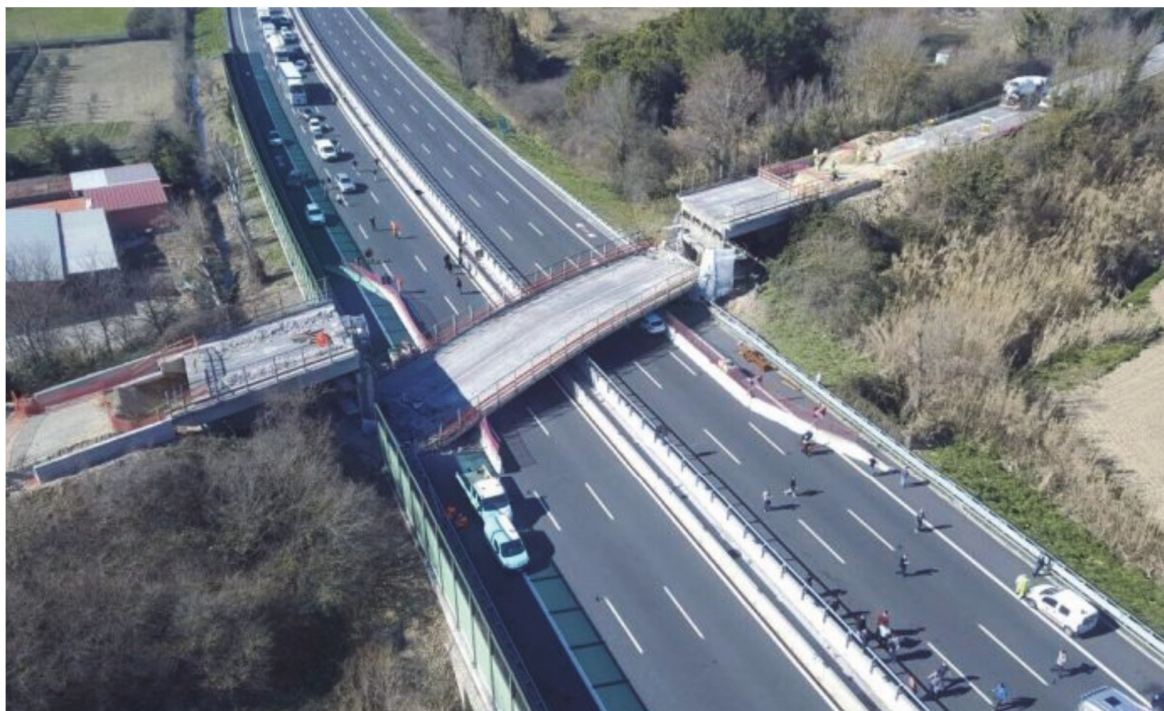
Figure 6: Ancona overpass after the collapse (from web site [www.cronacheancona.it](http://www.cronacheancona.it)).

This collapse occurred on 9 March 2017, near Ancona, along the A14 Italian Highway. The bridge (167 at km 235+800) was constituted by a steel-concrete composite deck 16.5 m wide and 36 m long with a simply supported beam scheme (Fig. 6). When collapsed, the deck was uplifted for maintenance operation and it was supported by a temporary structure. The deck fell on the underlying highway, causing the death of 2 people that were transiting underneath.

The case of the collapse of the overpass on the A14 motorway near Ancona is quite different from the others and was caused only by a resounding error during the execution phase. The works involved the adjustment of the altimetric height of the overpasses, consisting of raising the decks, creating an extension of the support structures and the re-profiling of the associated ramps. The lifting took place through the use of hydraulic jacks with few centimeters steps, after positioning of steel plates for distribution. The appointed subcontractor to perform this specific process decided to replace the supporting steel plates with similar plates in neoprene, much lighter to move. Numerical analyses conducted during investigations by prof. Tarantino highlighted how a difference between the temporary supports of a few millimeters generates horizontal forces not compatible with the shear deformability of the numerous neoprene plates stacked on top of each other. This generated an unexpected bridge horizontal displacement and the collapse occurred. Further details are under investigation.

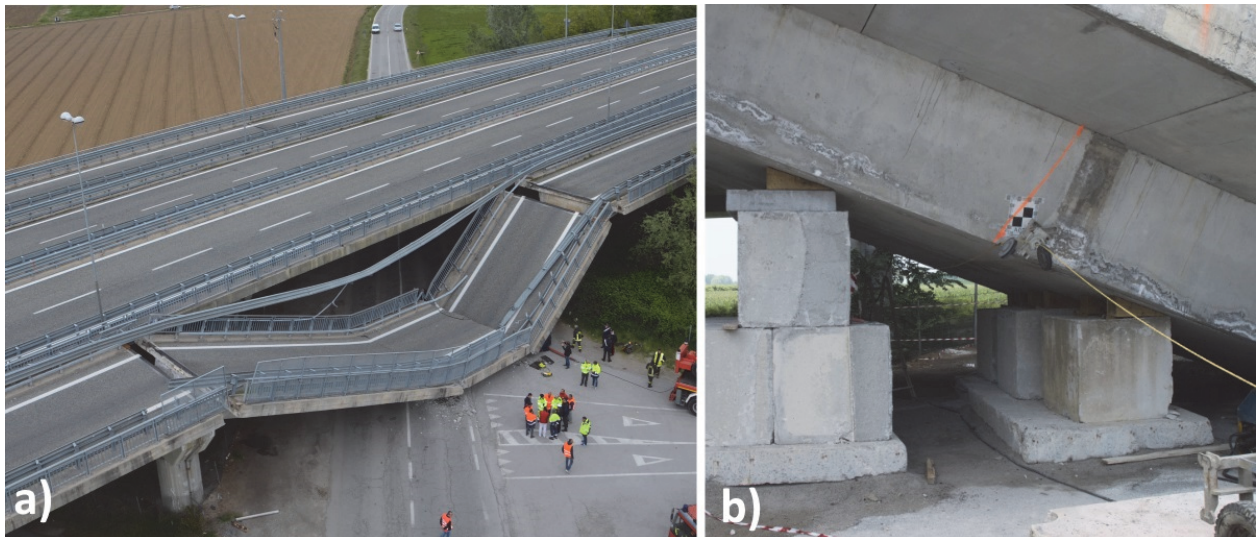
Figure 7: Overview of the collapsed Fossano bridge (a) and structural scheme (b).

The collapsed overpass is one of the 108 that constitutes the Fossano (Cuneo) bypass road. This road has several viaducts, and the one involved in the failure is one of the ramps of La Reale Viaduct, where it crosses the S.P. 165. The collapse occurred on April 18, 2017, and luckily (2.45 p.m.) no vehicles were going across or underneath the structure. The sudden collapse took place without out-of-plane displacements (Fig. 7(a)). A modest slip ahead in one of the bearings has been identified in the collapsed configuration. The structure was a simply supported beam, 30.80 m long and 8.90 m wide, constituted by a multiple-box post-tensioned beam and by a in-situ casted slab. The section was realized by connecting two concrete precast U-elements by a shear-key casted in situ. In the longitudinal direction, the bridge was built in 3 segment, the central one 11.50 m long and the lateral ones 9.35 m long. The connection between the segments was realized by an in-situ casted concrete joint 0.5 m wide (Fig. 7(b)). Post-tensioning system constituted in 8 parabolic cables, each of them made by 19 0.8" strands. Total weight of the structure was about 400 t. The collapsed structure evidenced an intact joint and a collapsed one, together with an evident shear failure where the bridge impacted the ground. For this event, several information can not be given at the moment due to secrecy related to the running investigations. Visual inspections consented to affirm that the collapse mechanism was triggered by a shear failure in one of the joint due to the absence of the equilibrating action of the prestressing (Fig. 8). This means that in some part between the support and the intact joint, the cables were damaged. Visual inspections immediately also demonstrated that the cables did not have sufficient grout protection in the collapsed joint area (Fig. 9(a)). The damage was not compatible with a 20 years old

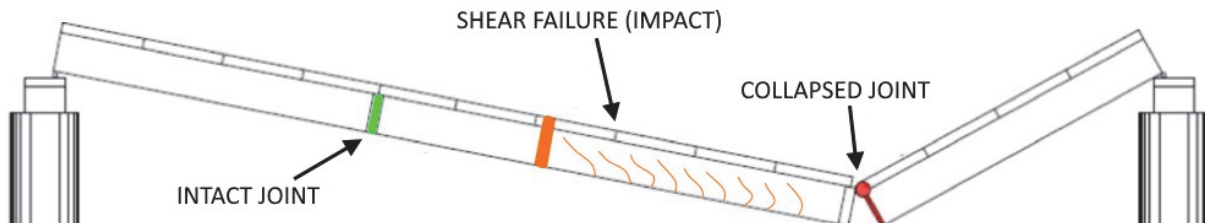
Figure 8: Collapse mechanism.

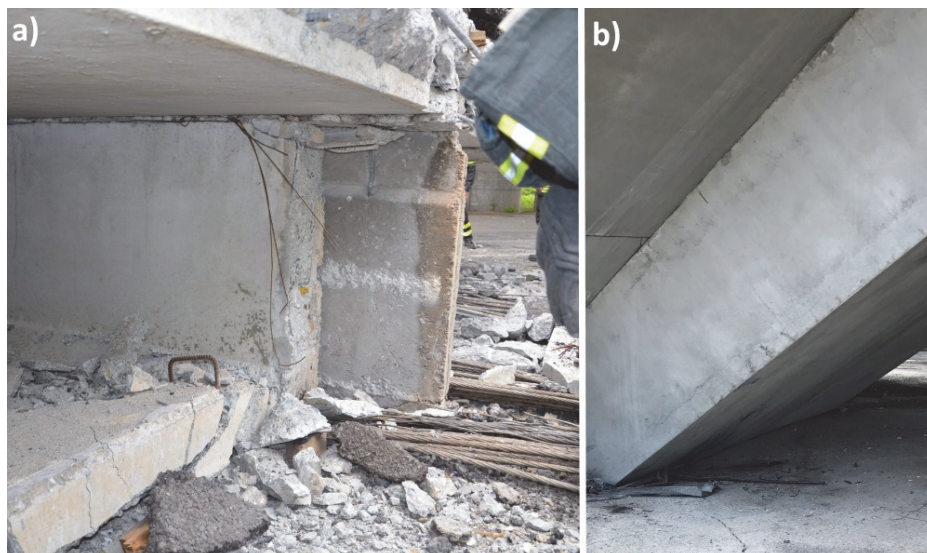
concrete structure damage scenario, and moreover, the overall external condition appeared healthy (Fig. 9(b)). This unusual structural failure, and the fear of a systematic bias, has been followed by detailed analyses and the structure has been dissected in order to establish the causes. To date, the vulnerabilities of this structure can be summarized as follows:

- absence of ductility and structural robustness, there is no redundancy in the prestressing device;
- inadequate grout injection inside the cables, which led the water to a preferential way inside the sheathing;
- total non-accessibility for structural inspections.

Figure 9: Prestressing cables in the collapsed joint area (a); external concrete conditions (b).

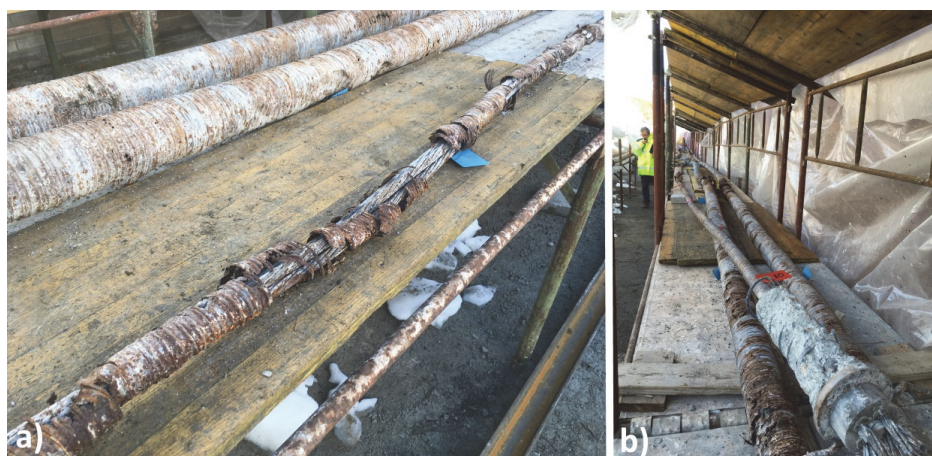
Figure 10: prestressing cables, extracted and analyzed. It is possible to note the direct correlation between grout content and oxidation rate of both sheathing and strands.

The number of the analyses that have been carried on investigating this collapse was enormous: simulated rain tests to locate the water gateways, chemical tests for the crystallized residuals and molds, and each segment was carefully demolished and each cable was extracted and inspected (Fig. 10). A complete autopsy was conducted on the bridge. When the investigations will be finished, the civil engineers will learn a lot from the final reports of the investigation committees.

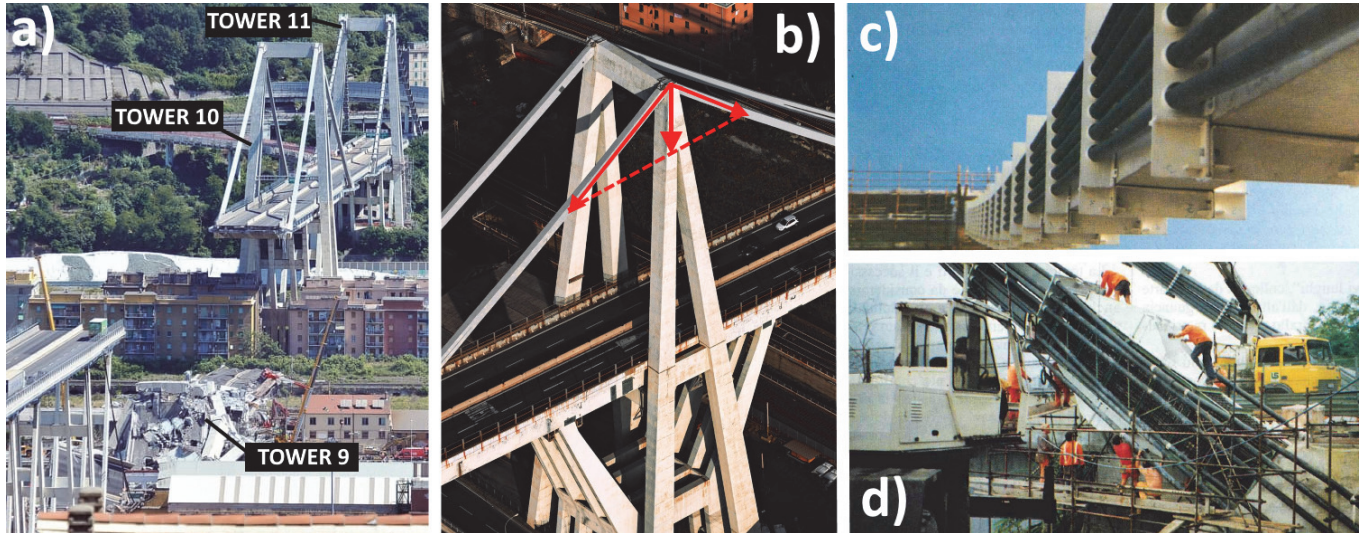
Figure 11: overview of the Polcevera bridge collapse (a); structural scheme of the tower (b); stay cables replacement intervention (1993) (c,d) [4].

On August 14, 2018, the Tower 9 of the Polcevera bridge, abruptly collapsed on the underlying industrial hub, Polcevera river and rail track of the city of Genoa (Fig. 11(a)). This collapse represents a categorical failure for the Italian Structural Engineering community. Whatever the causes of the collapses would be addressed to, object of the undergoing investigations, it is evident how there have been errors in the check procedure. Starting from the design (1960), the structural system (“*cavalletto*” [4]) that realized the tower relied on the balanced compressive force along the lateral columns (Fig. 11(b)) coming from the stays. The assembled framed tower, plus a four-point supported deck, exhibits a complete absence of robustness and structural redundancy, which means that in case of failure of one of the components, there was no control in preventing a catastrophic collapse [5]. Many colleagues affirmed and condemned the designer for the collapse. As written in the introduction, we can affirm that the lack of robustness was normal for the typological structures of that era and consequent to the available tools in the 60'. It is easy today to perform analyses for highly indeterminate structures by using computers, but it was not at that time. The structures were designed by using the simplest possible schemes, in order to have easier calculation to be made. Consequently, no ductility expedient, at any scale, was adopted to exclude fragile collapse [6]. Robustness and ductility are two design control parameters for structural safety in the ultimate state of collapse. Moving forward along the chain, maintenance and monitoring are two control activities that usually go along with an important bridge structure. Because of its audaciousness, Polcevera bridge has been continuously investigated and consolidated over the years. Along the 70s, the designer himself, started with regular visual inspections [7], while over the '80s a distributed restoration of the concrete components was carried out [4] starting from the towers and then moving through the deck. In 1993, a detailed inspection through the insertion of an endoscopy inside the stays of the Tower 11, evidenced a severe oxidation of the metallic protective membrane and of the strands themselves. Additionally, significant presence of humidity and absence of grout were reported. Moreover, some of the strands appeared slacked or sheared, sign of a tensile rupture due to steel cross-section reduction [7,8]. This preoccupying scenario advised the entire structure management authorities over the risks of material decay due to micro-cracking in the prestressed concrete. In fact, the concrete section of the stays was designed to be subjected to light but continuous decompression-compression cycles due to live loads. The peculiar cables disposition, core of the M5 patent [9], had the aim to avoid large stress variations in the steel strands, but this was possible only with a magnitude of the tendon force close to the ultimate one. All the described conditions led the structure to a quickened state of material decay and the entire sets of stays of the Tower 11 were replaced with an external prestressing system (Fig. 11(c), Fig. 11(d)). After this massive intervention (12 cables  $\phi 150$  mm with 22 0.6" diameter strands for each stay and 4 months of work with reduced

traffic), many other maintenance and monitoring activities have been performed over the viaduct [10]. Most of the monitoring regarded the health condition of the strands of the remaining towers [11], while the repairing affected the carriageway slabs. When Tower 9 collapsed, a replacement intervention of its strands was planned for the following two months, and ongoing maintenance was present on the deck.

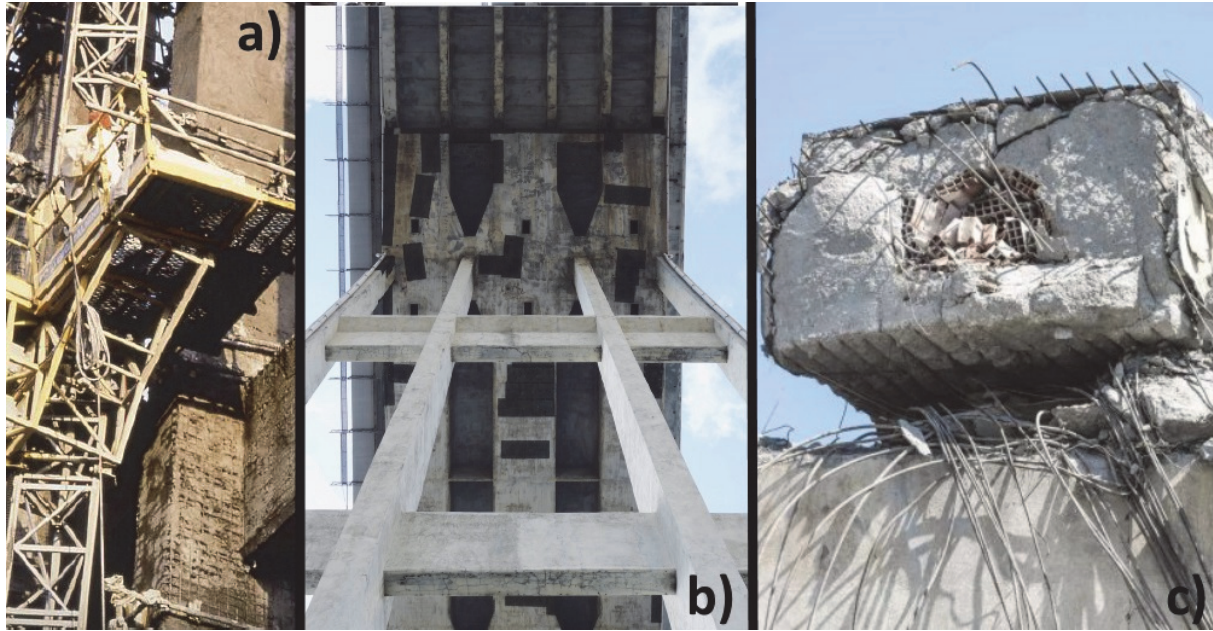
the epoxy covering was substituted with the Emaco S88 retained shrinkage grout and an Emaco Bianco white painting (Fig. 12(b)). Images of the collapsed Tower 9 prove the presence of this protective layer, but at the same time is possible to observe a neat discontinuity between the old and the new surfaces (Fig. 12(c)). Today, the state of the art for the same intervention prescribes that the removal must occur for all the thickness of the corrupted concrete, and complete bonding has to be assured between old and new surfaces to avoid stagnation and contaminant penetration [22].

Figure 12: Repairing of one of the tower of the Polcevera viaduct [17] (a); white covering of Tower 9 (b); ruins of Tower 9 (c).

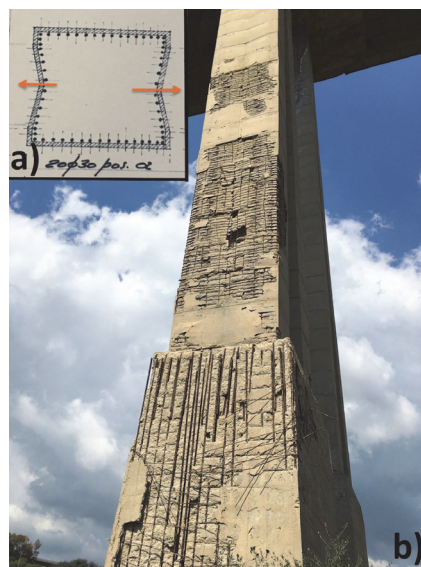
Figure 14: Column details (a); state of decay of the columns (b).

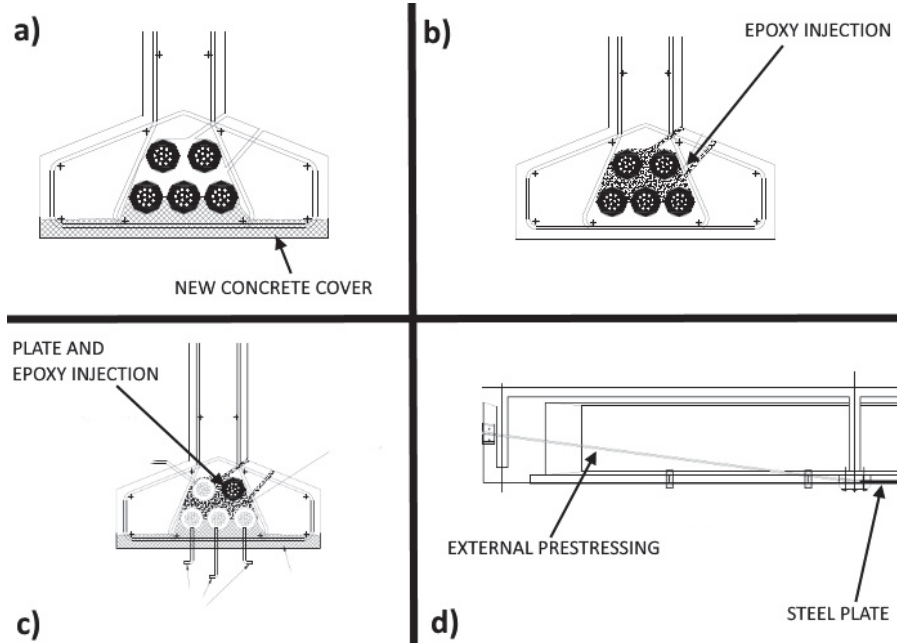
Figure 15: Suggested retrofitting. Level 1 damage (a); Level 2 damage (b); Level 3 damage (c); Level 4 damage (d).

The retrofitting intervention proposed for the Petrulla viaduct (Fig. 15) had also the purpose of increasing the robustness of the structure. Local plates and the external prestressing made recover structural continuity to the beams. Furthermore, the external cables are easy to inspect and check for integrity. This opportunity represents also a form of robustness because of the redundancy of controls. On the contrary, structural arrangement like the one of the Fossano Bridge requires to retriever firstly the structural coherence. The joints represent a discontinuity towards the fragile shear mechanism. This means that, if the cables are unbonded across the joint area, there is no possibility for the vertical loads to reach the supports once the cables are broken. This could be easily testified by looking at the intact joint that resisted the impact on the ground when bridge failed (Fig. 7(a)). Moreover, inspections in the web and epoxy void injections seems unfeasible due to the section shape. In the same way, external prestressing is rather impassable, since it is unknown the adequate force and steel to apply. A promising solution is represented by resurfacing the concrete beam with a steel carter that works both in shear and flexural regime (Fig. 19). The mandatory condition for this repair intervention is the absolute adherence between the steel sheathing and the concrete, in regard to congruent strains and humidity proofing [27].

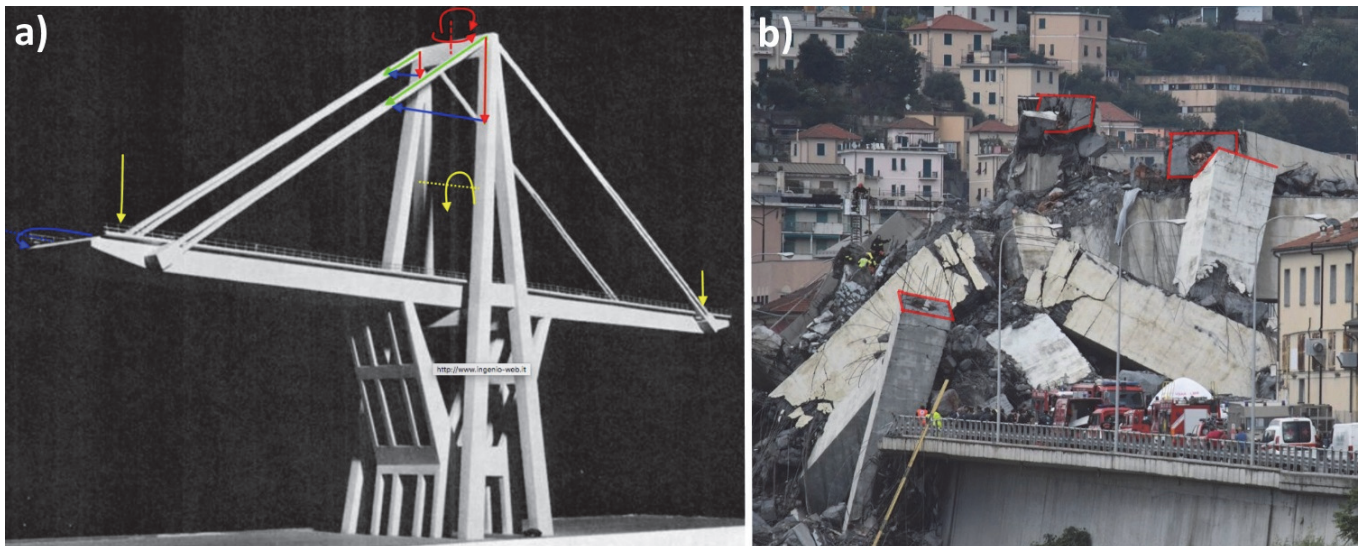
Figure 18: resisting mechanism of the Polcevera Tower: equilibrium in the three planes [www.ingenio-web.it]. (a); planar failure surfaces (b).

One of the shocking aspects of the Polcevera Viaduct collapse was its catastrophic nature. Even if the causes are currently under investigation, it is clear that the failure of one component has been followed by the entire structure, composed by the tower (green, Fig. 17) and two simply supported Gerber decks (red, Fig. 17). As anticipated, the equilibrium of the system rests upon the balance between the symmetry axes of the tower (Fig. 18a). A lack of balance in one of the two directions of the equatorial planes induces a flexural moment in the deck plane that can lose in-plane stability and could break due to unbalanced compressive forces (blue, Fig. 18(a)). Under these circumstances, the in-plane twisting could cause the slip of the Gerber decks, that without a vertical support become free to fall. At the same time, a disequilibrium in the plane of the bridge direction induces torsion and bending moment to the double framed A tower (red, Fig. 18a). This structure could not have the ductility capacity to resist at such asymmetric stress, because of the limited rotational capacity at the base (wider) and the lack of redundancy for force redistribution. Moreover, unbalanced forces in the plane of the stays causes deck uplifting on one side and subside to the other. This mechanism, could be again

responsible for the support loss of the Gerber deck and the rupture of the deck due to bending in its plane (yellow, Fig. 18a). An asymmetric fall of the deck causes and inevitable impact with the intermediate deck support that would find themselves dragged into the collapse. Finally, the observation of the Tower 9 ruins allows an additional comment: many of the parts of the tower broke with planar surfaces, evidencing low or nonexistent process zone and plastic hinge creation. These planar surfaces represent probably the casting phases of the vertical structure. This would imply that (i) no sufficient rebars content was present in that zones, or (i) the boxed section had not sufficient plasticity reserve (red, Fig. 18b). In the end, at this level of knowledge, the lack of structural robustness can be addressed to these factors:

- the low number of stays elements that causes zero redundancy in deck support;
- the low rotation capacity of the A framed lateral tower and its limited redistribution;
- the statically determined scheme for the entire viaduct, which causes higher displacements (and cracking as a consequence) and domino effect collapse;
- the low ductility at member scale;
- the intrinsic sudden loss of strength of prestressing technology.

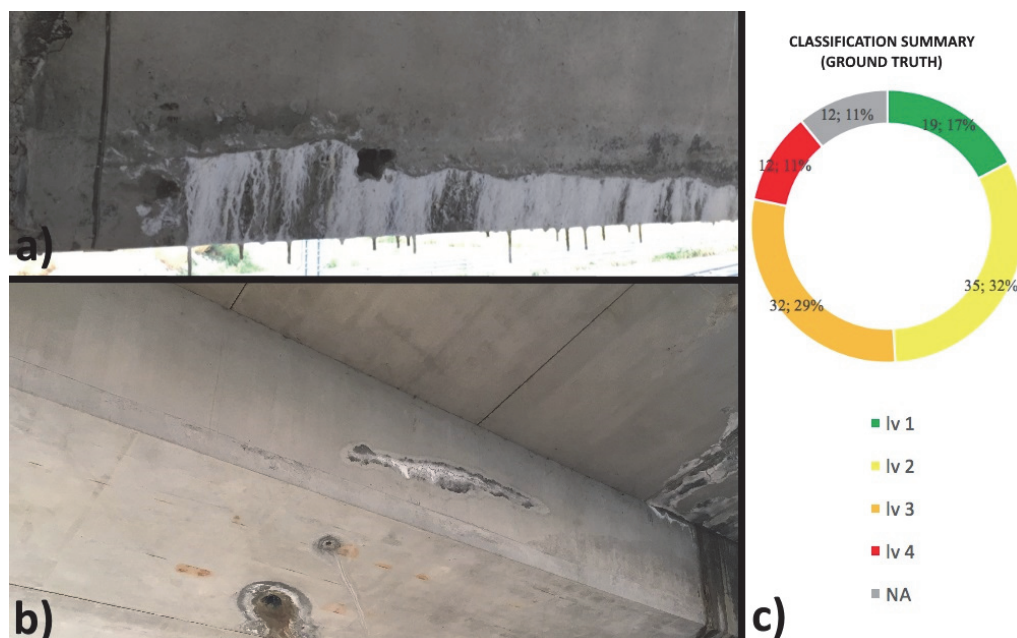
Figure 22: White stains due to grout drainage (a); red-brown stains due to corrosion (b); results from classification (c).

The spot in Fig. 22(a) exhibits a with a pale color and a layered aspect. This stain testifies a drainage of the grout by water seepage inside the cables. This obviously implicates inadequate water protection but also suggest that the cables lie in

bonded condition. At the contrary, red-brown stains (Fig. 22(a)) suggest unprotected cables and rust transport by continuous water gradient. This latter condition represents of course the worst scenario, with maximum damage and lower robustness. The presence of this particular damage has been catalogued as Lv.4 (red) for the entire bridge. Extended and joint-diffused white stains have been catalogued as Lv.3 (orange), while local or isolated as Lv.2 (yellow). Lastly, a clear external surface of the bridge deck has been assigned to a Lv.1 degree of damage (green). After the first photographic campaign, an image classification (labeling) has been carried out manually by experts. Results of this classification are shown in Fig. 22c. These results have been used as ground truth for the building of the image layer of a DCNN CV detector Fig. 23(a). The set has been splitted in 65%-35% for training and validation. Before training, each picture has been filtered for red-contrast enhancement. A random set of 200 images from Kaggle has been used as false test. Training lasted 21 hours on a 2014 MacBook Pro. DCNN has been implemented with Pytorch and Anaconda 3.5.2.0. Other two layers have been implemented in the net, one based on the results of the load test and one on the dynamic properties of the bridge, both computed by a FEM tuned model Fig. 23(b). To date, other two photographic campaigns (tablet-based) have been carried out by A.N.A.S. technicians, and Fig. 24(a) shows the results of the application of the DCNN on the bridge n. 48. The system correctly spotted a red stain and classified the bridge as a Lv.3. Analogously, for bridge n. 52 (Fig. 24(b)), a Lv.4 classification has been successfully matched. Regarding instead span n. 85, classified Lv.3 manually, the DCNN detected a Lv.2. damage degree Fig. 25(a).

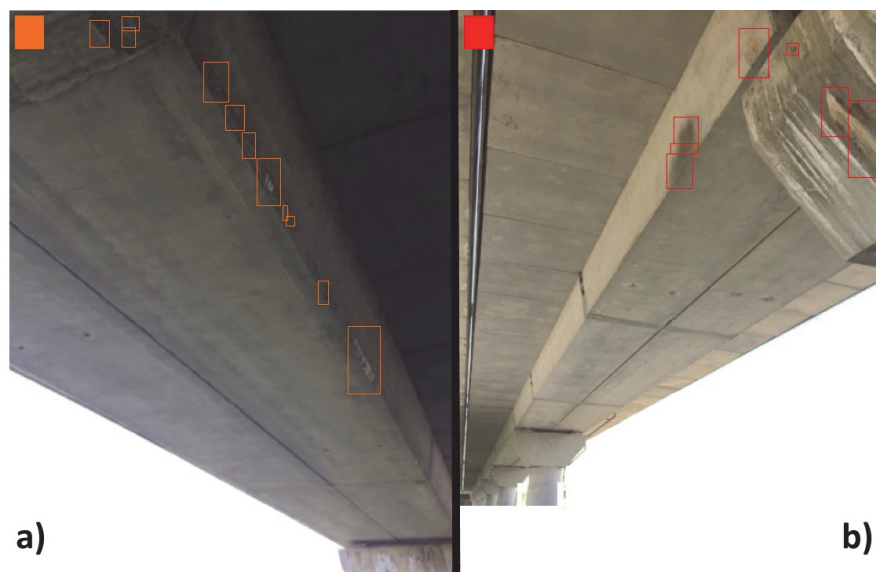
Figure 24: Detection of a Lv.3 damage (a); detection of a Lv.4 damage (b).

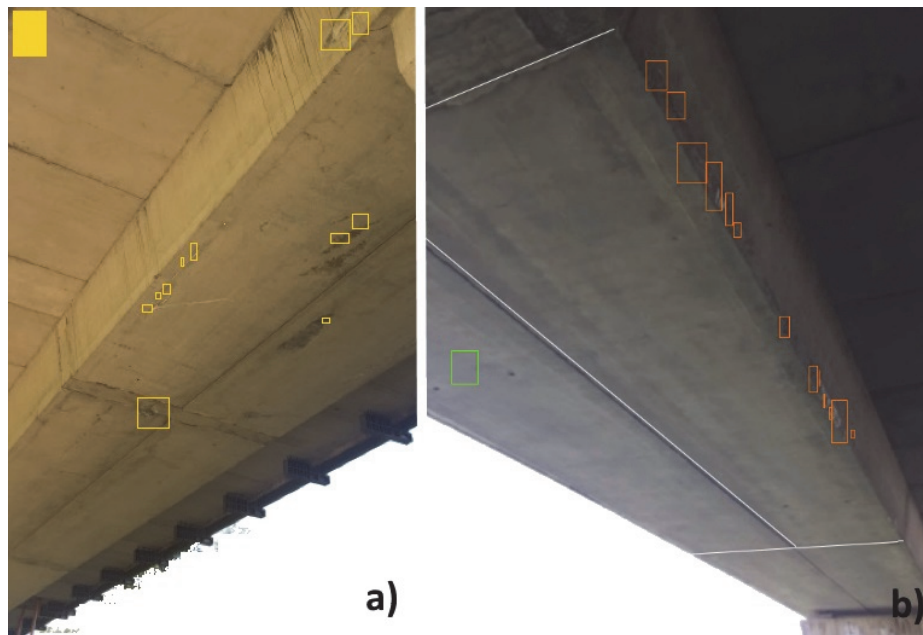
Figure 25: mismatch of damage degree (a); element-scale analysis (b).
