Considerations over the Italian road bridge infrastructure safety after the Polcevera viaduct collapse:
past errors and future perspectives

Considerations over the Italian road bridge infrastructure safety after the Polcevera viaduct collapse: past errors and future perspectives

Fabio Bazzucchi, Luciana Restuccia, Giuseppe Andrea Ferro

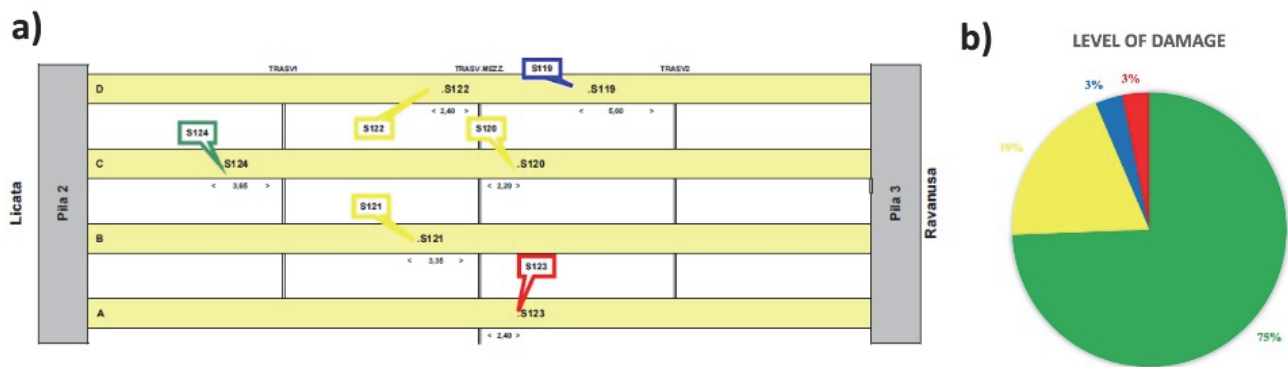
A visual inspection campaign was carried out for all the others remaining beams that constituted the Petrulla viaduct. Four level of damage degree were defined, from no noticeable damage (green) to exposed prestressing cables with visible signs of oxidation (red). In Fig. 3(a), the visual inspection location with its relative degree of damage for the bridge n. 2 has been reported. In Fig. 3(b), results for the entire viaduct have been summarized. It is worth to note that, even if less than 7% of the cases had a high degree of damage (blue and red), they represented 8 different visual inspections, which meant 8 possible beams with no active prestressing forces. This viaduct has been object of reparation and after four years has become operative again. It is reasonable to say that the investigation, repair, and public costs due to the inoperable structure are significantly higher than the ones associated with careful construction procedures. The adopted safety solutions are discussed in the next section (par 6).

Figure 3: Example of the deck visual inspections (a); damage degree results survey (b).

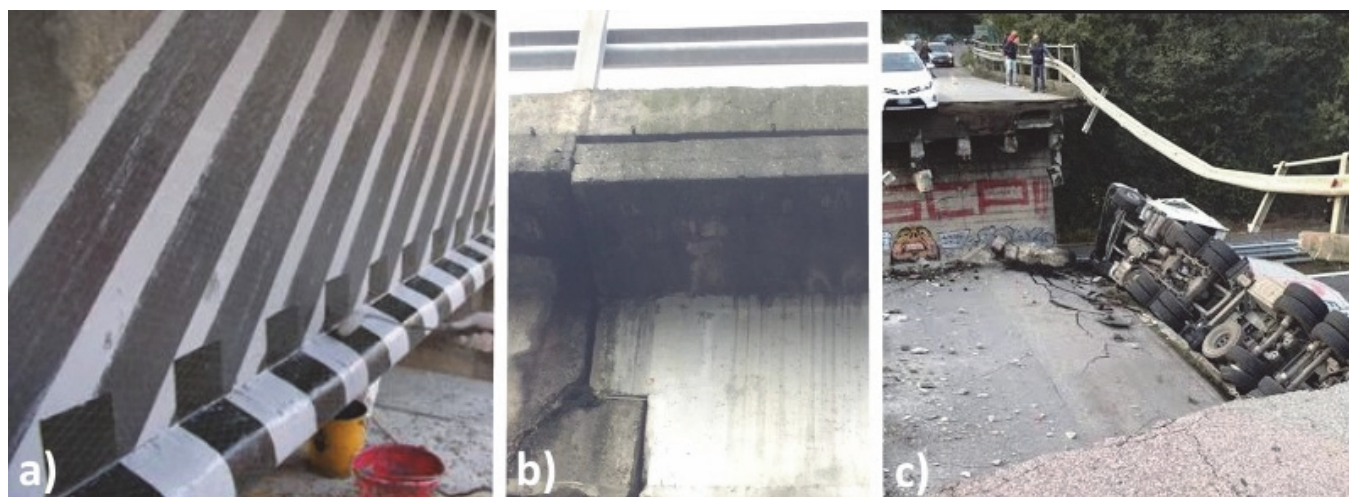
The collapse occurred when a 107.6 t heavy 8-axels truck went across the deck with a low moving speed (Fig. 5(c)). Once the load was carried entirely by the central beam, the external repaired dapped end corbel collapsed due to the vertical reaction established for supporting the beam. Total weight on the structure was approximately 172 t, which is 10 % higher than the maximum design load adopted equal to 155 t. However, this excess should have been overcome in the safety factor. This bridge was catalogued as category II by Italian Building Codes [3], but the safety requirements were not fulfilled by the structural properties. Investigation [1] have demonstrated that this failure was compromised by:

- an initial design flaws in the dapped-end corbel that significantly reduced the ultimate load;

- reinforcement in the precast beams was not enough to ensure a category II bridge classification;
- the presence of a shear fracture along the dapped end corbel promoted the oxidation of the reinforcement bars in the joint;
- the passage of II category loads (more than 100 per year) puts frequently the structure close to its ultimate bearing capacity.
- the eccentricity produced by a transit misaligned by the carriageway central line significantly increased the loading in the external dapped end joint.

Figure 5: Dapped end corbel conditions before the collapse (a); humidity presence and water stagnation (b); failure loading configuration (c) [1].

These results have been produced by detailed destructive analyses that can not be carried out for an existing structure. This means that the only control parameter that we can adopt in these cases is load checking and protective device installments for delicate parts, as Gerber supports.

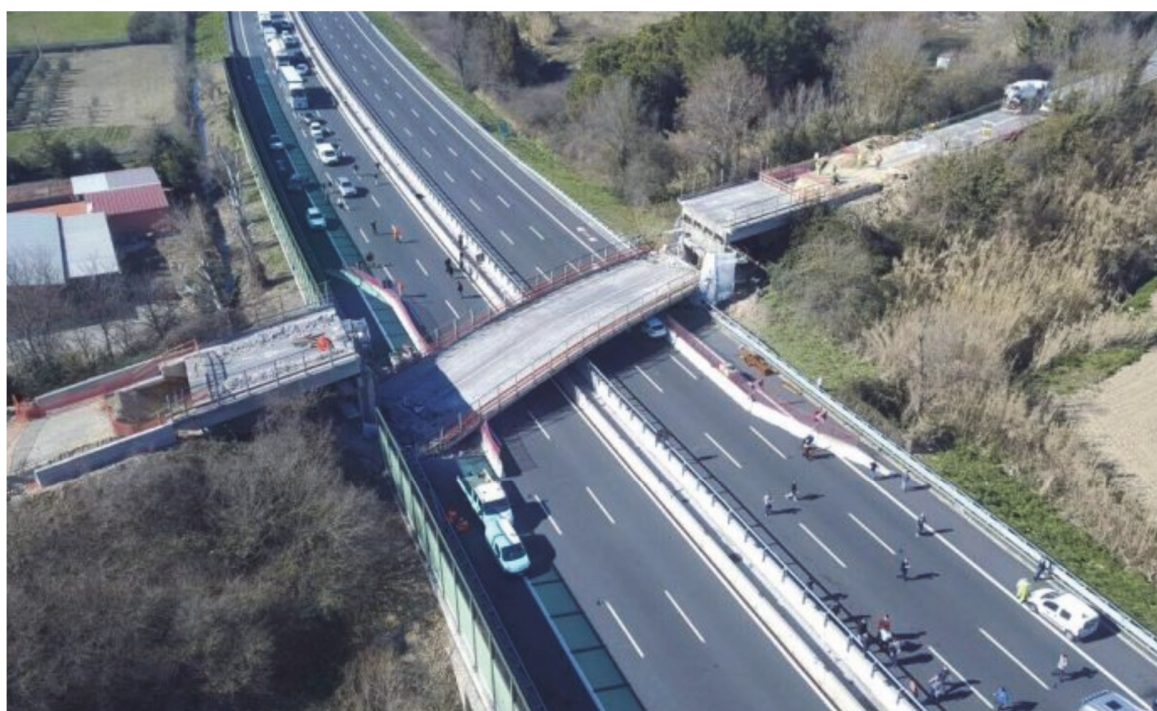
Figure 6: Ancona overpass after the collapse (from web site www.cronacheancona.it).

This collapse occurred on 9 March 2017, near Ancona, along the A14 Italian Highway. The bridge (167 at km 235+800) was constituted by a steel-concrete composite deck 16.5 m wide and 36 m long with a simply supported beam scheme (Fig. 6). When collapsed, the deck was uplifted for maintenance operation and it was supported by a temporary structure. The deck fell on the underlying highway, causing the death of 2 people that were transiting underneath.

The case of the collapse of the overpass on the A14 motorway near Ancona is quite different from the others and was caused only by a resounding error during the execution phase. The works involved the adjustment of the altimetric height of the overpasses, consisting of raising the decks, creating an extension of the support structures and the re-profiling of the associated ramps. The lifting took place through the use of hydraulic jacks with few centimeters steps, after positioning of steel plates for distribution. The appointed subcontractor to perform this specific process decided to replace the supporting steel plates with similar plates in neoprene, much lighter to move. Numerical analyses conducted during investigations by prof. Tarantino highlighted how a difference between the temporary supports of a few millimeters generates horizontal forces not compatible with the shear deformability of the numerous neoprene plates stacked on top of each other. This generated an unexpected bridge horizontal displacement and the collapse occurred. Further details are under investigation.

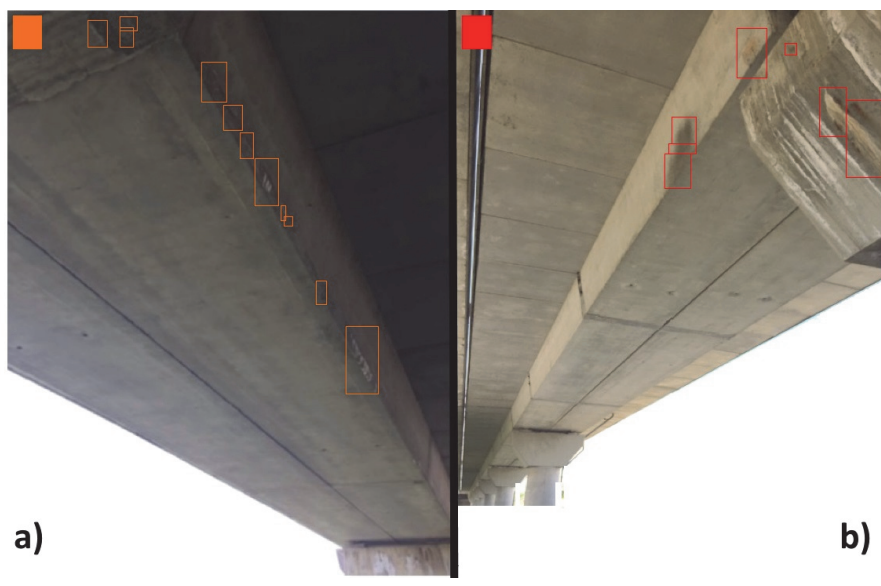
Figure 24: Detection of a Lv.3 damage (a); detection of a Lv.4 damage (b).
