CFD simulation of multiple dust explosion occurred in a flour mill

## CFD Simulation of Multiple Dust Explosion Occurred in a Flour Mill

Paola Russo <sup>a,\*</sup>, Achraf Tabib <sup>a</sup>, Michele Mazzaro <sup>b</sup>, Enrico Danzi <sup>c</sup>, Luca Marmo <sup>c</sup>

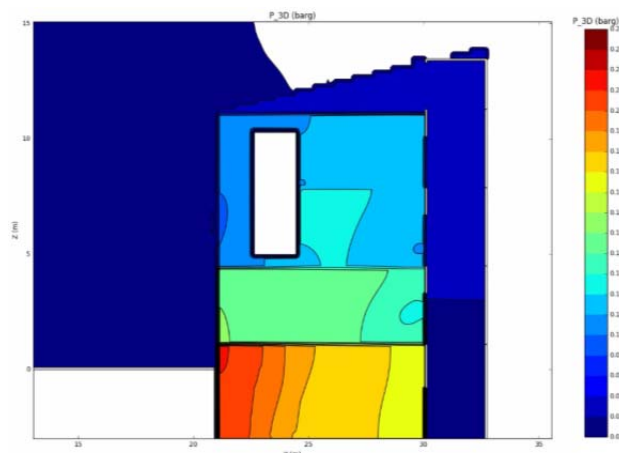
Figure 6. Map of  $P_{\max}$  reached in the hoist and in the basement (at 960 ms).
