The anatomy of a collapse: forensic analyses, monitoring and restoration attempts of the Fossano Bridge

F. Bazzucchi & G. A. Ferro

*Department of Structural, Building and Geotechnical Engineering
Politecnico di Torino, Torino, Italy*

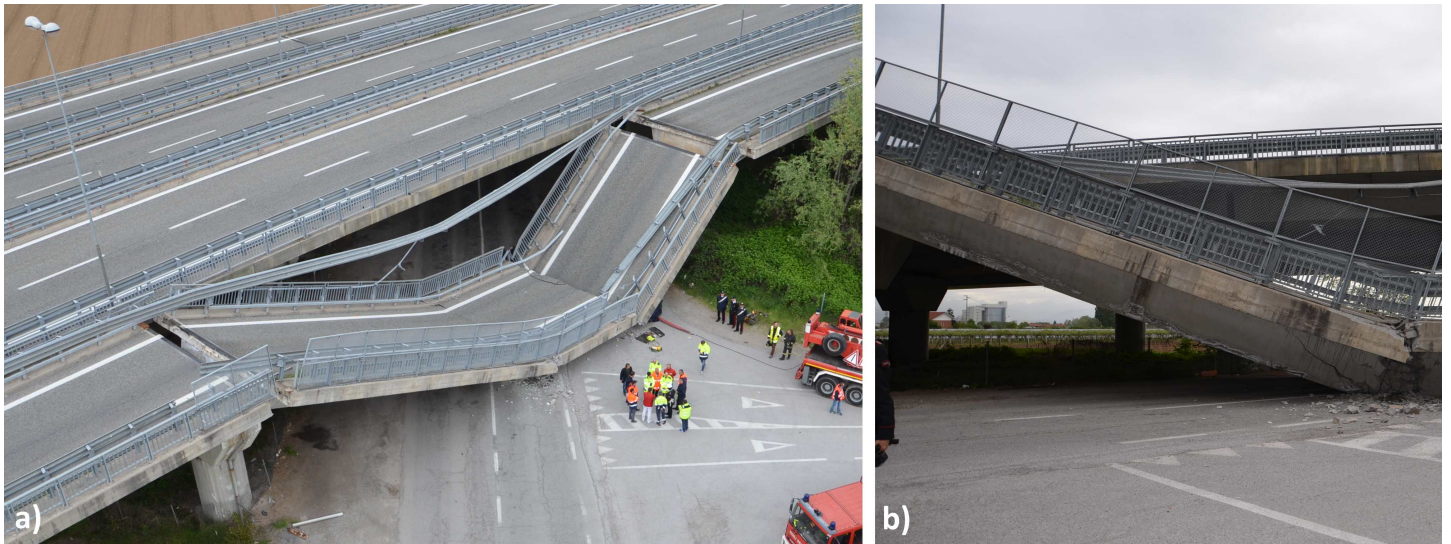
On the early afternoon of 18th of April 2017, one of 108 spans that constituted the Fossano bypass viaduct collapsed abruptly on the street below (Figure 1a). Luckily, the incident did not involve any person or moving vehicle, apart from a parked empty car under the bridge. At the time, this collapse represented the third in a row for the Italian infrastructure network on a time span of sixteen months (Bazzucchi, Restuccia, & Ferro 2018). The level of pressure affixed to the system by the civil society and road authorities concerning the safety of whole system was particularly high after the event, and it skyrocketed when the iconic Morandi bridge on the Polcevera river collapsed on August 2018.

Figure 1: a) collapsed structure. b) in-situ casted intact joint.

The collapsed bridge was constituted by a simply supported beam, 30.80m long and 8.90m wide, made by a multiple-box post-tensioned beam and by a in-situ casted slab. The section was realized by connecting two concrete precast U-elements by a shear-key casted in situ. In the longitudinal direction, the bridge was built in 3 segments, the central one 11.50m long and the lateral ones 9.35m long. The connection between the segments was realized by an in-situ casted concrete joint 0.5m wide (Figure 1b). Post-tensioning system constituted in 8 parabolic cables, each of them made by 19 0.8" strands (934cm^2). Total weight of the artifact was about 400t. The collapsed structure evidenced an intact joint and a damaged one, together with an evident shear failure where the bridge impacted the ground.

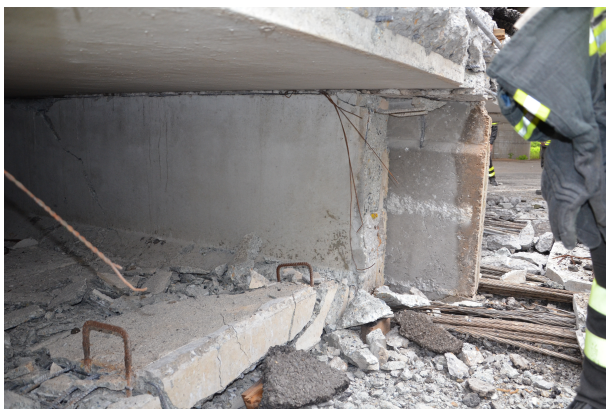
Figure 2: Collapsed joint.

Visual inspections consented to affirm that the collapse mechanism was triggered by a shear failure in one of the joint due to the absence of the equilibrating action of the prestressing. Same inspections immediately evidenced the lacking of the sufficient grout protection in the opened joint area (Figure 2). Corresponding level of cable oxidation was not compatible with such a *young* structure (20 years old) concrete

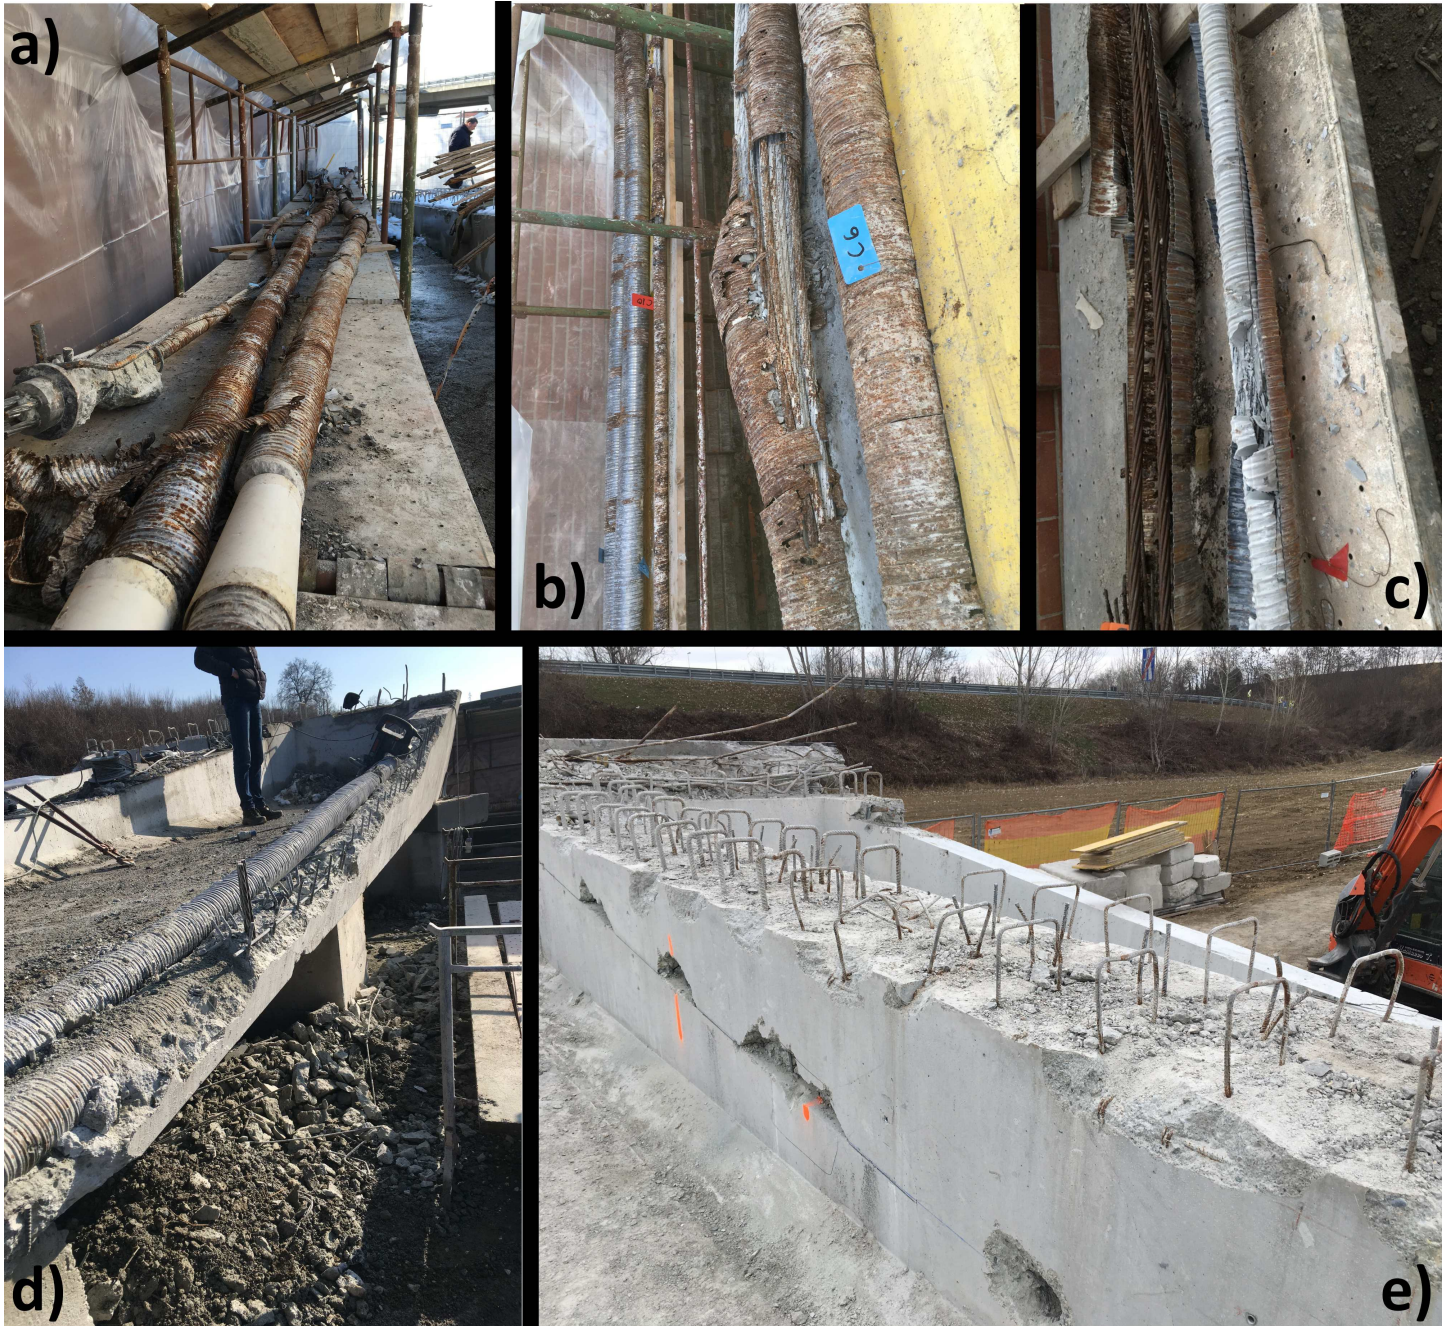
Figure 3a,b exhibits the oxidation pattern of the longitudinal trend of the cables. Compared to the smaller diameter ones (precasted inside the central segment (Figure 3c)), it can be seen how important is the protection and passivation role played by the grout to the steel. In Figure 3d, the extraction of the main lateral cables is shown from the side of the intact joint. Also in this case, state of conservation was considerably high. As a last act of the dissection, Figure 3e shows the detachment of the slab from the deck to examine the presence and the position of the connecting longitudinal stirrups.

Figure 3: a,b) oxidated cables. c) in situ casted cable. d) dissection and extraction of one of the main cables. e) extracted stirrups

- inadequate grout injection inside the cables;
- complete non-accessibility for structural inspections of the deck beams.

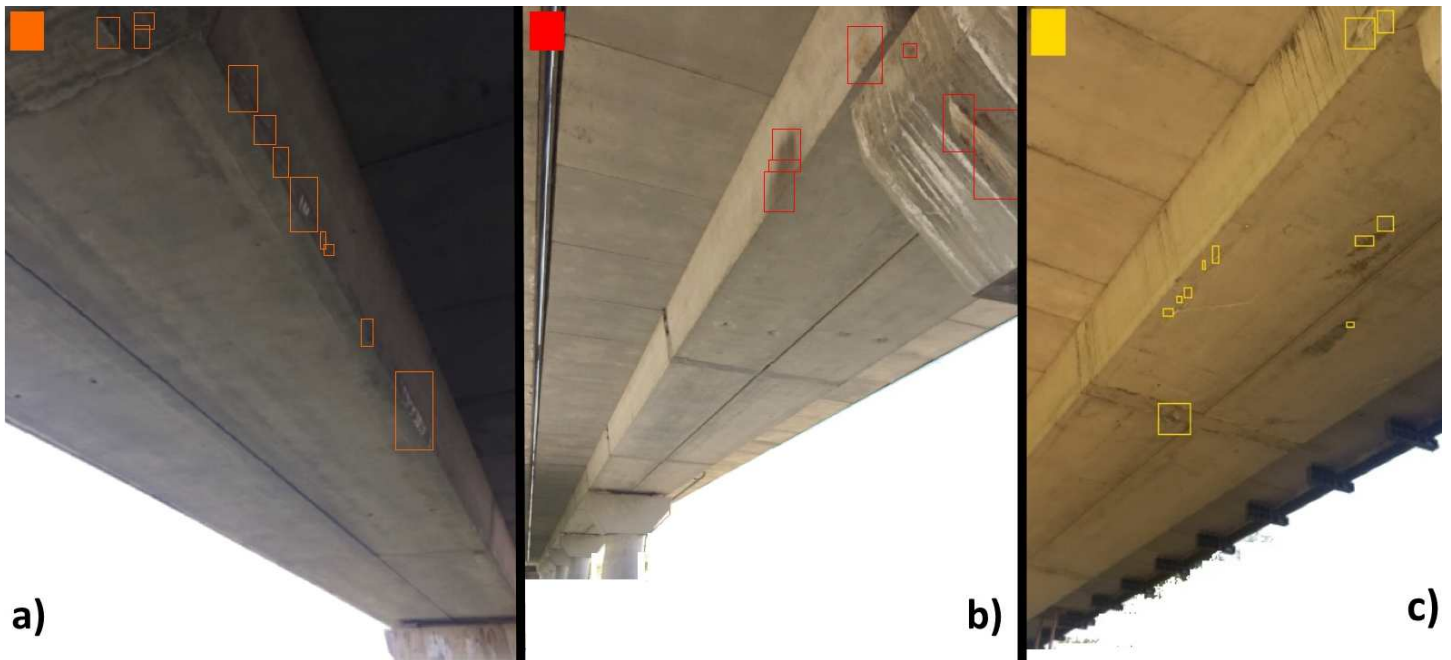
Four photographic campaigns have been carried out (tablet-based) as reported in Table ??, and every picture was geolocalized for an automatic processing. Figure 5a shows the results of the application of the DCNN on the bridge n. 48. The system correctly spotted a red stain and classified the bridge as a Lv.3. Analogously, for bridge n. 52 (Figure 5b), a Lv.4 classification has been successfully matched. Regarding instead span n. 85, classified Lv.3 manually, the DCNN detected a Lv.2. damage degree Figure 5c. To date, 73% of accuracy has been encountered, and after the second campaign no evolution from previous damage degree has been noticed. Incrementation of this accuracy is strictly dependent on the number of input data. Apart from the collecting of a larger set of images (work in progress) we are testing in the lab the possibility to create a collaborative system with a fiber optic device across the joints (Bragg's nets based).

Figure 5: a,b) lv. 3 and lv. 2 correctly classified decks. c) Incorrect lv. 2 classification.

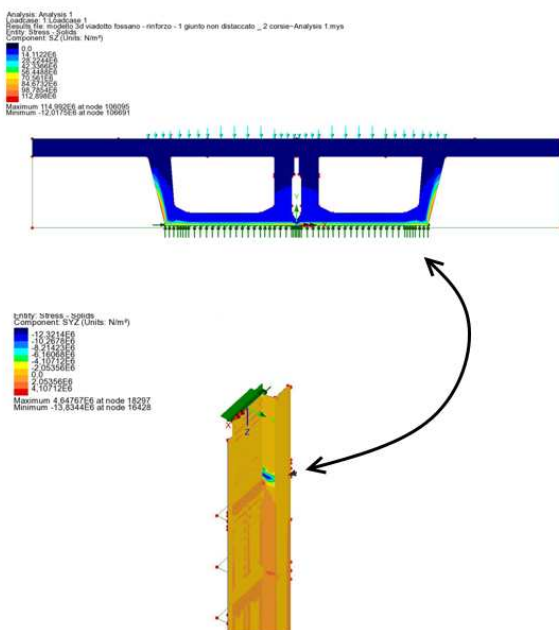
Figure 6: Numerical simulation of the steel U sleeve to attach at the deck.

While the first operation is now undergoing with epoxy resins injections and waterproofing pavement layers restorations, the second issue can be tackled only by the application of a structural component. In this case, a U steel sleeve has been designed to be attached across the joint to sustain both the shear and the flexural tensile force at the bottom. Connection has been designed with 56 M22 bolts per side. Each sleeve is designed with an embedded monitoring system for deformation to check if the prestressing force is diminishing by the progressive loading of the sleeve. Numerical simulations, i.e. reported in Figure 6, suggested that the system is able to bear the ultimate load with no operational limit state guaranteed.
