Seismic history of the church of San Pietro di Coppito in L'Aquila

## Seismic History of the Church of San Pietro Di Coppito in L'Aquila

Renato Masiani, Department of Structural Engineering and Geotechnics, La Sapienza University of Rome, via Gramsci 53, Rome 00195, Italy

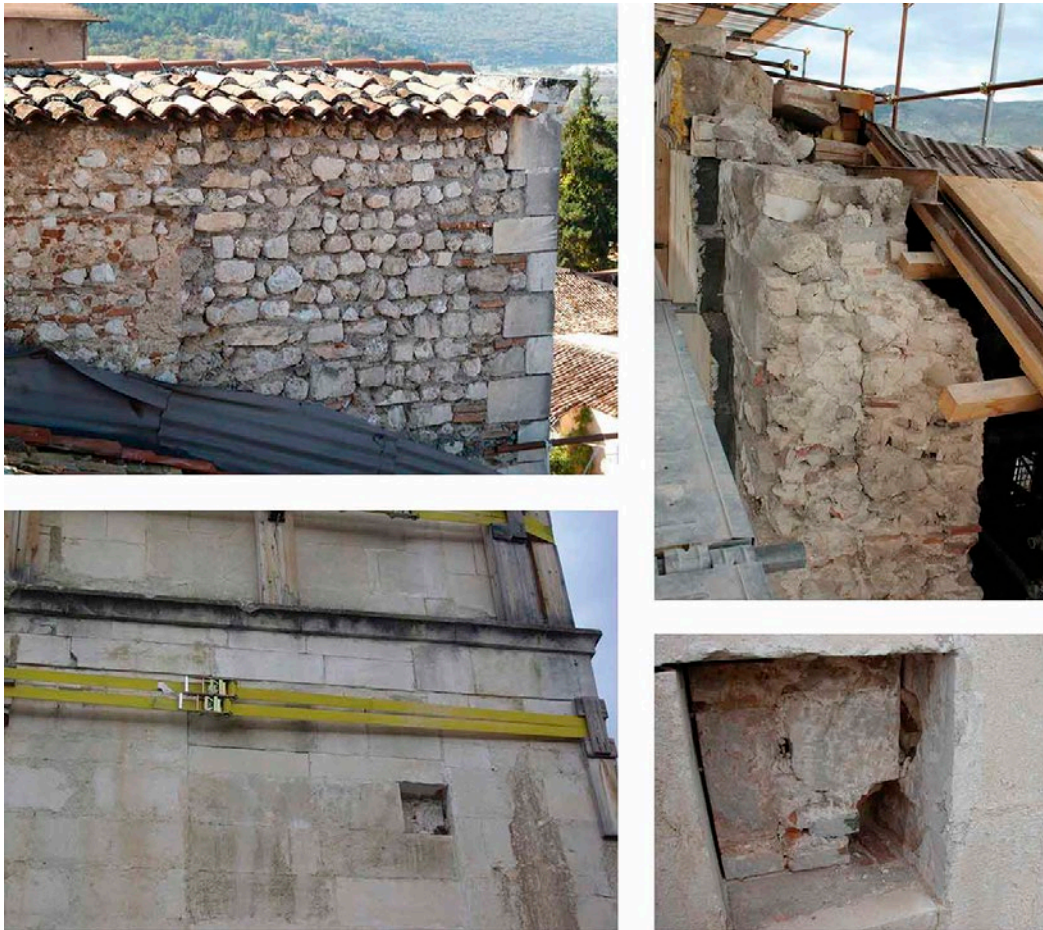
**Fig. 10.** Top: (on the left) the surviving false front of the façade (we can clearly see where the new masonry added by Moretti, rough stones laid on cement mortar, joins – without toothing out – to the original masonry, wedged with bricks and lime mortar, like the masonry visible on the façade wall inside the church); (on the right) the thickening of the nineteenth century façade obtained by Moretti by simply placing a new wall side by side with the existing one.

Bottom: direct survey of the stone facing in the façade by removing single stones from the cladding; on the right we can recognize the block bonding of the pilaster's ashlar in the rear masonry wall and the thick layer of cement mortar where big stone slabs are laid.

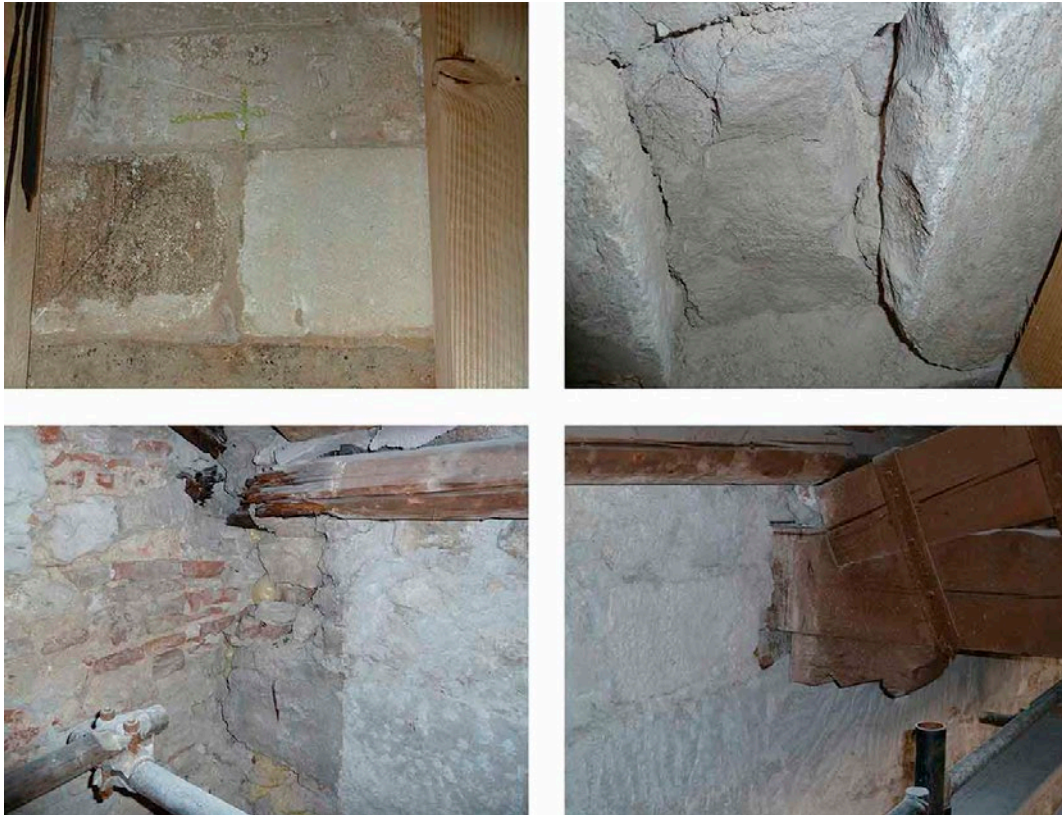
What we said about the masonry works of the nave walls can be repeated for the two pillars of the right wall (fig. 11, top). These both consist of an external face with a pseudo-isodomum arrangement of ashlar stone, and an inner core of rubble embedded in lime mortar, but exhibit, nonetheless, significant constructional differences, fully compatible with the different damage induced by the last earthquake.

The pillar closest to the façade has a stone facing of constant thickness on all four sides (20 - 25 cm), with well-placed ashlar and thin vertical joints; the inner core (for which no samples were taken but sonic tests (Russo, 2011) were performed) shows an adequate compactness, although being (obviously) less rigid than the faces and with an asymmetric distribution of damage (consistent with the greater damage detected towards the nave).

The second pillar, instead, which had already suffered serious prior damage, has been extensively and extremely badly reworked. The facing overlooking the aisle on the right consists almost entirely of thin slabs, no more than 10 cm thick, which can be clearly ascribed, also from the surface work, to the restoration done in the last century by Moretti: we may suppose that before this, the pillar was joined to a wall that was then removed, and so facing needed to be added to the part that was originally not in view. The other visible faces of the pillar, especially that overlooking the nave, show clear signs of previous seismic damage: the filling between the

**Fig. 11.** Top: (on the left) the filled-in joints of the first pillar (from the façade), face overlooking the aisle are still intact; (on the right) the poor quality of the inner core of the second pillar, face overlooking the aisle can be seen under Moretti's thin slab cladding.

Bottom: (on the left) the r.c. tie-beam is not anchored to the façade; (on the right) the tie-beam of the first roof truss behind the façade simply rests on a wooden sleeper placed on the extrados of the r.c. tie-beam (the supportig shelf is in fact hanging from the tie-beam).

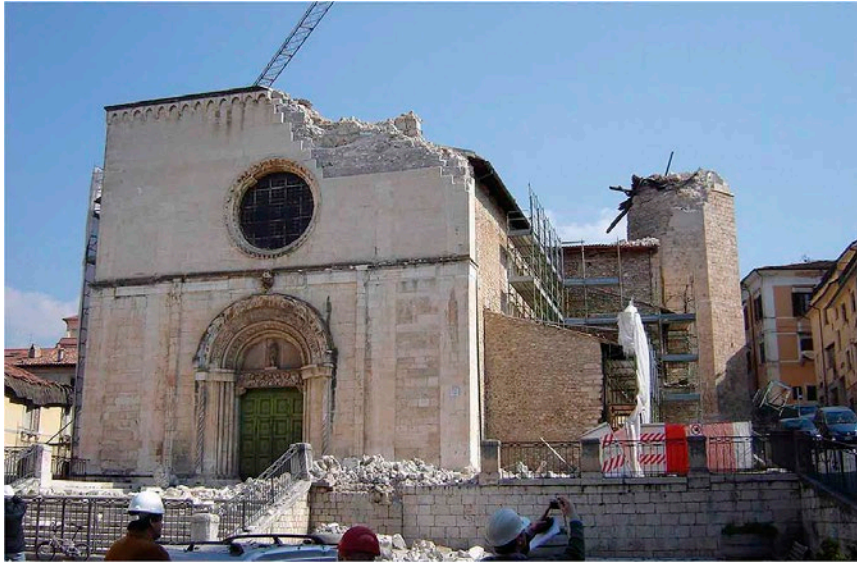
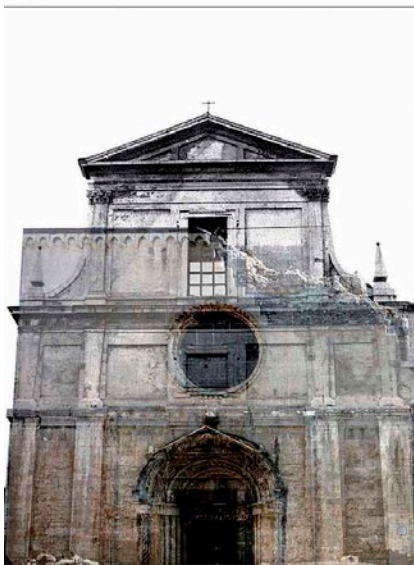
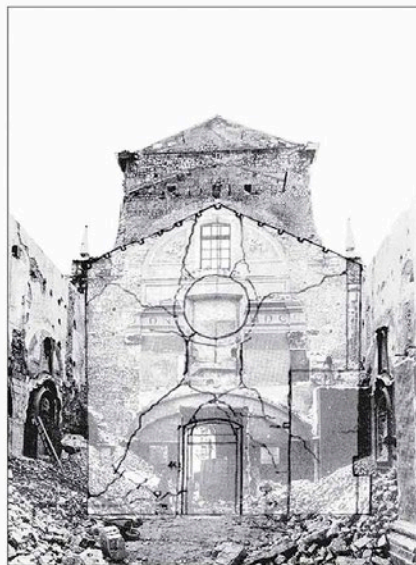
The longitudinal actions caused the damage to the bell tower and the upper part of the façade. The façade has come away from the two side walls of the church, with cracks along the previous crack lines which get bigger as they approach the top, where, in the remaining portion of the roof, the purlins of the rafters have partly (some completely) come out of their housings in the façade. The greater weakness of the right wall of the church, due to the three arches that drastically reduce the shear resistance area (limited, in fact, only to the solid part behind the façade), is consistent with the stronger longitudinal oscillations affecting the right side of the church and the consequent collapse of the upper part, not effectively held in place, of the façade (the part that collapsed was the one added by Moretti in order to create the squared shape) (fig. 12).

**Fig. 12.** Damage due to the earthquake of 6 April 2009. The right corner of the façade has collapsed, as also the top of the bell tower, which, falling, also badly damaged the roof of the transept. The collapse shows that the stone cladding consists of thin stone slabs stuck onto the wall; moreover, the first row of stone cladding, which remained in place, does not seem to extend beyond the part (trapezoidal pilasters) where Moretti reused the stones elements of the previous façade for his restoration (top and lower left). Inside the church, the cracks follow the lines of the Baroque façade (lower right).

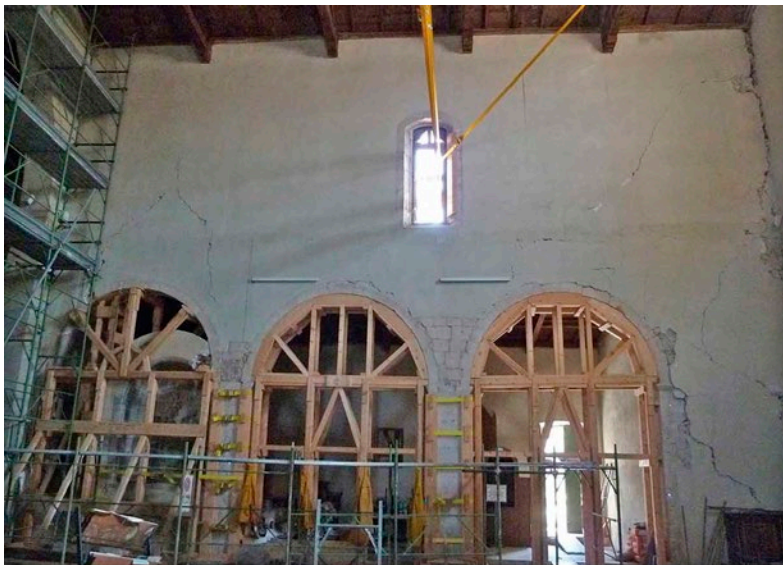
The masonry wall behind the façade, on the right, was badly damaged, as also the two pillars in which some ashlar were crushed by concentrations of load due to the oscillations. Moreover, the removal of the plaster from the masonry highlighted the extensive alterations made to the structure even before Moretti's interventions, and the consequent constructional weakness – in addition to geometric insufficiency – of the right wall (fig. 13, top).

**Fig. 13.** Top: in-plane shear cracks in the right nave wall, in both the masonry structure behind the façade and the two pillars. The cracks are bigger than those in the left nave wall because of a smaller overall stiffness (due to the presence of the pillars); this in turn is responsible for the more pronounced movements seen in the right part of the façade and the consequent collapse of the top portion of the latter.

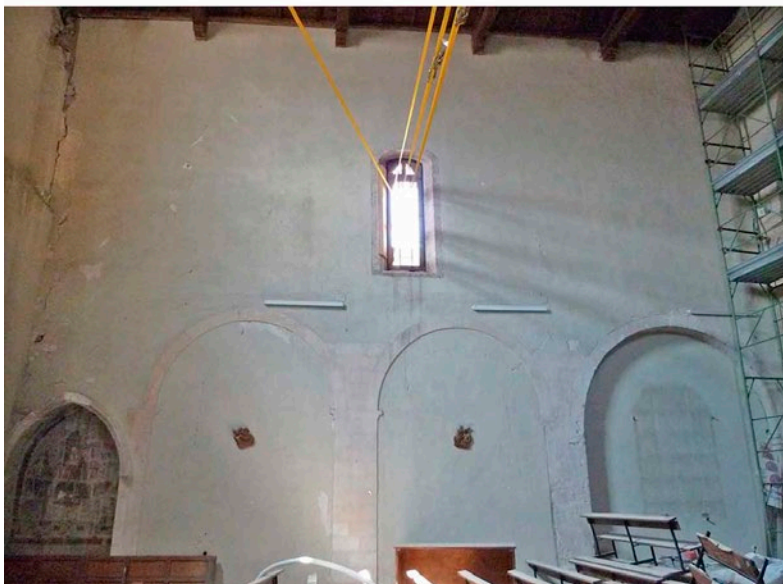
The left wall, too, was more badly damaged near the façade, where the greater concentration of shear stresses was accompanied by a particular weakness of the wall in terms of both geometry (the wall is less thick because of a niche) and constructive quality (due to the presence of prior damage and consequent alterations to the masonry work) (fig. 13, bottom).

Bottom: in-plane shear cracks in the left nave wall. It should be noted, moreover, that the inner side of this wall is not perfectly vertical and was corrected by adding a substantially perpendicular external facing. This is an evident sign of prior damage repaired by external cladding.
