REINFORCEMENT OF THE 18TH CENTURY BUTTRESSES OF MANIACE CASTLE:
DESIGN AND EXECUTION

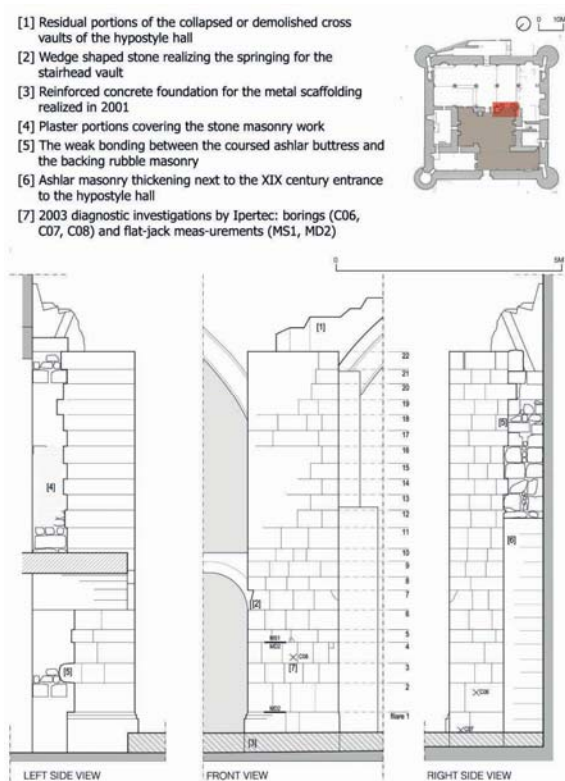
Figure 7 Survey of the right buttress. Both buttresses present a stonework arrangement with regular running bonds and headers forming a coursed ashlar with adequate grout core. They are juxtaposed with rougher masonry work in which the trilobate columns of the hall are partially embedded.

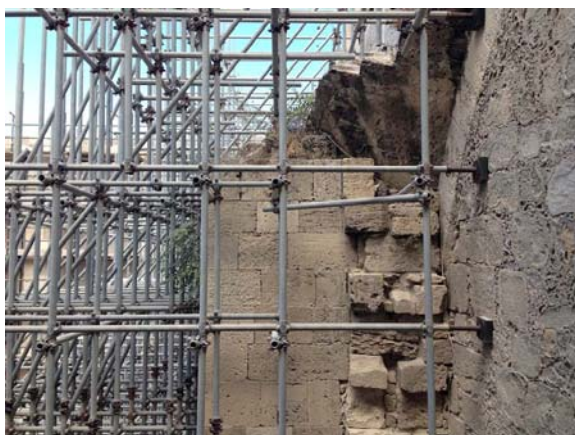
Figure 8 A lateral view of the stonework arrangement of the right buttress. From the top of the buttresses, the surviving *tas-de-charge* portions of the vaults, which collapsed or were demolished in the 18th century, can be seen.

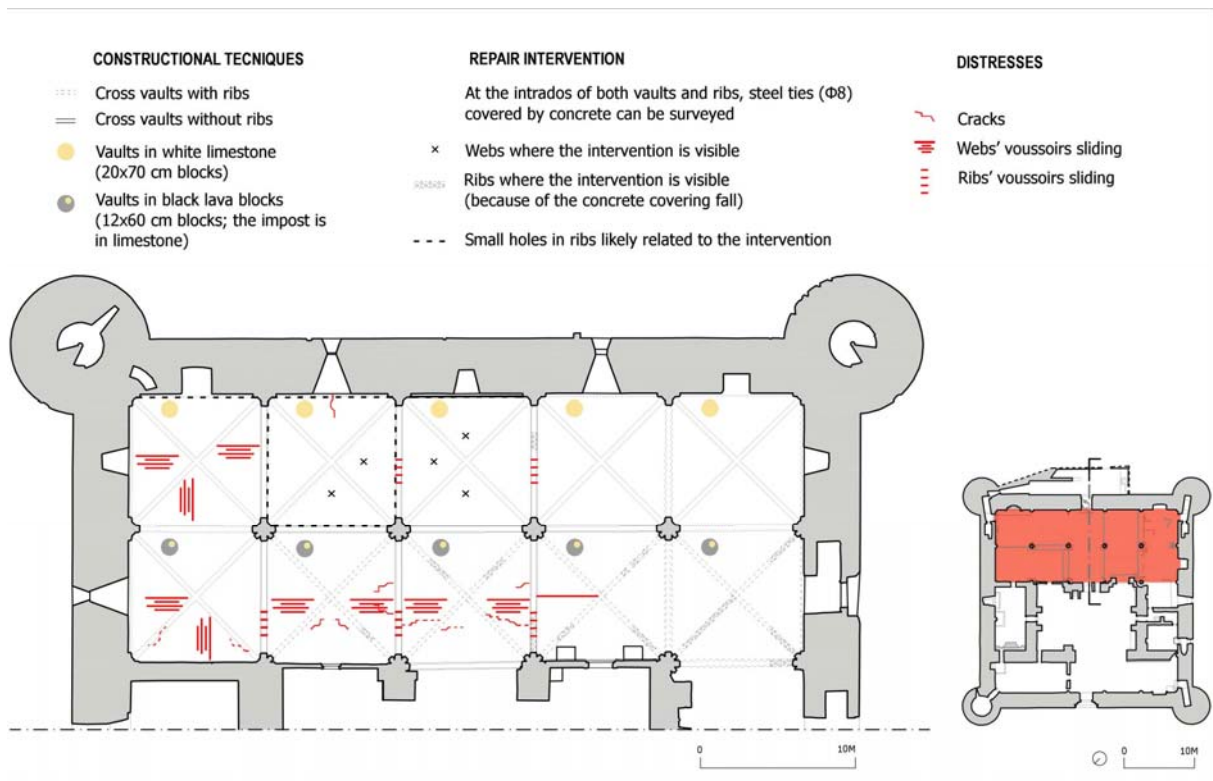
Figure 9 The crack pattern surveyed on the vaults' intrados is compatible with an outward movement of the courtyard façade due to the unbalanced thrust of the surviving vaults.

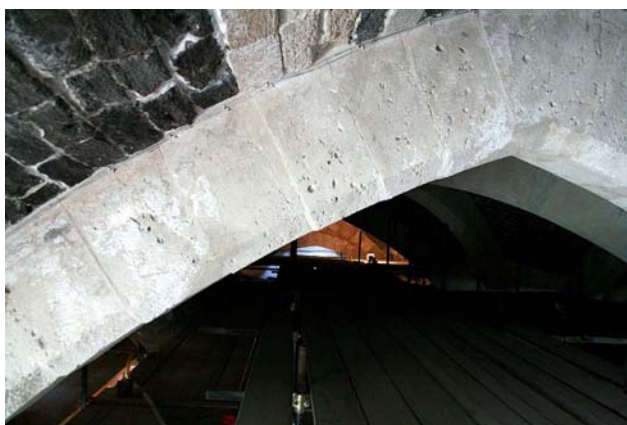
Figure 10 The classical sliding mechanism (as a consequence of the springing displacement) surveyed on the *voussoirs* of the pointed arches rising from the trilobate columns.

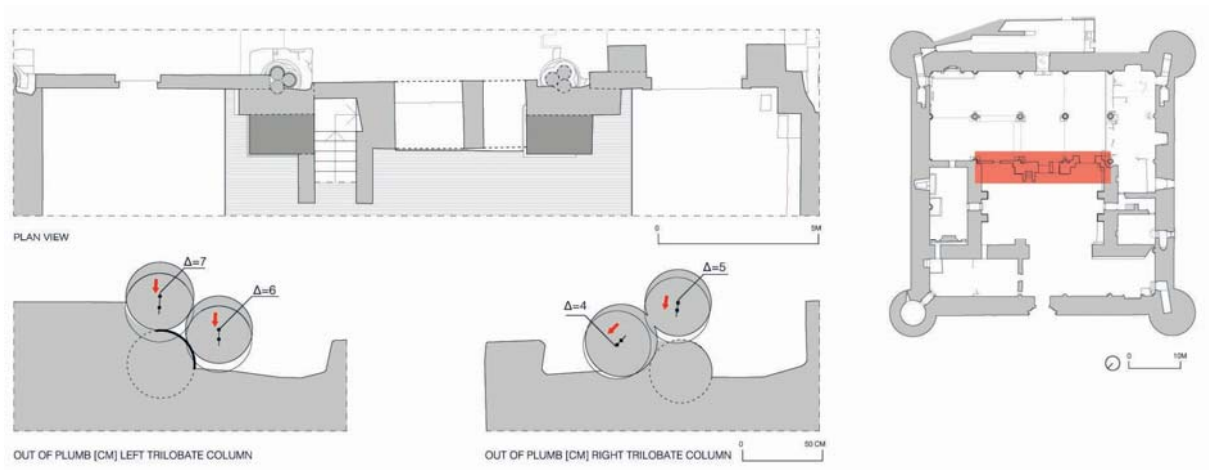
Figure 11 The out-of-plumb registered for both trilobate columns.

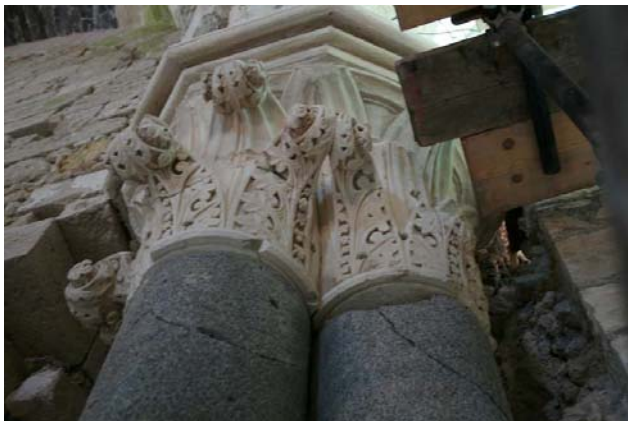
Figure 12 Cracks in the marble shafts of the trilobate columns deriving from the stress concentration due to eccentric axial loads.
