Non- destructive characterization of carbon fiber composite/Cu joints for nuclear fusion applications

This is the author post-print version of an article published on *FUSION ENGINEERING AND DESIGN*, Vol. 83, pp. 702-712, 2008 (ISSN 0920-3796).

Abstract

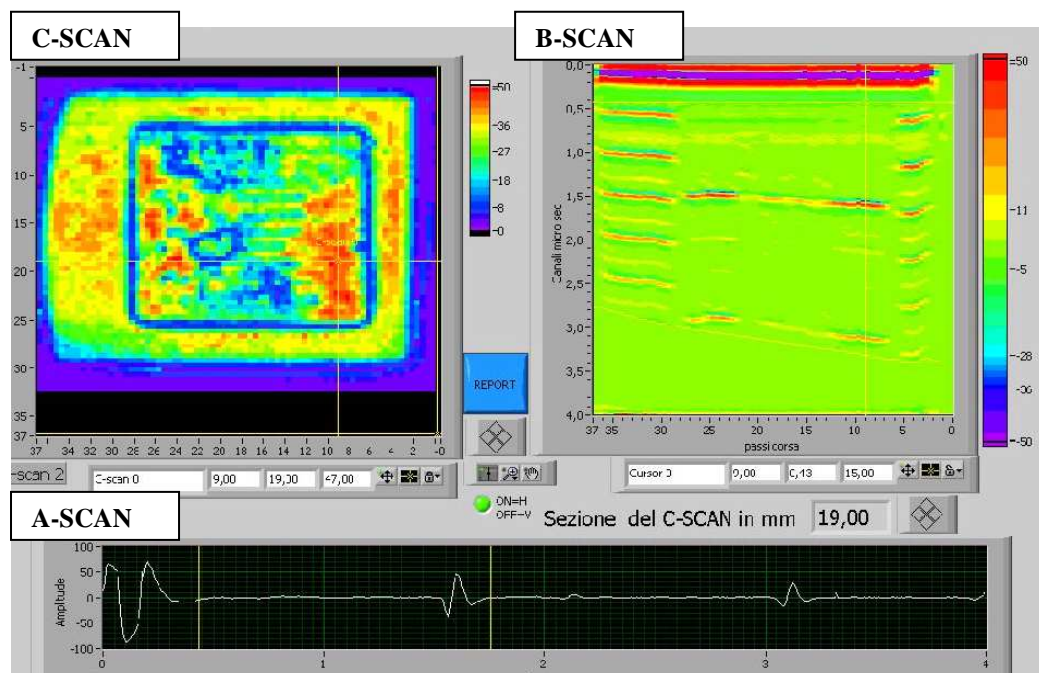
C-scan reported in figure 4 was obtained with an extended window over $3,5\text{ mm}$ in depth. Defects are localized on the left and on the right side of the sample at CFC/Cu interface (red areas). Blue areas show good joint interface (no defects).

Figure 4 Defects localization (red color on the C-scan) at Cu/CFC interface for sample K

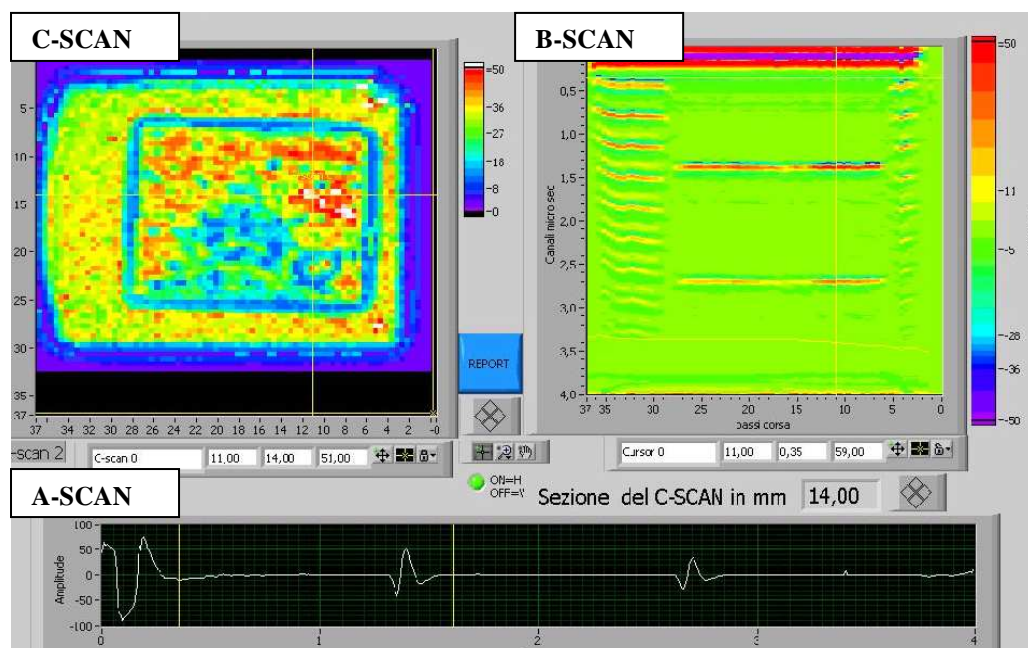
Concerning test on sample L, reference signals have been determined as for sample K (about 1 mm Cu/CuCrZr interface and about 3 mm Cu/CFC interface that correspond to $0.43\text{ }\mu\text{s}$ and $1.3\text{ }\mu\text{s}$ on time axis respectively). Figure 5 shows discontinuities at CFC/Cu interface. Cu/CuCrZr interface is quite continuous; only limited area (figure 6) indicates a defect.

Figure 5 CFC/Cu interface scan of sample L : defects are located in yellow-red areas

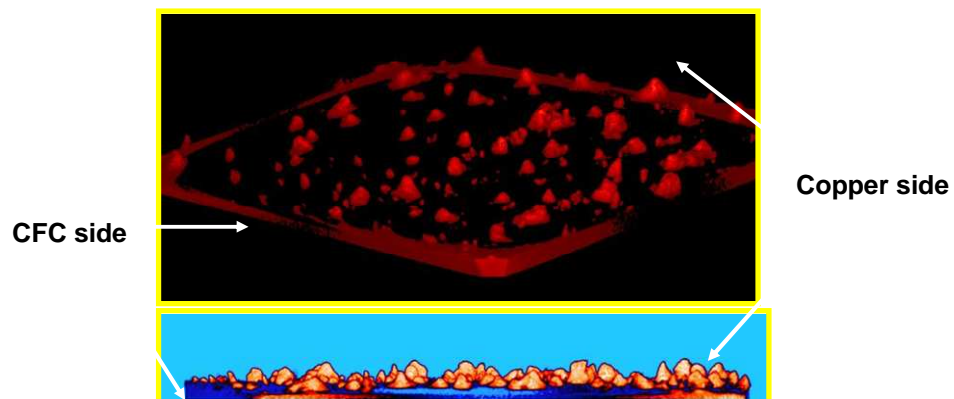
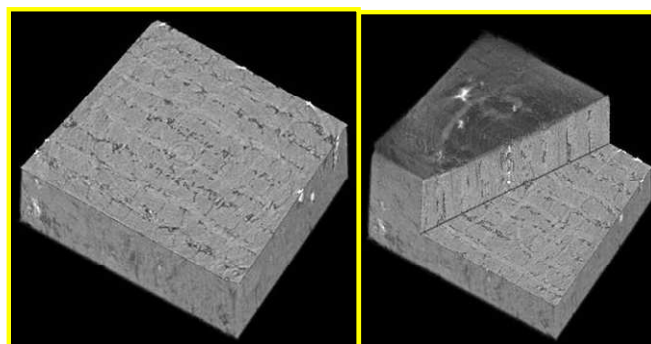
In figures 8 and 9 are shown some tomography of sample M achieved with 85 kV peak energy with 0.8 mm Cu filter and 45 kV without filter respectively. In the first one, the copper layer is clearly observable, where the copper “finger-like” pattern at CFC/Cu interface can be distinguished, while in the second one, the CFC structure is more evident.

The effects of highly absorbing materials on tomographic reconstruction could lead to some “star-artifacts” (white rays radiating away from a spot, a typical star-like pattern also known as metal-artifact.) on the surface of the analyzed sample; they correspond to “lack of information” zones (figure 10). These spots could be explained as voids at CFC/Cu interface but actually they are reconstruction artifacts.

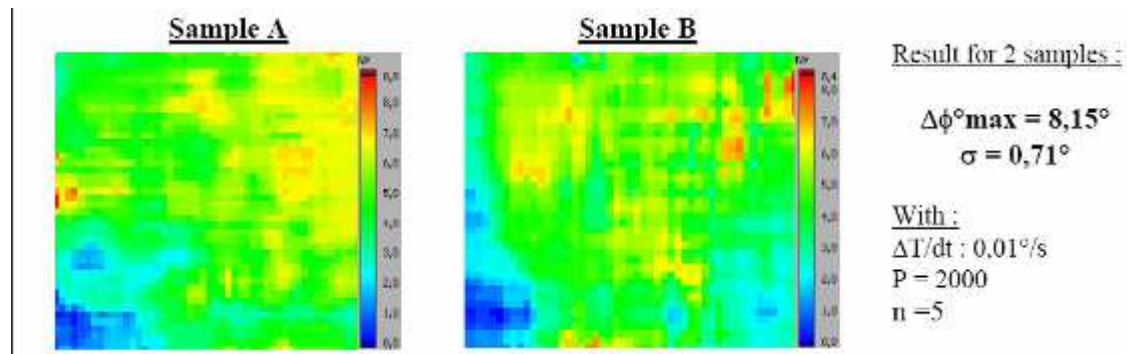
Figure 13

Phase contrast cartography was measured for samples K and L (figure 13); these phase contrast values are in the experimental noise.

The reduced heat transfer capability of some areas of the joined samples, in particular due to the presence of flaws at the interface CFC/Cu can be detected by this technique; not bonded areas indicated by non-homogeneity of the values of the phase contrast cannot be detected in figure 13. As a consequence no defects on K and L samples were detected by means of this technique, in contrast with results of ultrasonic tests.

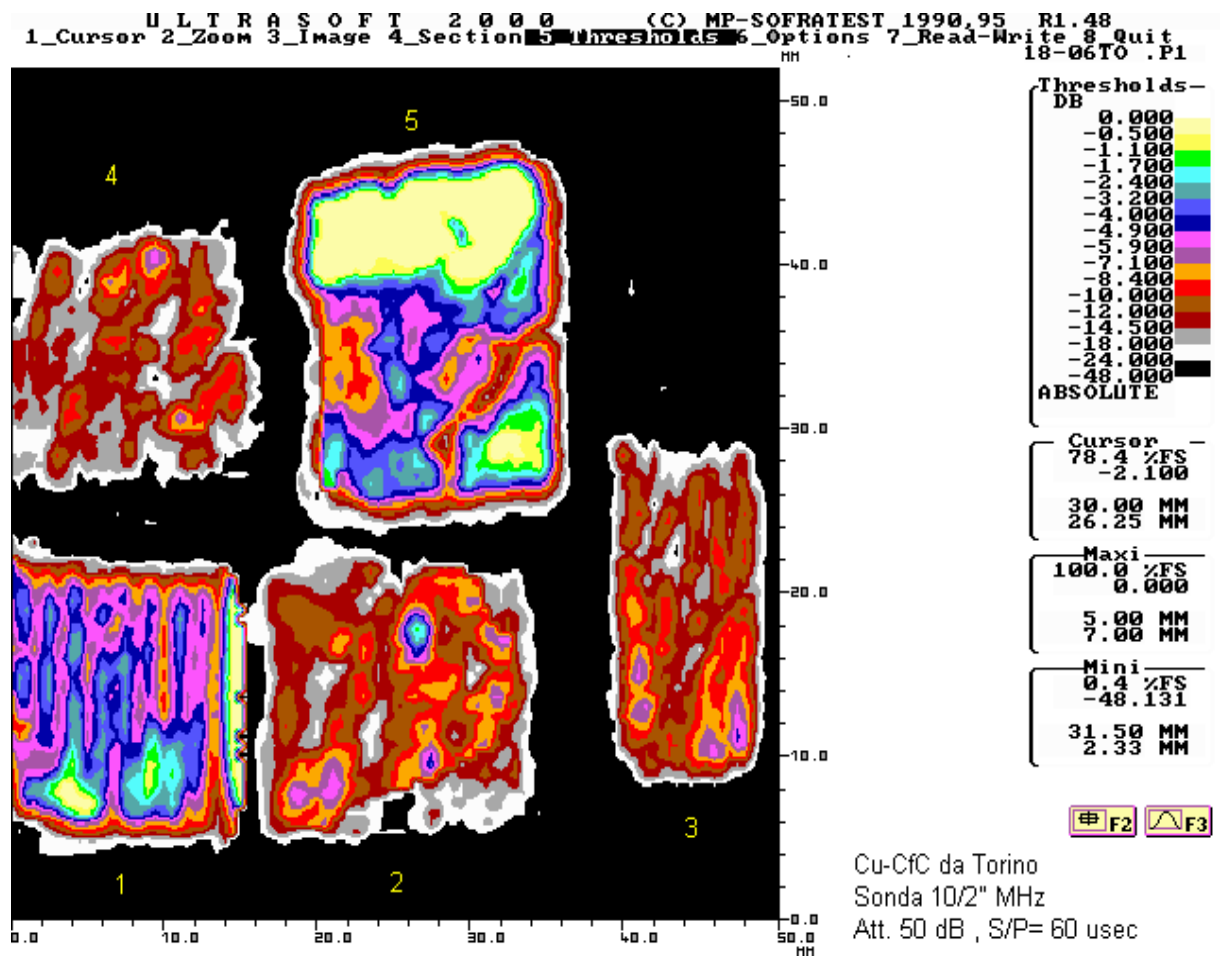
Figure 14

Ultrasonic inspection gave divergent results also for examination of CFC NS31 (silicon doped carbon-carbon) joined to Cu; 5 samples were tested before thermal fatigue test. Sample 1 and 5 (figure 14) showed many defects, especially sample 5 in the upper part (yellow area); these two samples sustained 30 cycles during thermal fatigue test and fracture surface analysis didn't reveal significant detached areas at interface.

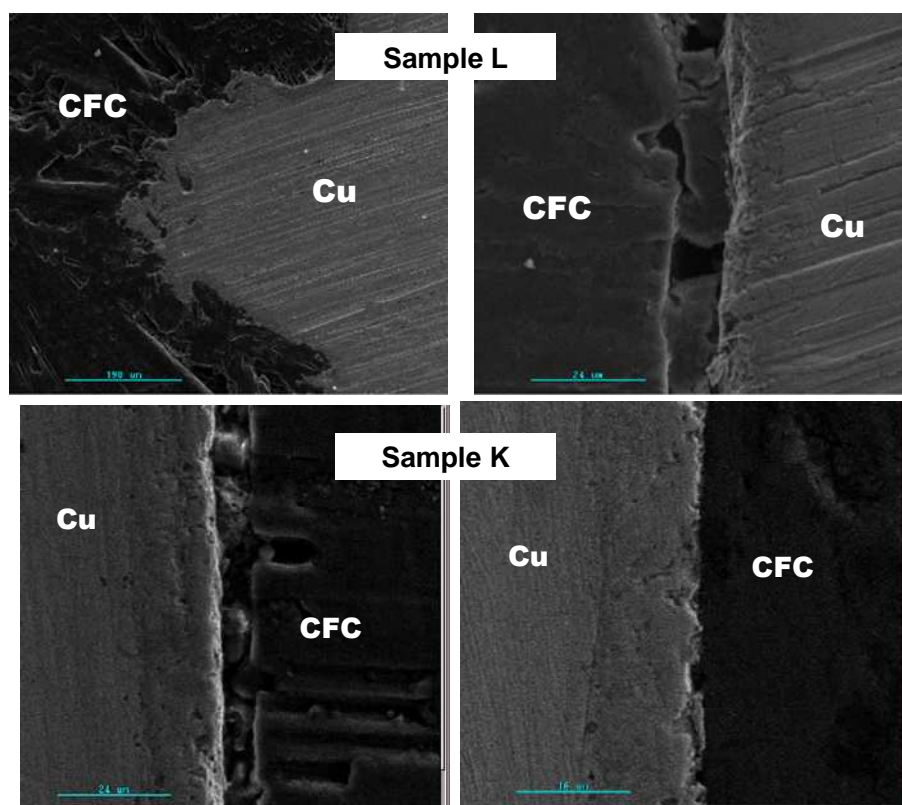
Figure 16

SEM and optical micrographs on samples K and L (figure 16) revealed some voids at CFC/Cu interface, but at the same time supposed detached areas are not confirmed by morphological inspection; as a consequence metallographic analysis doesn't agree completely with results from ultrasonic inspection and ultrasonic analysis disagrees with lock-in thermography.

It can be explained if discontinuities at CFC/Cu interface are small (reduced gap between CFC and Cu surfaces). In that sense, the thermography map can't point out discontinuity at the interface, since thermal response of the joint is quite good; on the contrary mechanical strength should be low.
