Non- destructive characterization of carbon fiber composite/Cu joints for nuclear fusion applications

Non- destructive characterization of carbon fiber composite/Cu joints for nuclear fusion applications / Casalegno, V., Salvo, M., Ferraris, M., Smeacetto, F., Merola, M., Bettuzzi, M.. - In: FUSION ENGINEERING AND DESIGN. - ISSN 0920-3796. - 83:(2008), pp. 702-712. [10.1016/j.fusengdes.2008.04.005]

Abstract

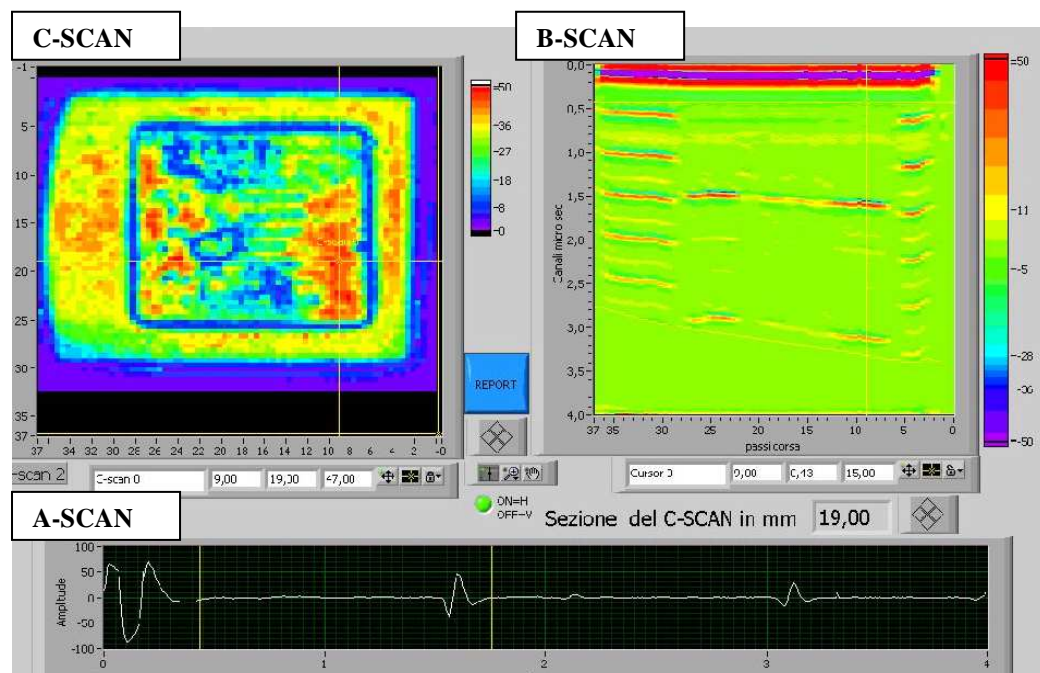
C-scan reported in figure 4 was obtained with an extended window over $3,5\text{ mm}$ in depth. Defects are localized on the left and on the right side of the sample at CFC/Cu interface (red areas). Blue areas show good joint interface (no defects).

Figure 4 Defects localization (red color on the C-scan) at Cu/CFC interface for sample K

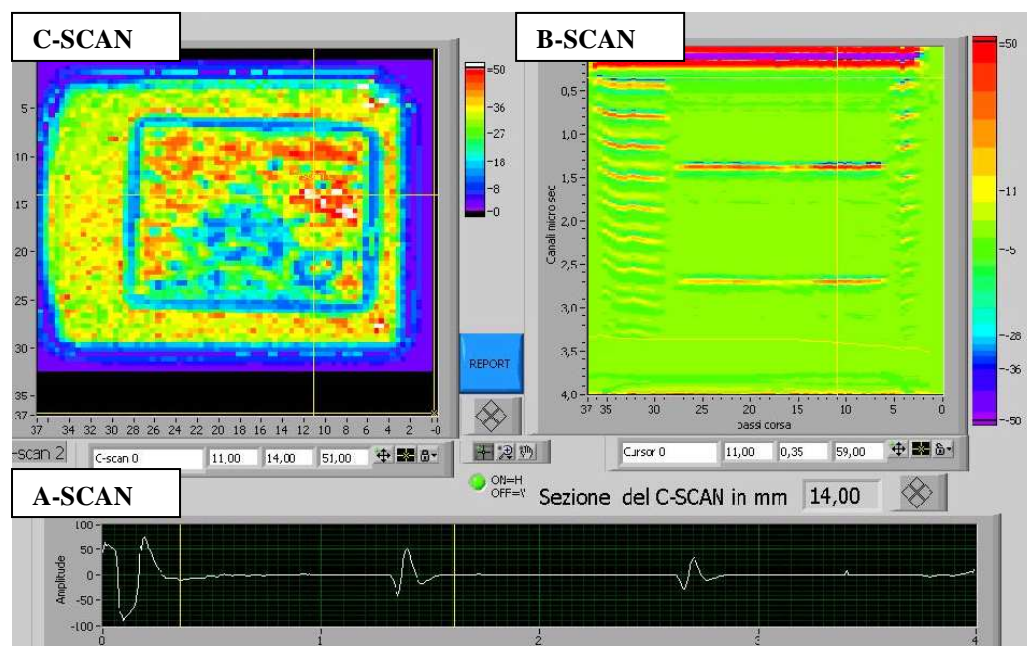
Concerning test on sample L, reference signals have been determined as for sample K (about 1 mm Cu/CuCrZr interface and about 3 mm Cu/CFC interface that correspond to $0.43\text{ }\mu\text{s}$ and $1.3\text{ }\mu\text{s}$ on time axis respectively). Figure 5 shows discontinuities at CFC/Cu interface. Cu/CuCrZr interface is quite continuous; only limited area (figure 6) indicates a defect.

Figure 5 CFC/Cu interface scan of sample L : defects are located in yellow-red areas

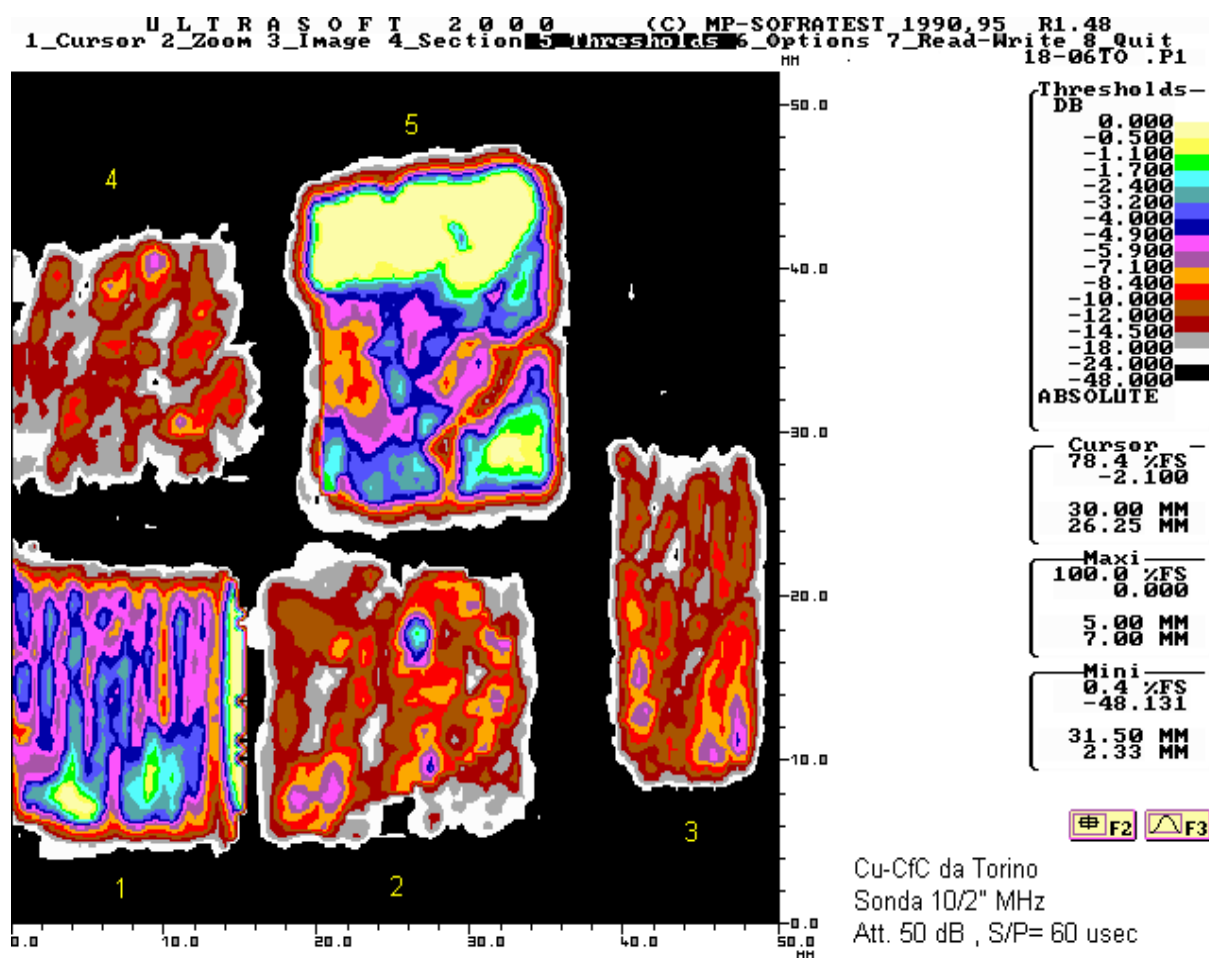
Figure 14

Ultrasonic inspection gave divergent results also for examination of CFC NS31 (silicon doped carbon-carbon) joined to Cu; 5 samples were tested before thermal fatigue test. Sample 1 and 5 (figure 14) showed many defects, especially sample 5 in the upper part (yellow area); these two samples sustained 30 cycles during thermal fatigue test and fracture surface analysis didn't reveal significant detached areas at interface.

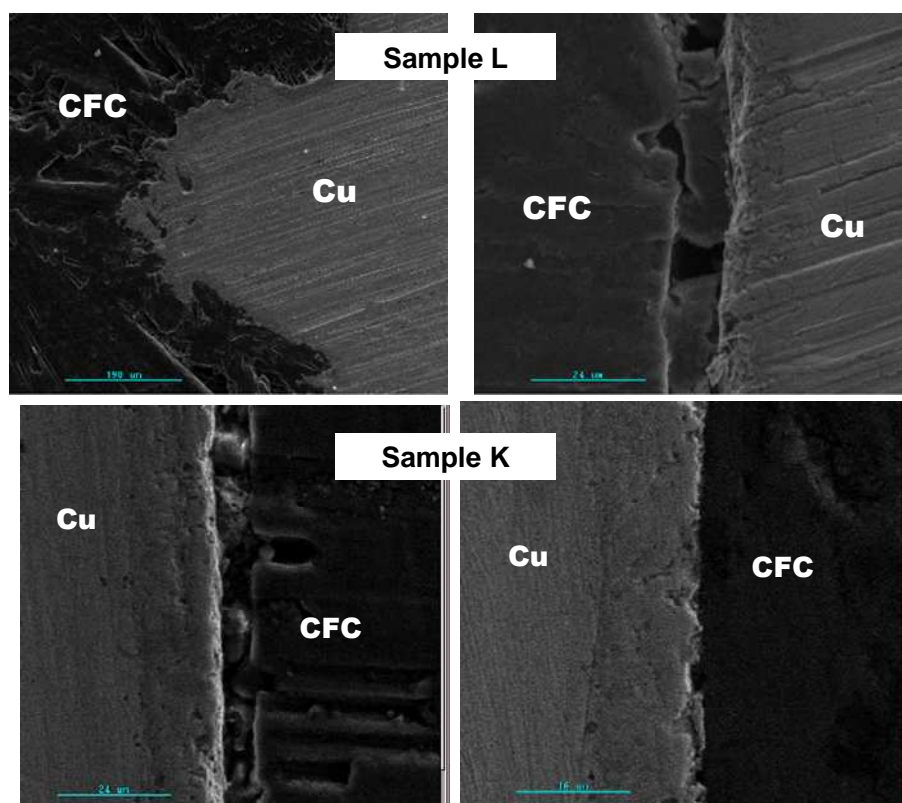
Figure 16

SEM and optical micrographs on samples K and L (figure 16) revealed some voids at CFC/Cu interface, but at the same time supposed detached areas are not confirmed by morphological inspection; as a consequence metallographic analysis doesn't agree completely with results from ultrasonic inspection and ultrasonic analysis disagrees with lock-in thermography.

It can be explained if discontinuities at CFC/Cu interface are small (reduced gap between CFC and Cu surfaces). In that sense, the thermography map can't point out discontinuity at the interface, since thermal response of the joint is quite good; on the contrary mechanical strength should be low.
