Large N.G. explosion and fire involving several buried utility networks

N. Piccinini⁽¹⁾, R. Tommasini⁽²⁾, E. Pons⁽²⁾

This paper describes an accident (explosion and natural gas fire) that occurred in Turin (Italy), in which power distribution cables, tramway network feeding cables and a gas pipe were involved.

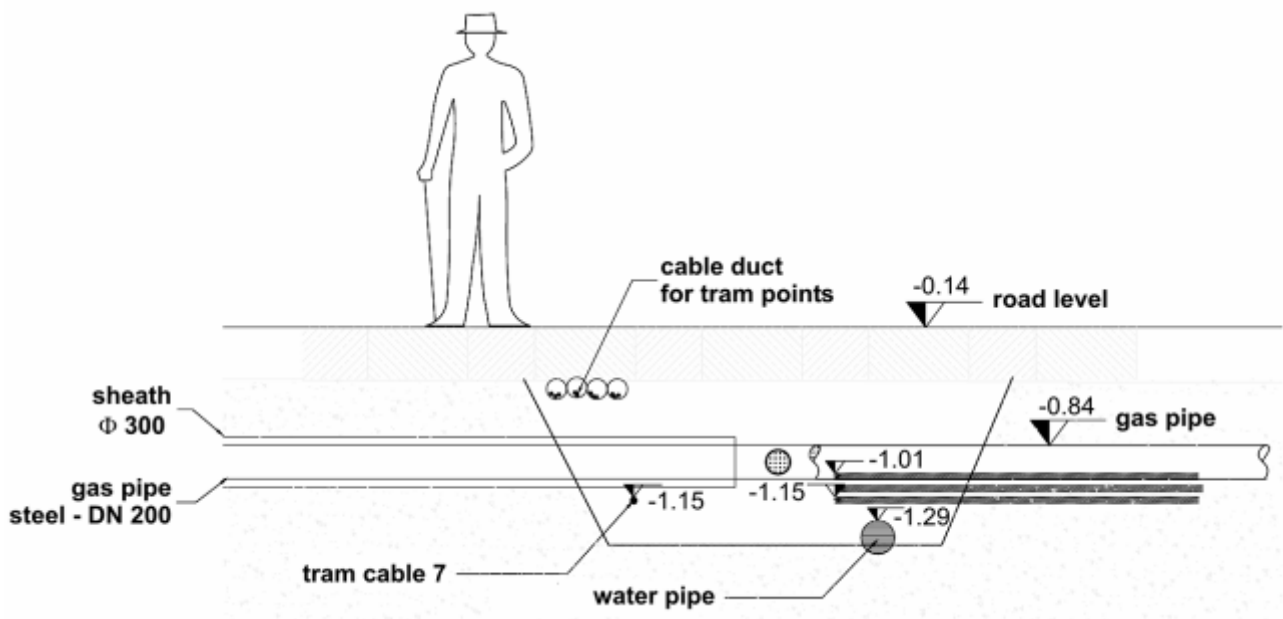
Fig. 1 – Depth survey

No trace of the gres pipe which protected tram cable n. 7 was found near the gas pipe. This was probably damaged and removed during previous works (perhaps when the old cast iron gas pipe was substituted by the steel pipe in 1980). Moreover, the space between the gas pipe, the water pipe and the tram cables 1-6 was not sufficient to allow the gres pipe to cross (see Fig. 1 for details).

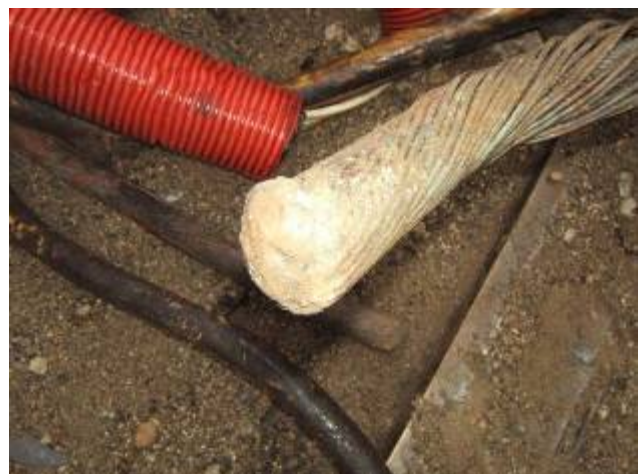
The damaged terminals of the cables are shown in Fig. 9 and Fig. 10.

Fig. 9 – Cable 7

Fig. 10 – Cable 1
