Large N.G. explosion and fire involving several buried utility networks

N. Piccinini⁽¹⁾, R. Tommasini⁽²⁾, E. Pons⁽²⁾

Abstract

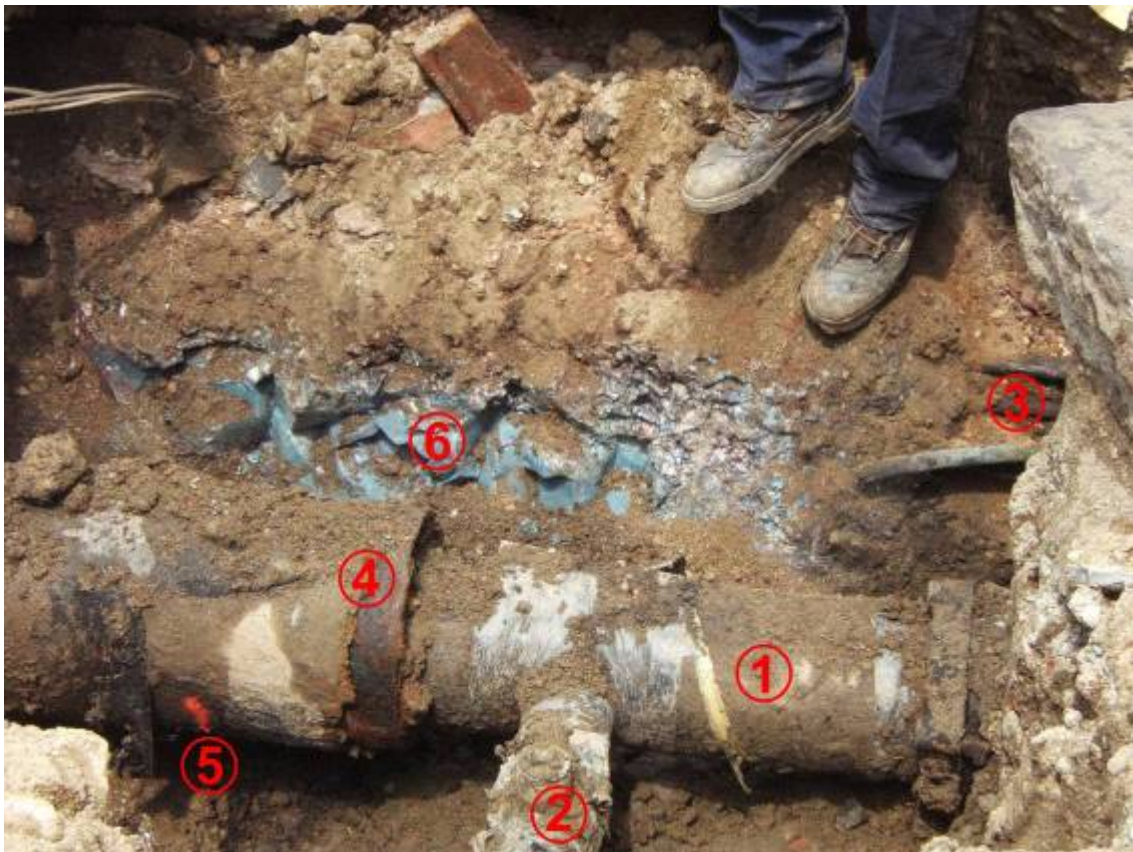
Fig. 8 - Trench

While digging the trench where damage “A” occurred (see Fig. 8), it was found that tram cables 1-6 were fused together with the soil, and formed a vitrified mass (n. 6 in Fig. 8).

The fused cable ends were also visible (n. 3 in Fig. 8).

- the gas pipe (n. 1, 2);
- the gas pipe sheath (n. 4);
- the damaged point “A” (n.5).
