Large N.G. explosion and fire involving several buried utility networks

N. Piccinini⁽¹⁾, R. Tommasini⁽²⁾, E. Pons⁽²⁾

This paper describes an accident (explosion and natural gas fire) that occurred in Turin (Italy), in which power distribution cables, tramway network feeding cables and a gas pipe were involved.

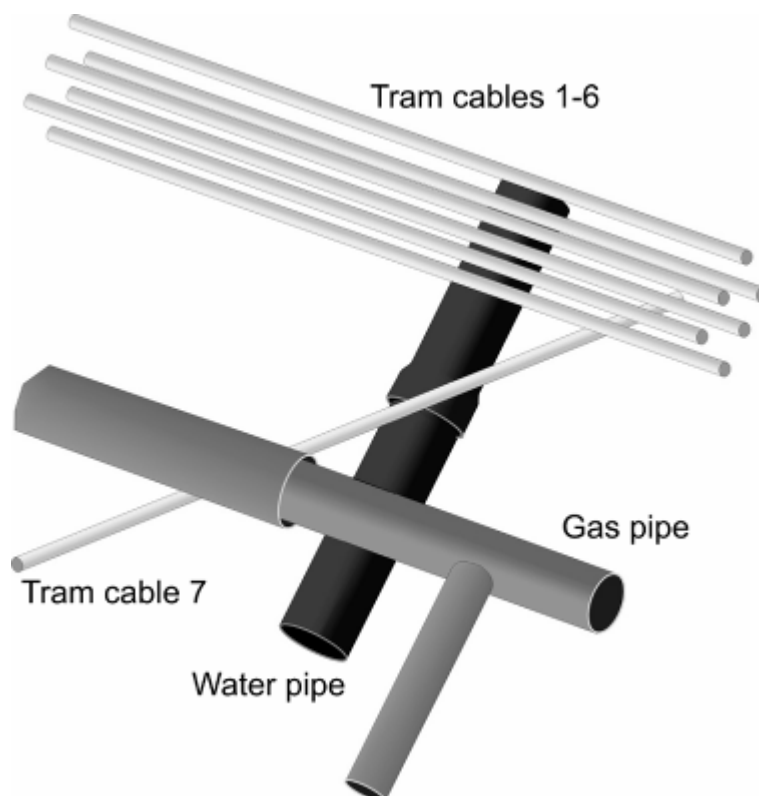
Fig. 3 – Lower buried facilities

There were many buried utilities below the road where the accident took place; from the ground surface and going downwards (for a detailed depth survey see Fig. 1) there were: traffic lights, tram points, public lighting, power distribution and tram network power cables, gas pipes and water pipes. The layout of the lower installations is described in Fig. 3.
