Seismic history of the church of San Pietro di Coppito in L'Aquila

## Seismic History of the Church of San Pietro Di Coppito in L'Aquila

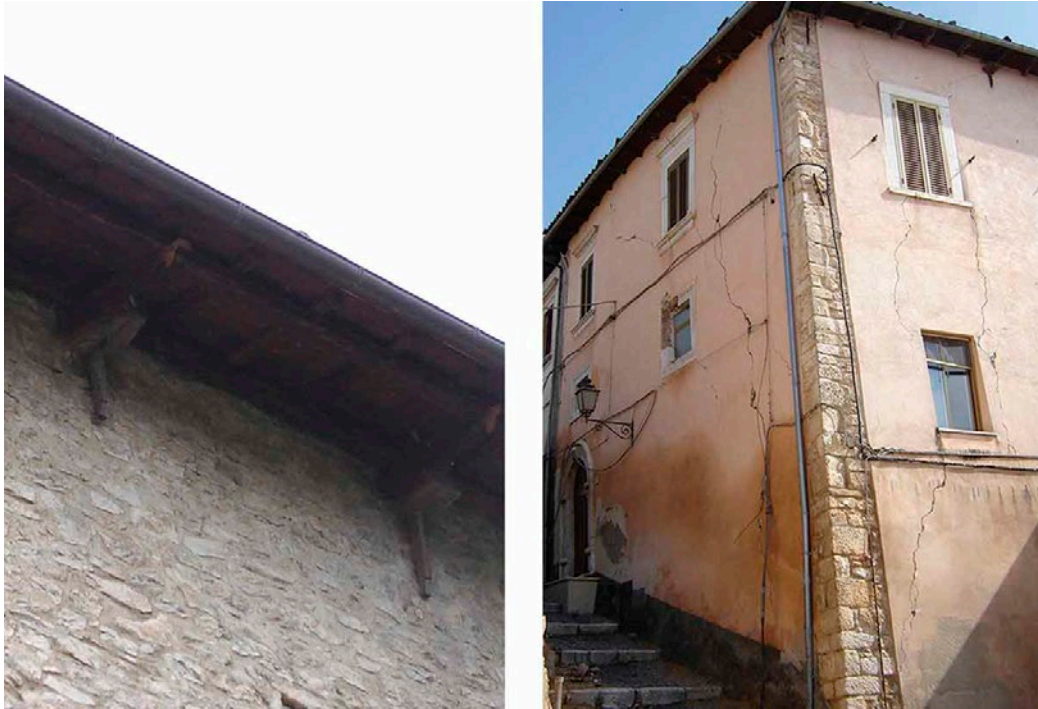
disastrous, because cracks appears in the walls but the building does not collapse) were systematically activated: a clear sign that *radiciamenti* and *impalettature* were effective in preventing out-of-plane (first mode) mechanisms which often damage, even quite badly, buildings devoid of the systematic connections that existed in L'Aquila (fig. 3, right).

**Fig. 3.** Paganica (AQ): the tie-beams of the roof trusses of the nave are systematically anchored (pegged) to the outside part of side walls with wooden pegs (on the left). Poggio Picenze (AQ): the systematic use of metal tie-rods and wooden logs, and the wedge shape of the outside walls, prevented the out-of-plane collapse of the facing walls (and determined their in-plane cracking (on the right)).

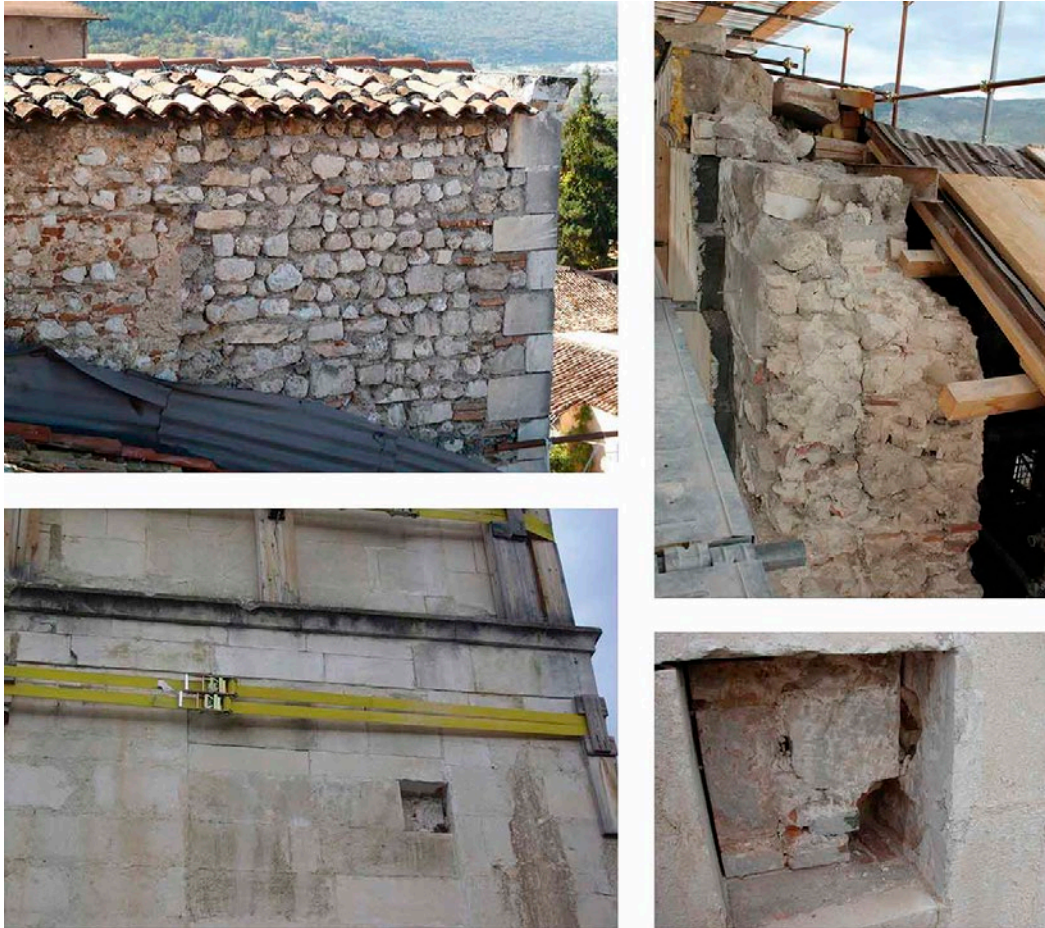
**Fig. 10.** Top: (on the left) the surviving false front of the façade (we can clearly see where the new masonry added by Moretti, rough stones laid on cement mortar, joins – without tothing out – to the original masonry, wedged with bricks and lime mortar, like the masonry visible on the façade wall inside the church); (on the right) the thickening of the nineteenth century façade obtained by Moretti by simply placing a new wall side by side with the existing one.

Bottom: direct survey of the stone facing in the façade by removing single stones from the cladding; on the right we can recognize the block bonding of the pilaster's ashlar in the rear masonry wall and the thick layer of cement mortar where big stone slabs are laid.

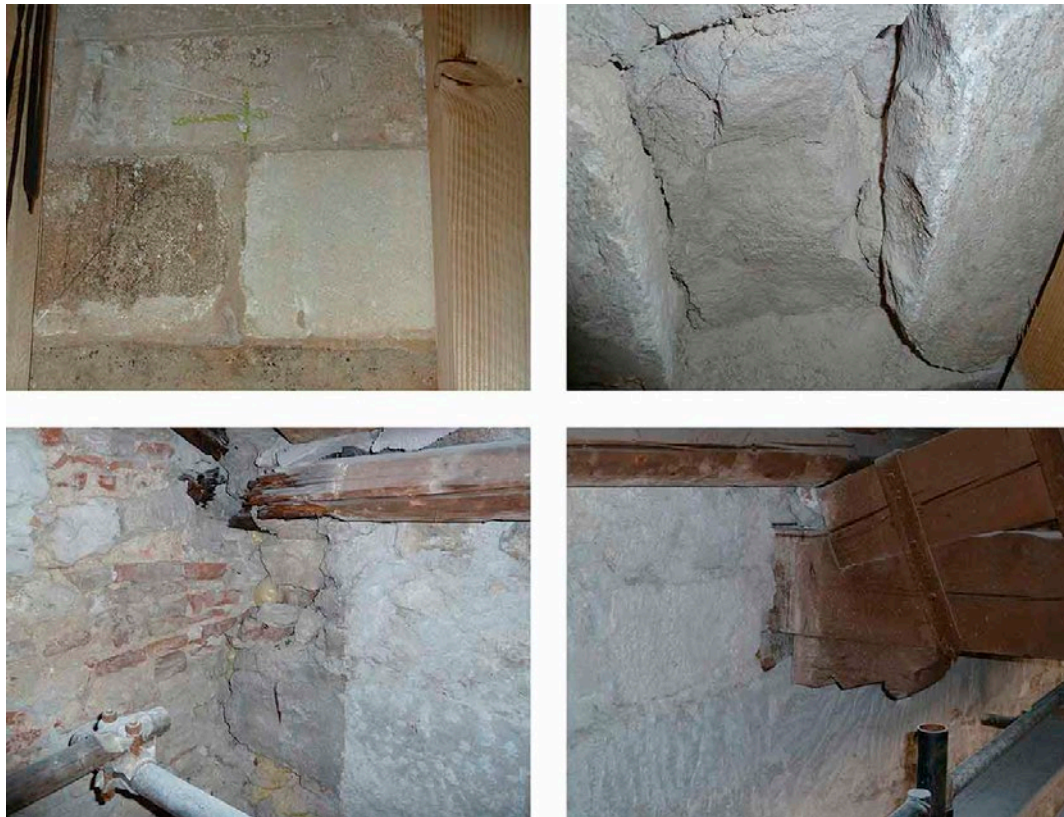
What we said about the masonry works of the nave walls can be repeated for the two pillars of the right wall (fig. 11, top). These both consist of an external face with a pseudo-isodomum arrangement of ashlar stone, and an inner core of rubble embedded in lime mortar, but exhibit, nonetheless, significant constructional differences, fully compatible with the different damage induced by the last earthquake.

**Fig. 11.** Top: (on the left) the filled-in joints of the first pillar (from the façade), face overlooking the aisle are still intact; (on the right) the poor quality of the inner core of the second pillar, face overlooking the aisle can be seen under Moretti's thin slab cladding.

Bottom: (on the left) the r.c. tie-beam is not anchored to the façade; (on the right) the tie-beam of the first roof truss behind the façade simply rests on a wooden sleeper placed on the extrados of the r.c. tie-beam (the supportig shelf is in fact hanging from the tie-beam).

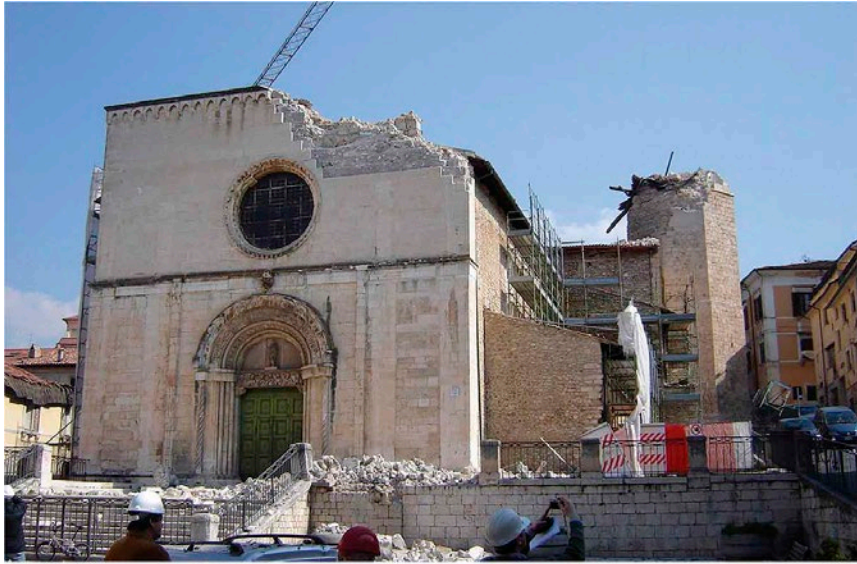
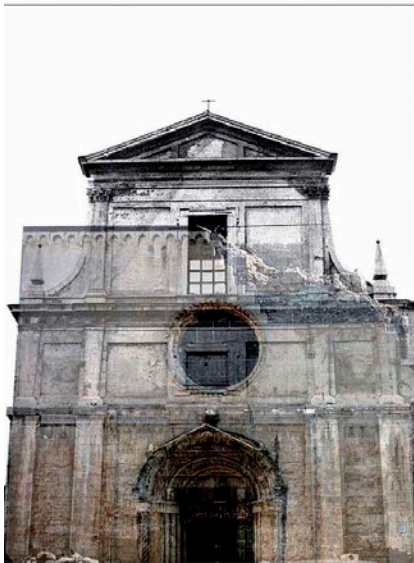
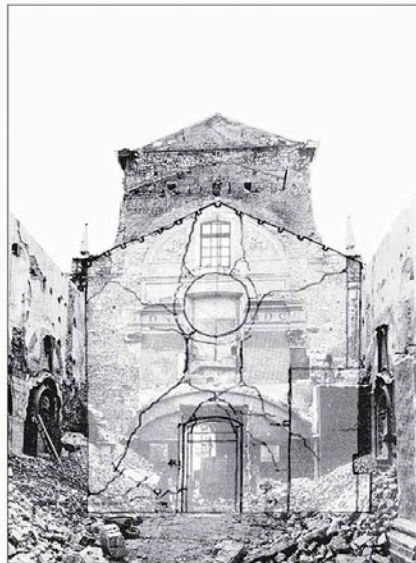
The longitudinal actions caused the damage to the bell tower and the upper part of the façade. The façade has come away from the two side walls of the church, with cracks along the previous crack lines which get bigger as they approach the top, where, in the remaining portion of the roof, the purlins of the rafters have partly (some completely) come out of their housings in the façade. The greater weakness of the right wall of the church, due to the three arches that drastically reduce the shear resistance area (limited, in fact, only to the solid part behind the façade), is consistent with the stronger longitudinal oscillations affecting the right side of the church and the consequent collapse of the upper part, not effectively held in place, of the façade (the part that collapsed was the one added by Moretti in order to create the squared shape) (fig. 12).

**Fig. 12.** Damage due to the earthquake of 6 April 2009. The right corner of the façade has collapsed, as also the top of the bell tower, which, falling, also badly damaged the roof of the transept. The collapse shows that the stone cladding consists of thin stone slabs stuck onto the wall; moreover, the first row of stone cladding, which remained in place, does not seem to extend beyond the part (trapezoidal pilasters) where Moretti reused the stones elements of the previous façade for his restoration (top and lower left). Inside the church, the cracks follow the lines of the Baroque façade (lower right).

These structural interventions, aimed at improving the seismic behaviour of the church, will be completed by the repair (or reinforcement) of the most damaged parts (fig. 17): the façade (for which the collapsed upper right part will be reconstructed, inserting a double row of in-plane tie-rods at the height of the lower edge of the collapsed part and inside the top masonry tie-beam, the thickening of the upper part of the nineteenth century façade (by Moretti) will be bonded to the old wall, the adherence of the stone facing will be improved by replacing some of the thin slabs with stone blocks bonded to the rear masonry wall), the pillars of the nave (whose broken or thin ashlar will be replaced by new ashlar firmly toothed out to the inner core, together with the repair of the core itself), the nave walls (where the parts that had been more deeply altered will be repaired).

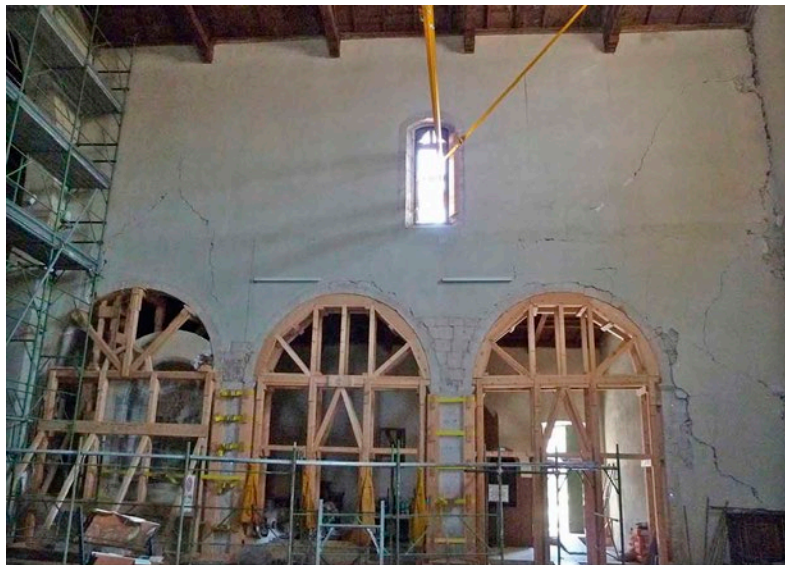
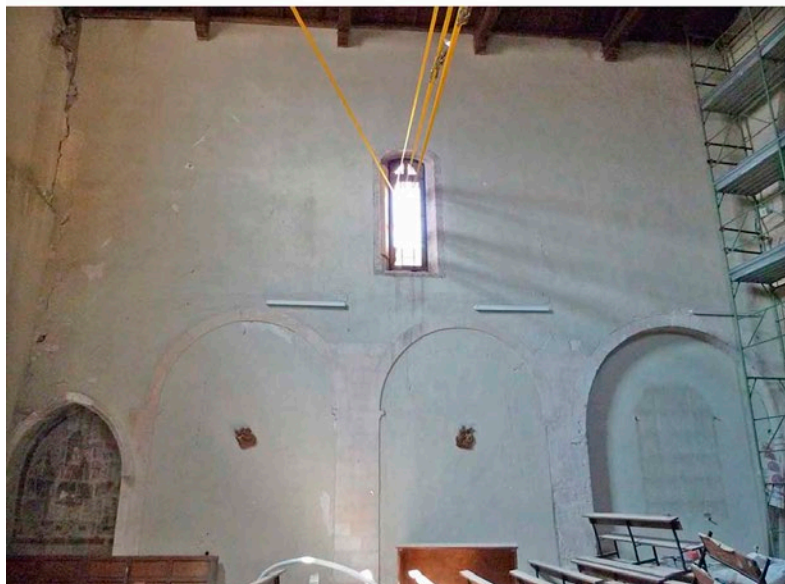
The masonry wall behind the façade, on the right, was badly damaged, as also the two pillars in which some ashlar were crushed by concentrations of load due to the oscillations. Moreover, the removal of the plaster from the masonry highlighted the extensive alterations made to the structure even before Moretti's interventions, and the consequent constructional weakness – in addition to geometric insufficiency – of the right wall (fig. 13, top).

The left wall, too, was more badly damaged near the façade, where the greater concentration of shear stresses was accompanied by a particular weakness of the wall in terms of both geometry (the wall is less thick because of a niche) and constructive quality (due to the presence of prior damage and consequent alterations to the masonry work) (fig. 13, bottom).

**Fig. 13.** Top: in-plane shear cracks in the right nave wall, in both the masonry structure behind the façade and the two pillars. The cracks are bigger than those in the left nave wall because of a smaller overall stiffness (due to the presence of the pillars); this in turn is responsible for the more pronounced movements seen in the right part of the façade and the consequent collapse of the top portion of the latter.

Bottom: in-plane shear cracks in the left nave wall. It should be noted, moreover, that the inner side of this wall is not perfectly vertical and was corrected by adding a substantially perpendicular external facing. This is an evident sign of prior damage repaired by external cladding.

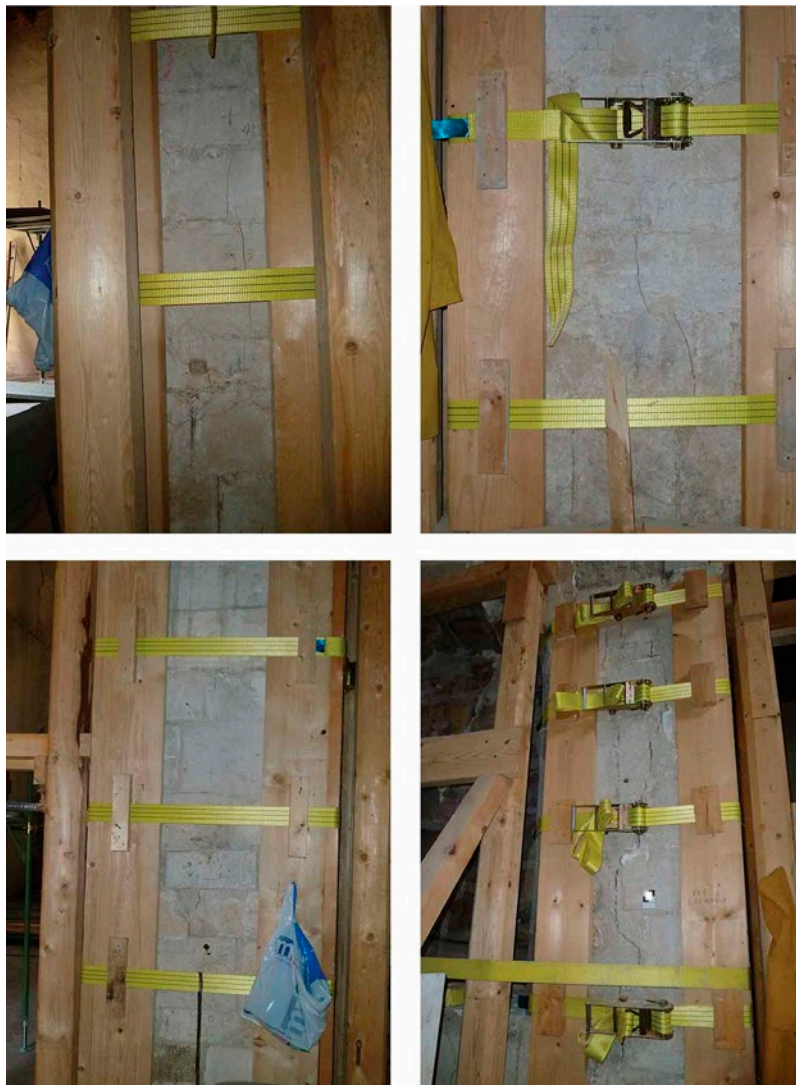
The pillar closest to the façade has a stone facing of constant thickness on all four sides (20 - 25 cm), with well-placed ashlar and thin vertical joints; the inner core (for which no samples were taken but sonic tests (Russo, 2011) were performed) shows an adequate compactness, although being (obviously) less rigid than the faces and with an asymmetric distribution of damage (consistent with the greater damage detected towards the nave).

The second pillar, instead, which had already suffered serious prior damage, has been extensively and extremely badly reworked. The facing overlooking the aisle on the right consists almost entirely of thin slabs, no more than 10 cm thick, which can be clearly ascribed, also from the surface work, to the restoration done in the last century by Moretti: we may suppose that before this, the pillar was joined to a wall that was then removed, and so facing needed to be added to the part that was originally not in view. The other visible faces of the pillar, especially that overlooking the nave, show clear signs of previous seismic damage: the filling between the

The cracks in the two pillars by the orthogonal faces of the nave, and the loosened stones in the second arch, show that there was also transverse movement (fig. 14). This is confirmed by cracks

**Fig. 14.** Top: the first pillar on the right of the nave. Cracks can be seen both in the face overlooking the aisle (on the right) and in the orthogonal face (on the left) and reveal both longitudinal and transverse movements (in line with the damage found on the facade and the triumphal arch of the transept). On a corner (towards the aisle and towards the transept), the stones were crushed by the longitudinal and transverse oscillations of the pillar.

Bottom: the second pillar on the right of the nave. Cracks can be seen in the surfaces that face (on the right) and are orthogonal (on the left) to the nave, revealing both longitudinal and transverse movements. Previous cracks, some of them big, have been plastered. The damage in this pillar is much more serious than in the other since it had already suffered previous damage.

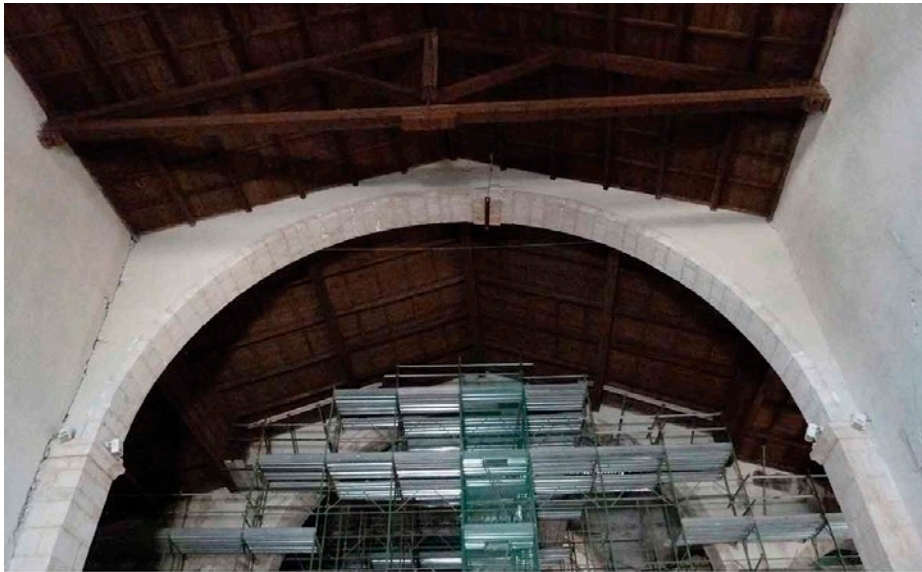
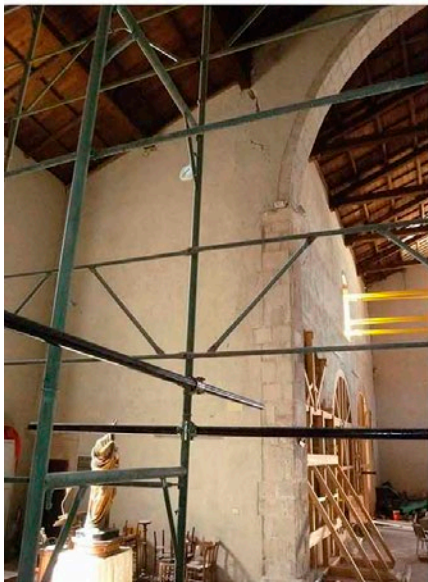
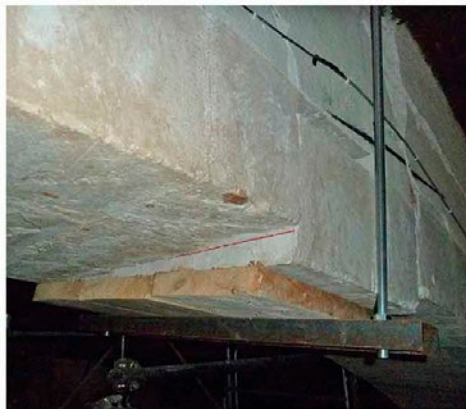
Transverse movement also triggered the damage to the triumphal arch of the transept and its left pier. The arch was affected by the classic mechanism known in the literature as bending mechanism, in which cracks appear at the top of the intrados and at the bottom of the extrados, while the pier on the left has clearly visible shear cracks on the external surface and less clear ones on the inside, due to the extensive alterations it underwent, highlighted by the effects of the last earthquake.

Moreover, the dislodgment of the key stones and the cracks in the stones next to both abutments, nave side, reveal the out of plane rotation of the arch and confirm the strong longitudinal seismic movement (fig. 15).

**Fig. 15.** The triumphal arch between the nave and the transept has cracks consistent with a classic flexural mechanism, at the top of the intrados and at the bottom of the extrados (top and lower left); the diagonal cracks in the left pier of the arch are consistent with an in-plane action. The dislodgment of the key stones (lower right) and the cracks in the stones next to both abutments, nave side, reveal the out of plane rotation of the arch and confirm the strong longitudinal seismic movement.

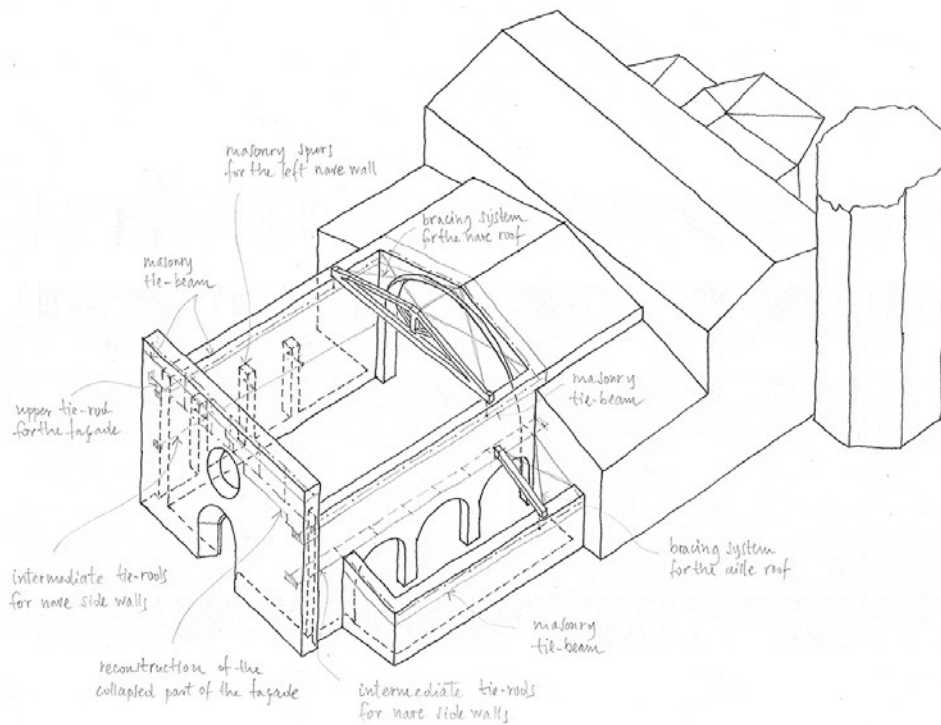
Fig. 16. Overall view of the connections designed for the nave.

From this point of view, and with reference to the nave, which the improvement project was limited to, the major problem is poor containment in both planimetric directions which is a consequence of Moretti's improper interventions and, on the contrary, had been one of the most serious concerns of the baroque builders, as it clearly arises from the historical research. An effective seismic improvement strategy would thus require, recalling the anti-seismic configuration of the eighteenth century church, the systematic introduction of connections to hold together the different structural elements, so that they act as a whole, with the introduction

of additional buttresses where defects in the layout are such that they cannot be realistically remedied by the simple use of tie-rods (fig. 16).
