Analysis of the communication anomaly during E-ST@R-2 mission operations

IAC-17.B4.3.3

ANALYSIS OF THE COMMUNICATION ANOMALY DURING E-ST@R-2 MISSION OPERATIONS

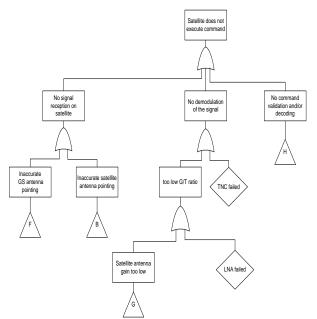
Fig. 5: FT for the top event "Satellite does not execute command"

The "missed execution of commands" can be caused by the missed signal reception by the satellite, the high line losses attenuation between antenna and transceiver, the failure in TNC line, and the lack of demodulation, validation and/or decoding of the command. The bad pointing of the GS antenna that produces an attenuation of about 1 dB should not generate missed signal. On the contrary, an inaccurate pointing of the satellite generates a high attenuation of the signal until the loss of the link when the satellite antenna face points to zenith. Inaccurate pointing of the satellite is probable because no attitude control acts on the satellite until ADCS is activated. A failure of one or more LNA components cannot be identified from radio-module data-sheet. However, it seems less probable that both LNA and HPA contemporary fail unless the module is not correctly powered.

The TNC temporary failure for a SEU or a bug in the software should be taken into account. These failure causes are excluded but, according to the planned procedures, a command is sent only after the reception of an AFSK packet. It implies that TNC software works properly because it correctly modulates the signal. Moreover, although the command is not executed, the satellite correctly transmits another AFSK telemetry packet correctly after 2 minutes from the previous one, confirming that TNC still works. Similarly, a failure of the OBC or of the communication between COM SYS and OBC, should prevent both uplink and downlink of AFSK signal. Unless uplink tasks on the OBC are stopped, downlink tasks still work and the watchdog circuit does not intervene: this condition never occur during the development tests and the AIV campaign.
