# Engineering Reconnaissance Following the October 2016 Central Italy Earthquakes *Version 2*

GEER Team Leaders: Jonathan P. Stewart and Giuseppe Lanzo

Geotechnical Extreme Events Reconnaissance Association  
Report No. GEER-050D  
8 May 2017

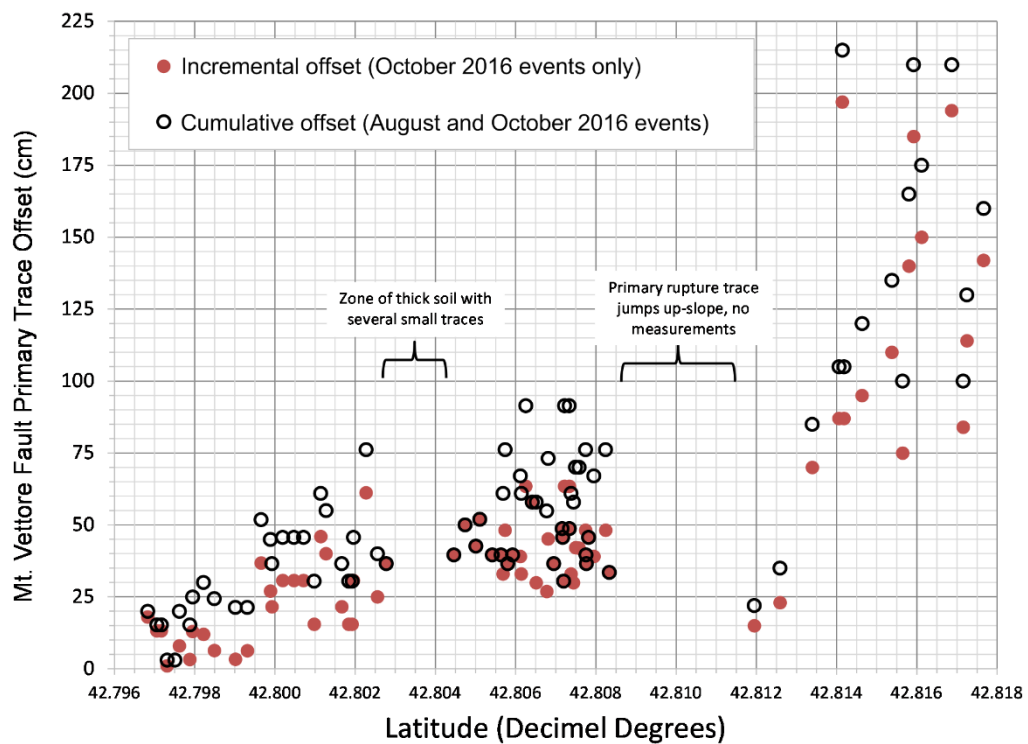
**Figure 2.6.** Distribution of incremental and cumulative fault offsets for the southern half of the Mt. Vettore fault. All data in this Figure from hand measurements.

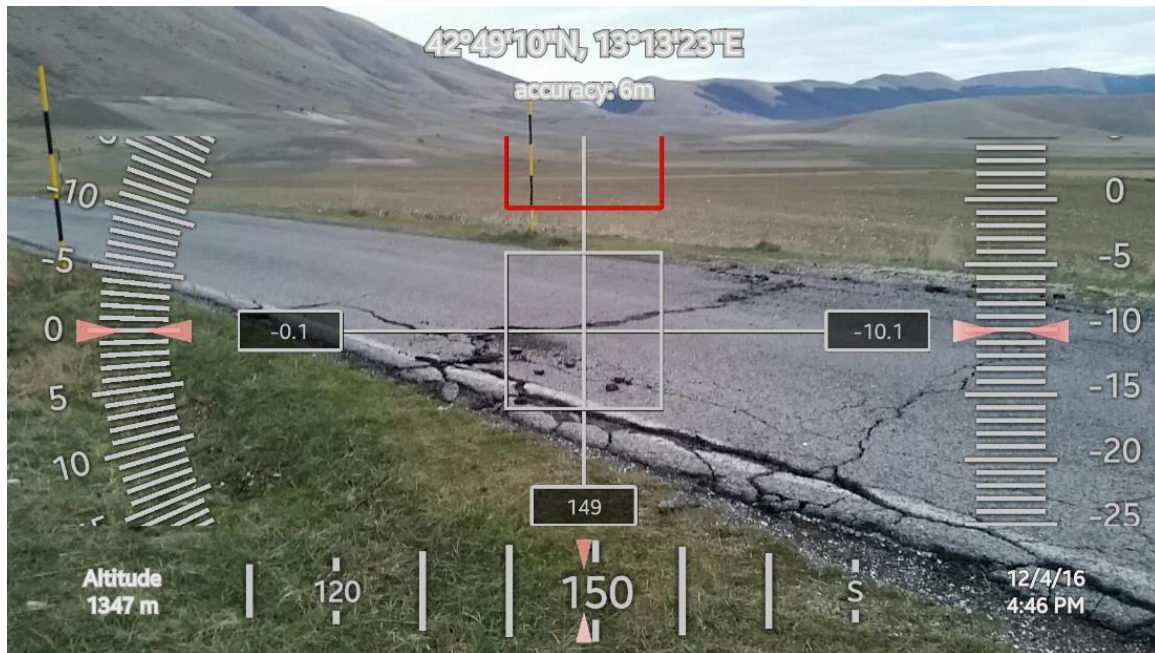
**Figure 2.20.** Secondary fault offset across a road on the Piano Grande at the base of the Mt. Vettore Massif. August 2016 event offset of 0cm. October 2016 event offset of 7 to 18 cm.

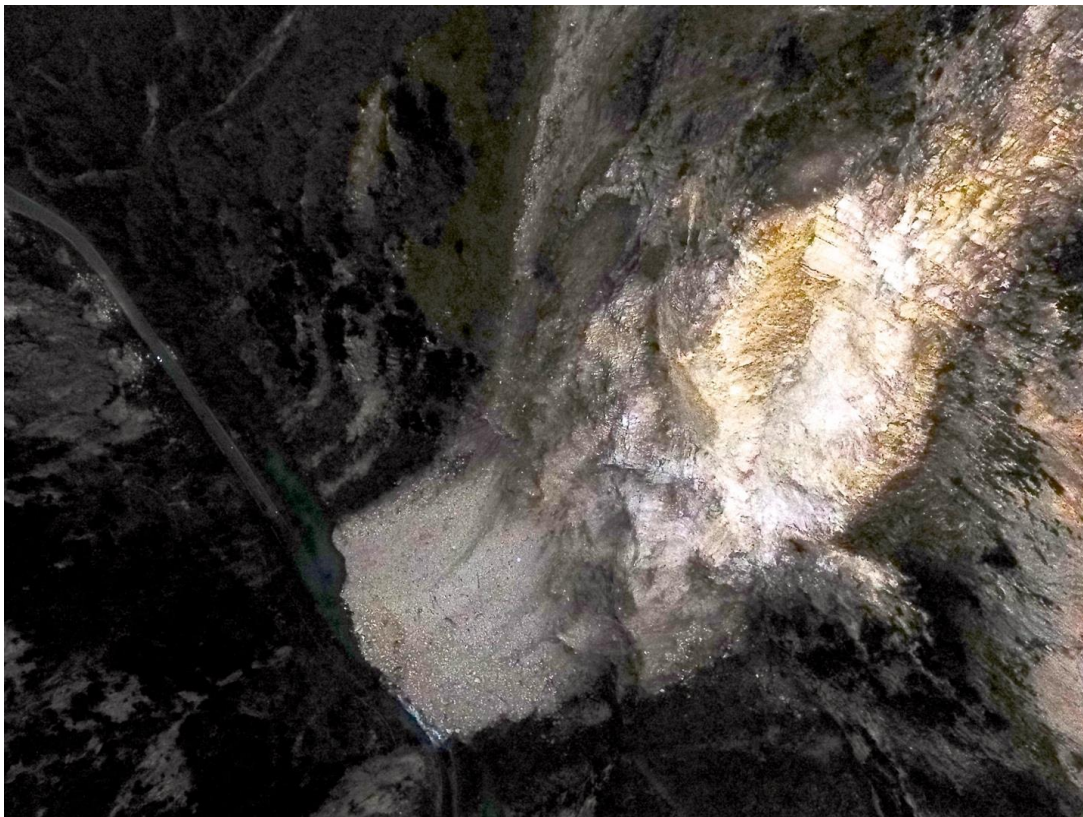
This large rock fall damaged national road SS-209 and formed a small landslide lake as shown in Figure 4.5. The rockfall severed road transportation between Visso and the Spoleto Valley. Access to Visso, the Nera river valley and the landslide was from the eastern Adriatic coast.

**Figure 4.5.** Nera rock avalanche photographed from the UCLA DJI Phantom 4 drone at an elevation of 400 meters above Route SS209. The primary rock-fall was a wedge that detached on the right side of the image and disintegrated into talus debris as it fell 330 meters to the river valley floor. The limestone bedding is visible in the scar of the wedge detachment

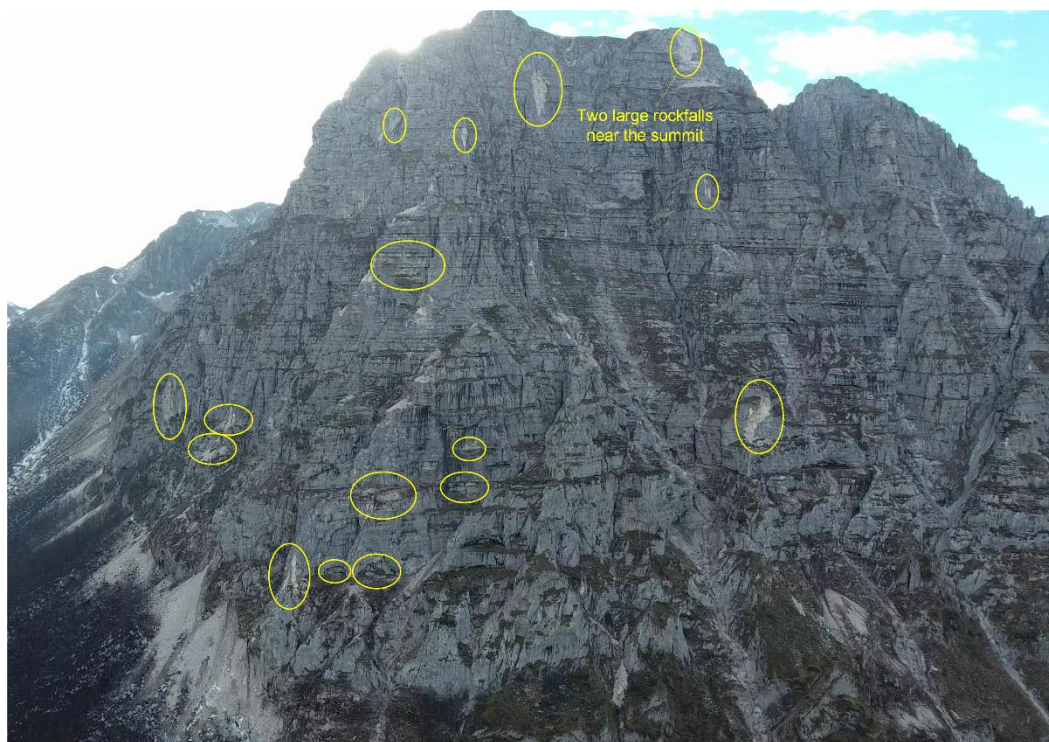
**Figure 4.9.** Phantom 4 UAV image of Monte Bove. Suspected rockfall sources are circled in yellow.

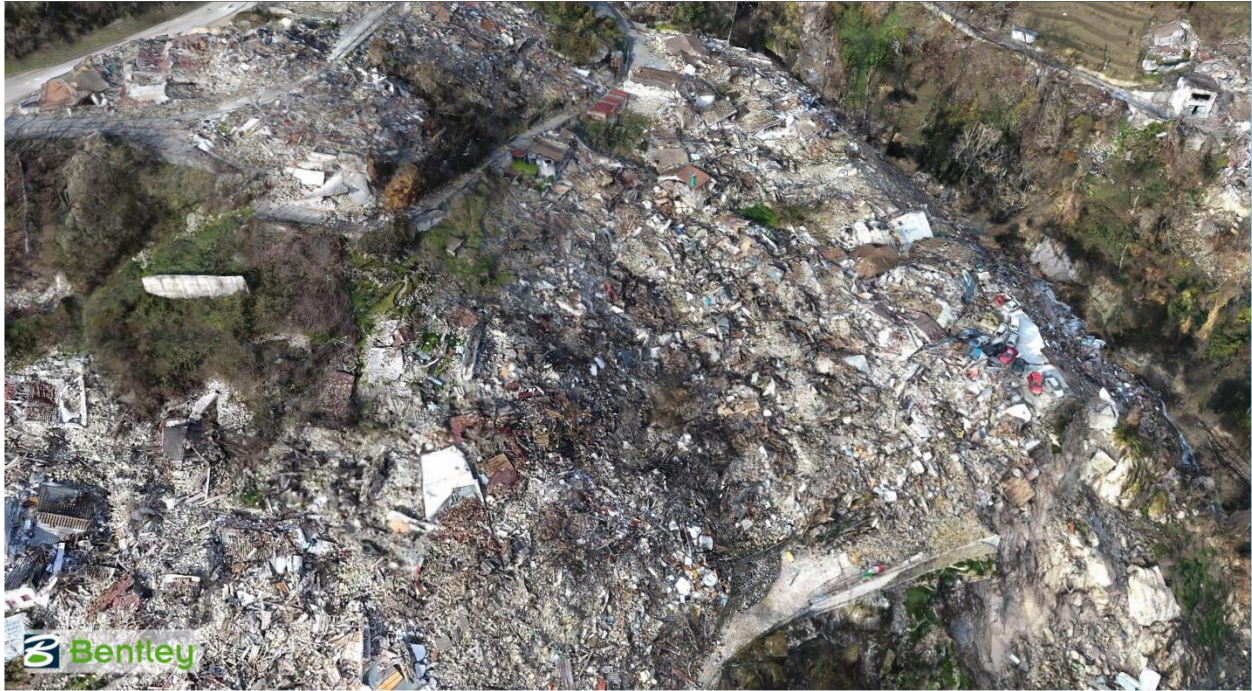
**Figure 4.14.** 3D SfM model of main damaged building area overlying talus deposits (Location 3a).

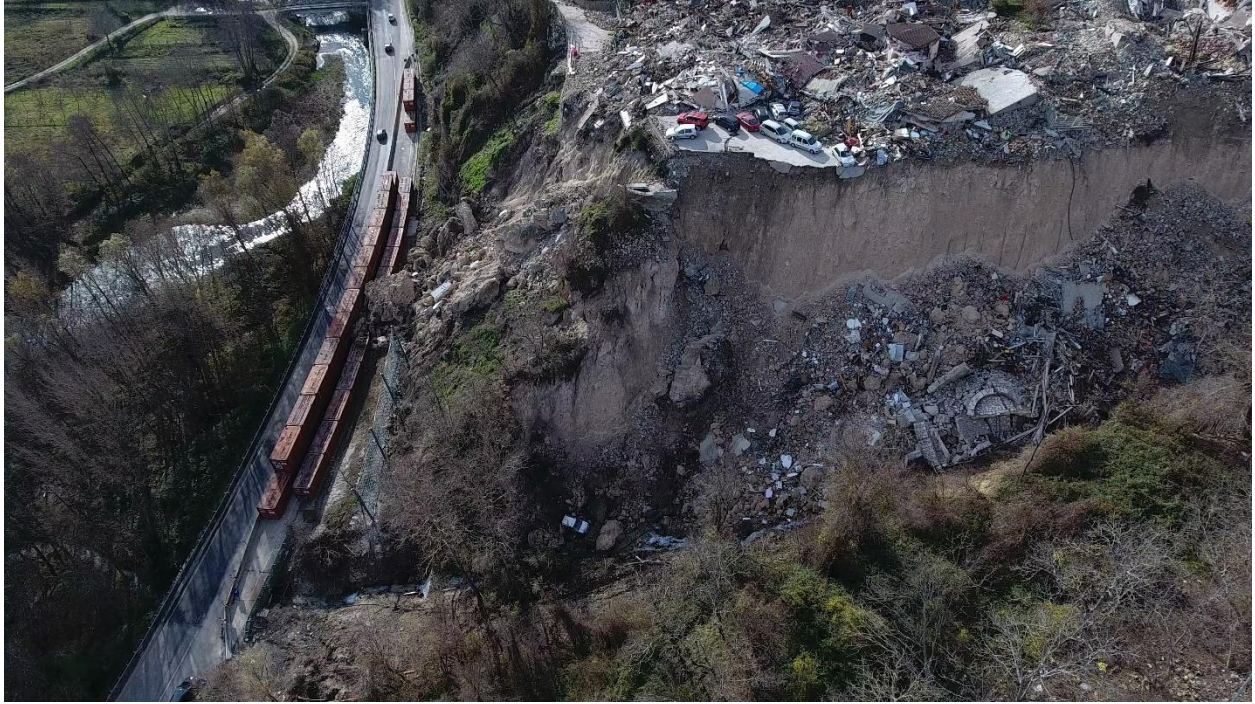
**Figure 4.15.** View of talus behind failed retaining wall by Strada Statale No. 4 (Location 3b).

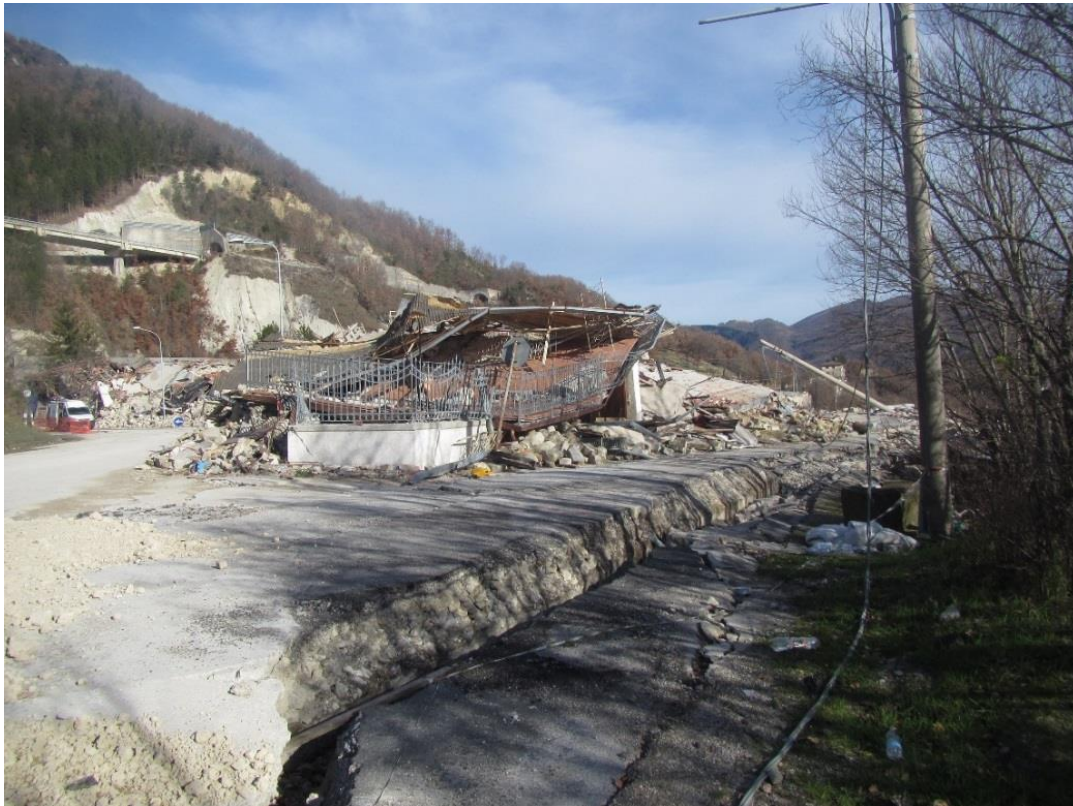
**Figure 4.16.** Pavement and road base damage induced by underlying stability failure of fill material (Location 3c).

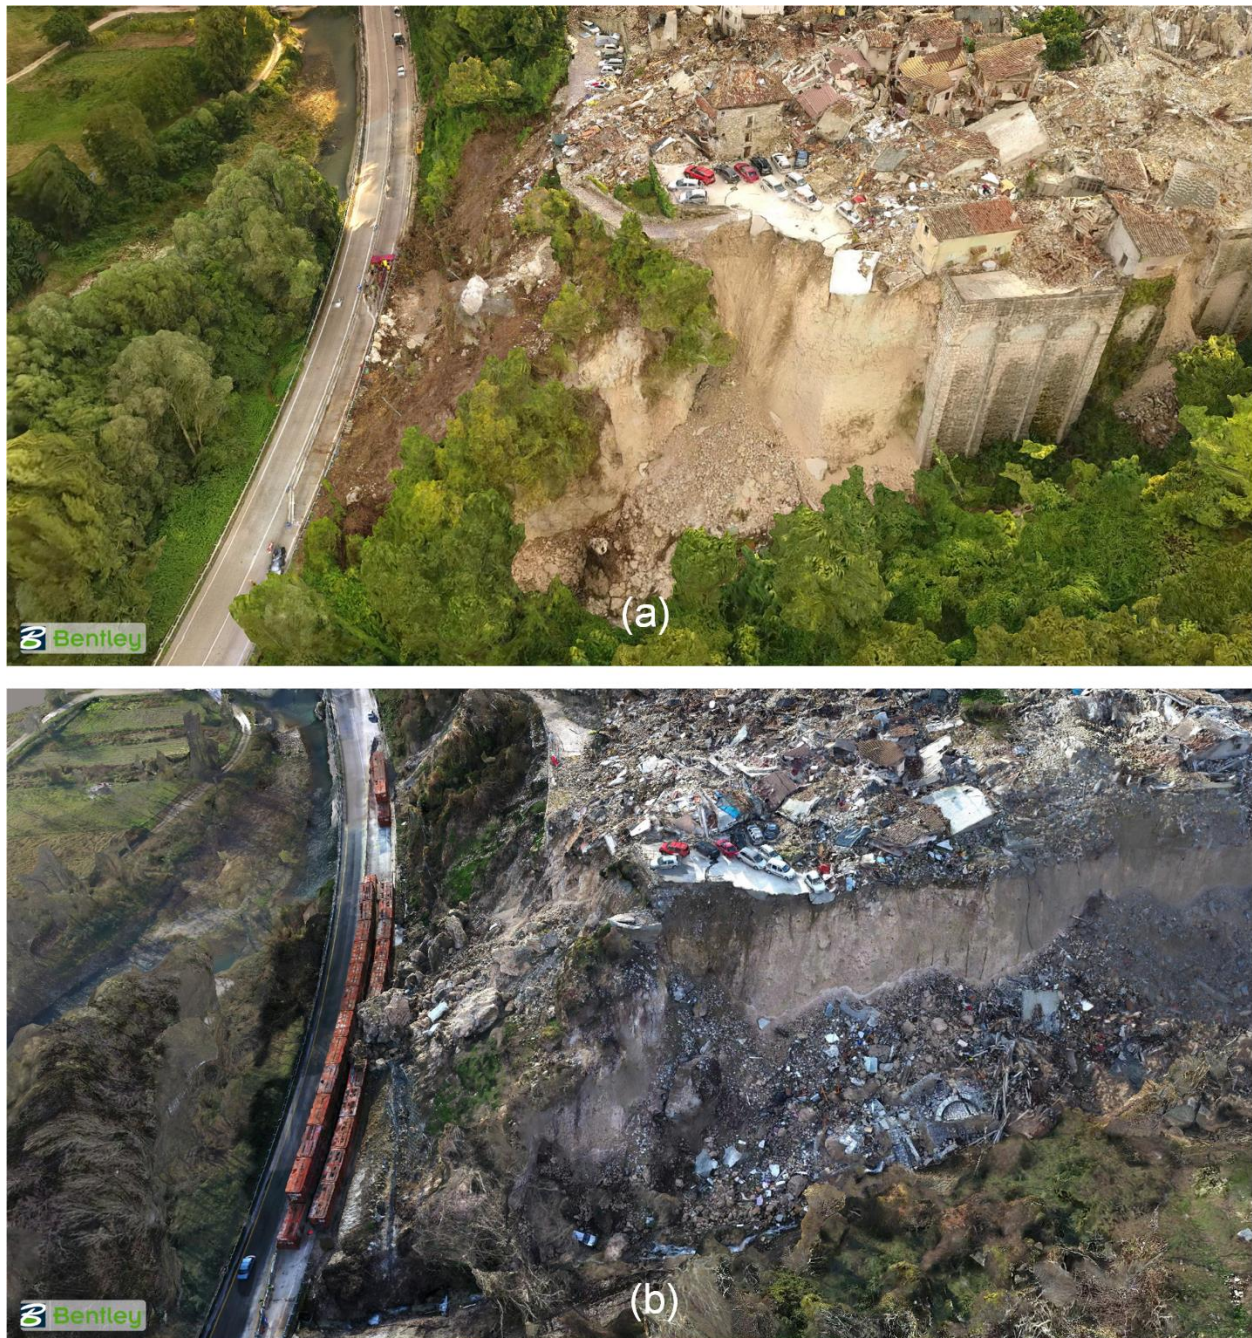
**Figure 4.24.** 3D model comparison of the failed retaining wall below Pescara del Tronto between September 2016 (a) and December 2016 (b).

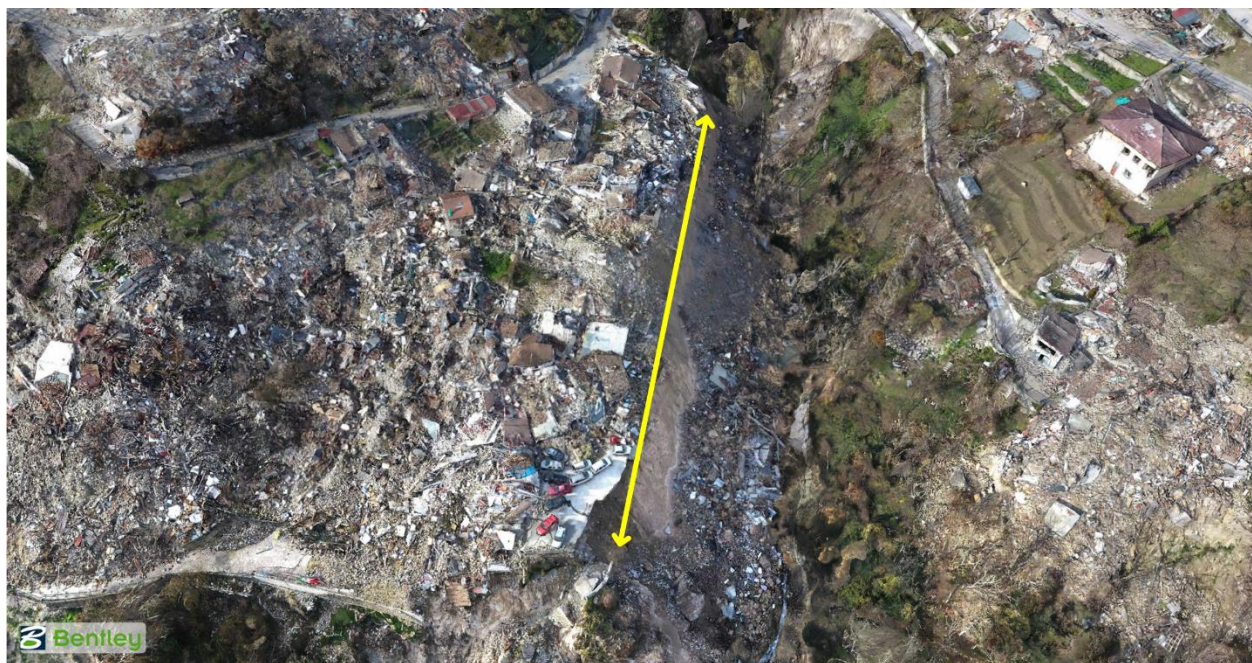
**Figure 4.25.** 3D SfM model view of scarp linearity behind failed lower retaining wall in Pescara del Tronto.

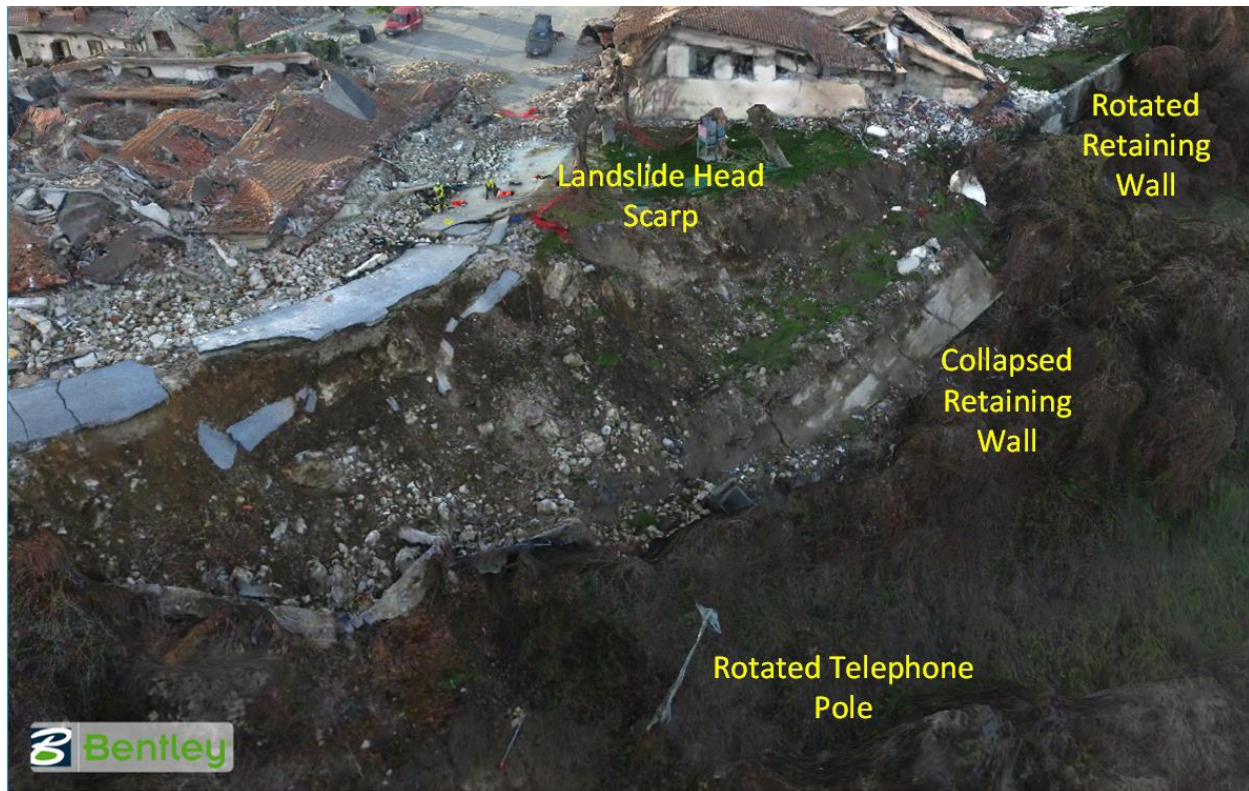
**Figure 4.32.** 3D model screenshot identifying objects of interest with the failed retaining wall and shallow slope failure at Point 4a.

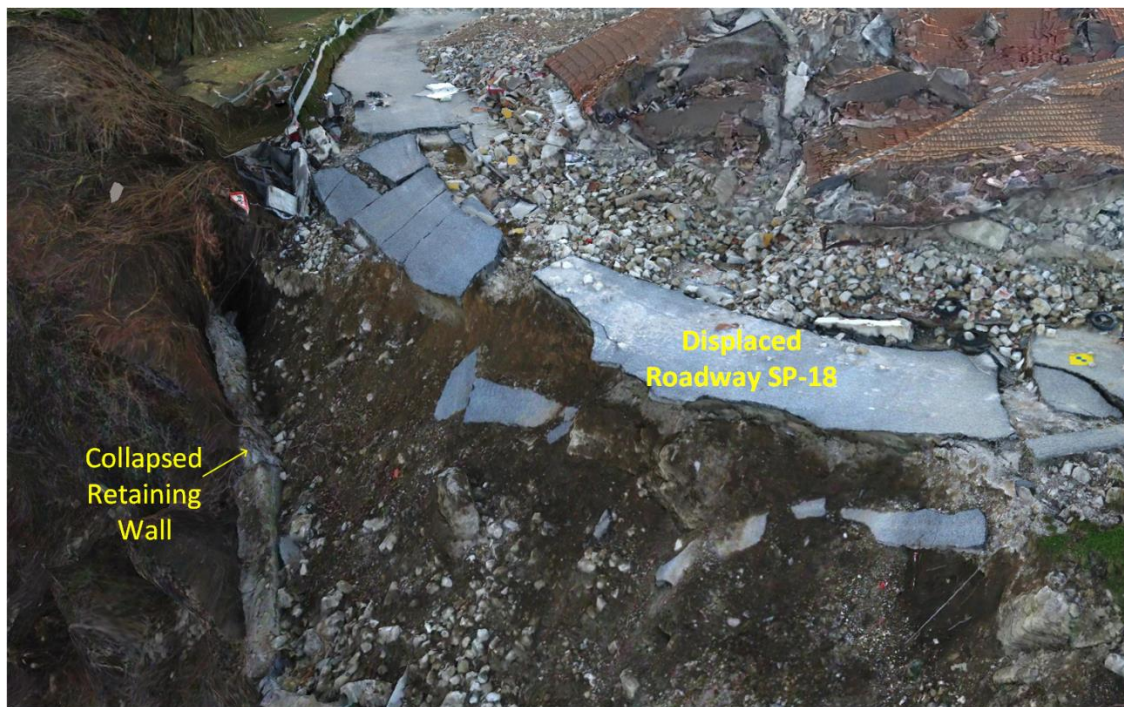
**Figure 4.33.** 3D model screenshot of the destroyed roadway Frazione Fonte del Campo (i.e., SP-18).

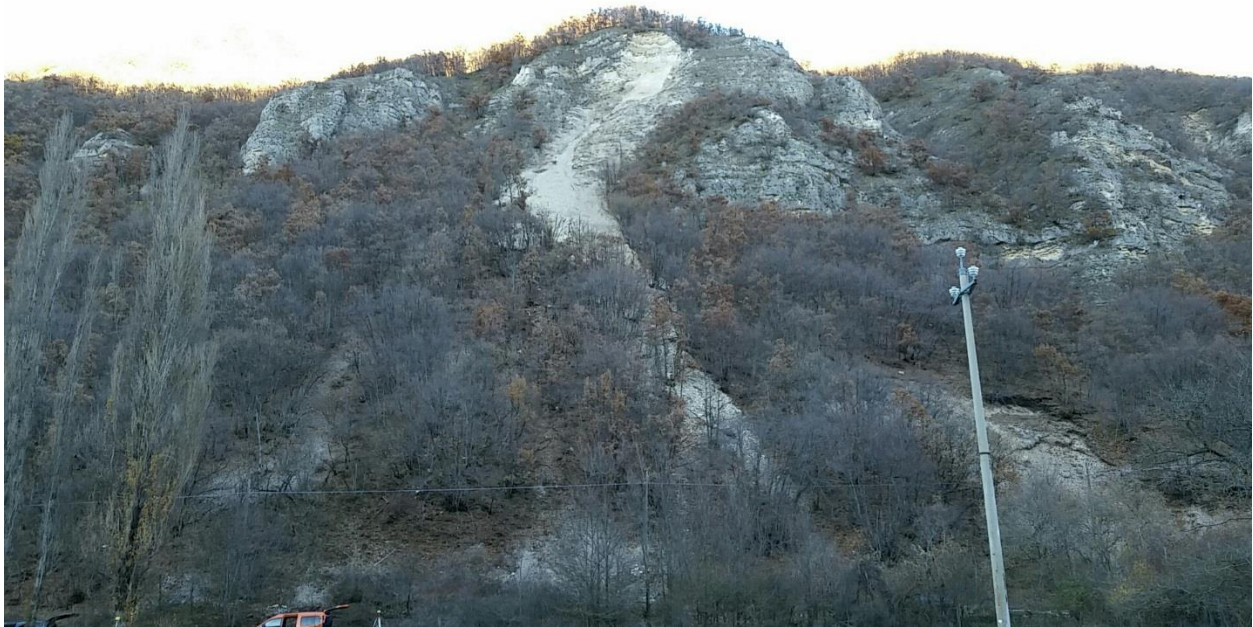
**Figure 4.60.** Pescia rockfall site 9b. Source area at top with runout damage. Not pictured: runout boulders across road and into field, corresponding to approximate 30 degree Fahrboeschung angles.

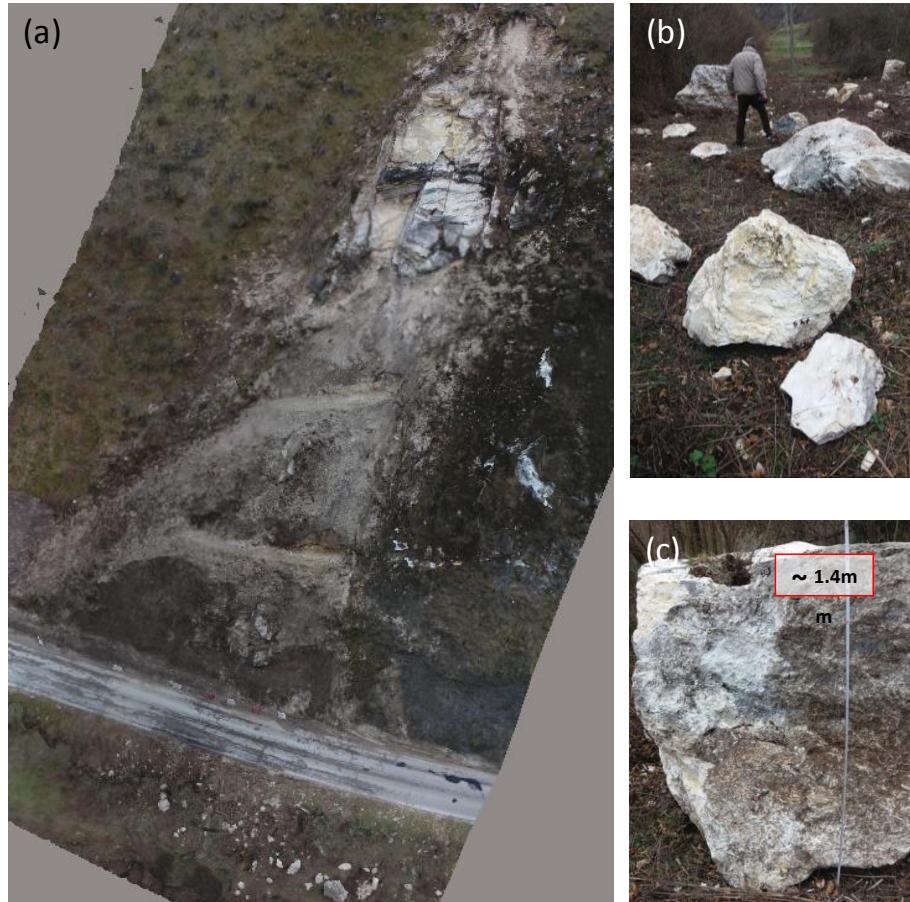
**Figure 4.64.** General oblique view from the drone of the rock slide on the right flank of the Nera valley (km 4 of SP134 motorway); the rock avalanche invaded the motorway and the valley bottom below for a stretch of about 70 m spreading large blocks (b-c).

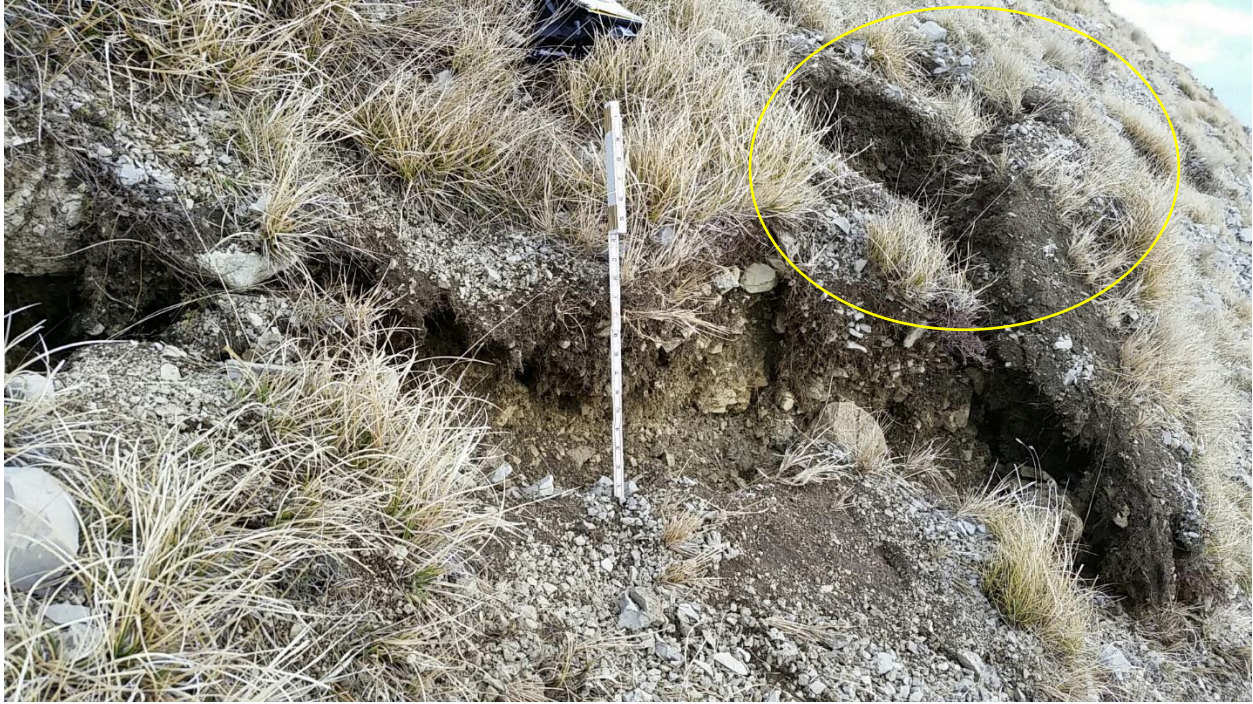
**Figure 4.70.** Image of fault scarp and associated nearby slope instabilities (yellow).

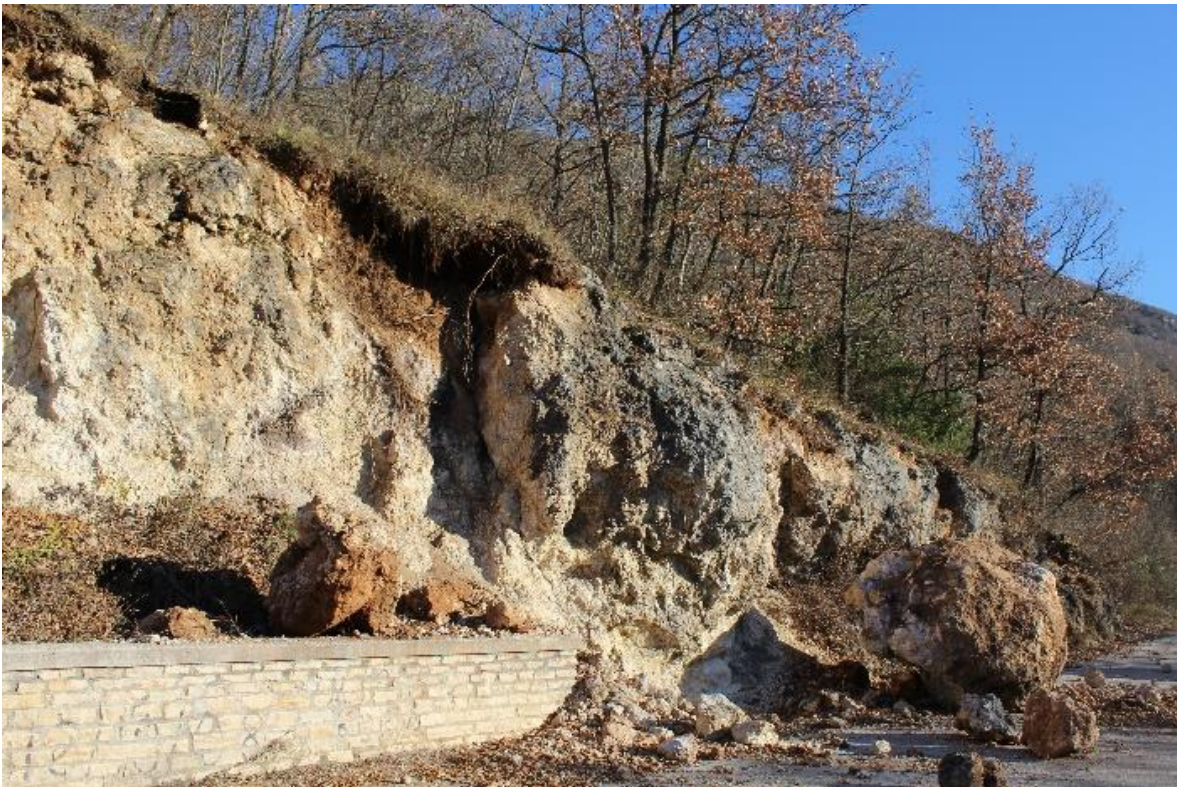
**Figure 4.74.** Rockfalls with boulders on the road.

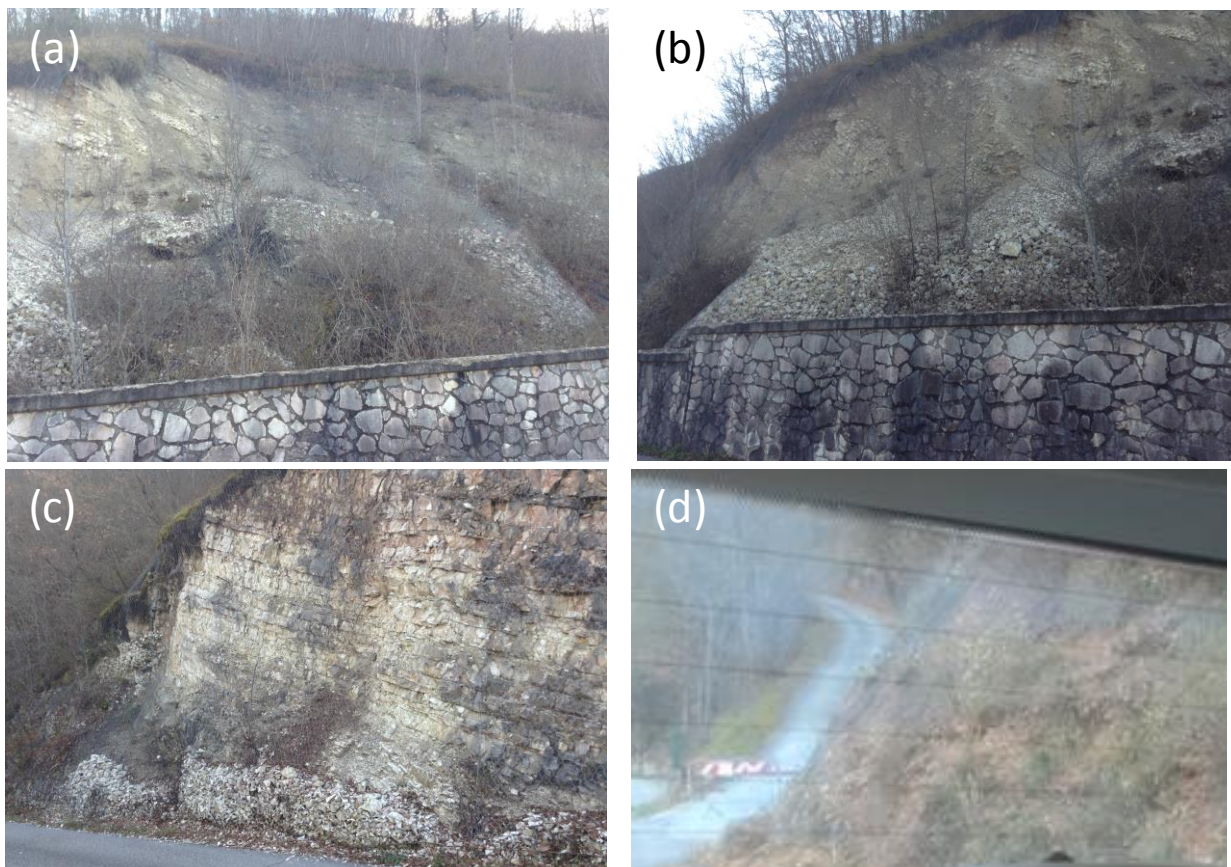
**Figure 4.99.** Observed rockfalls along SP476 (between Piedivalle and Preci).
