Engineering Reconnaissance Following the October 2016 Central Italy Earthquakes *Version 2*

GEER Team Leaders: Jonathan P. Stewart and Giuseppe Lanzo

Geotechnical Extreme Events Reconnaissance Association
Report No. GEER-050D
8 May 2017

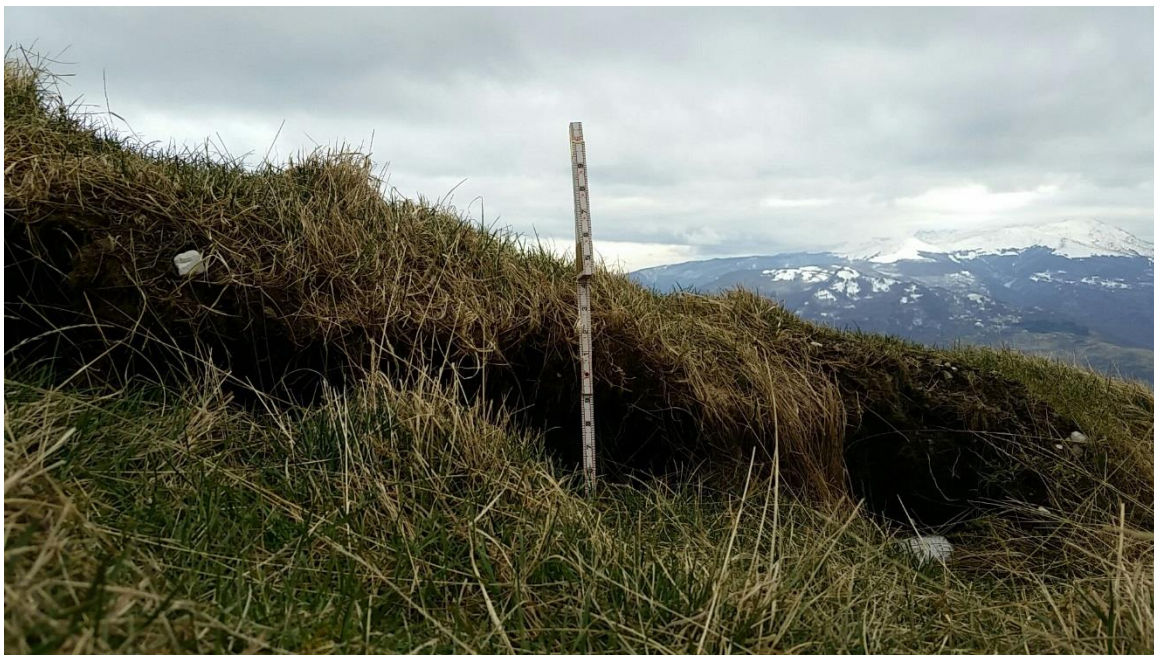
Figure 2.17. Fault offset measurement of one of several (4 to 6) small traces on the south face of Mt. Vettore in the area indicated in white in Figure 2.9. In this area surface soils are thick and ductile. Offset measured at 8 to 52cm on each trace. August offsets were 0 cm. Lat = 42.80483, Long = 13.26443.

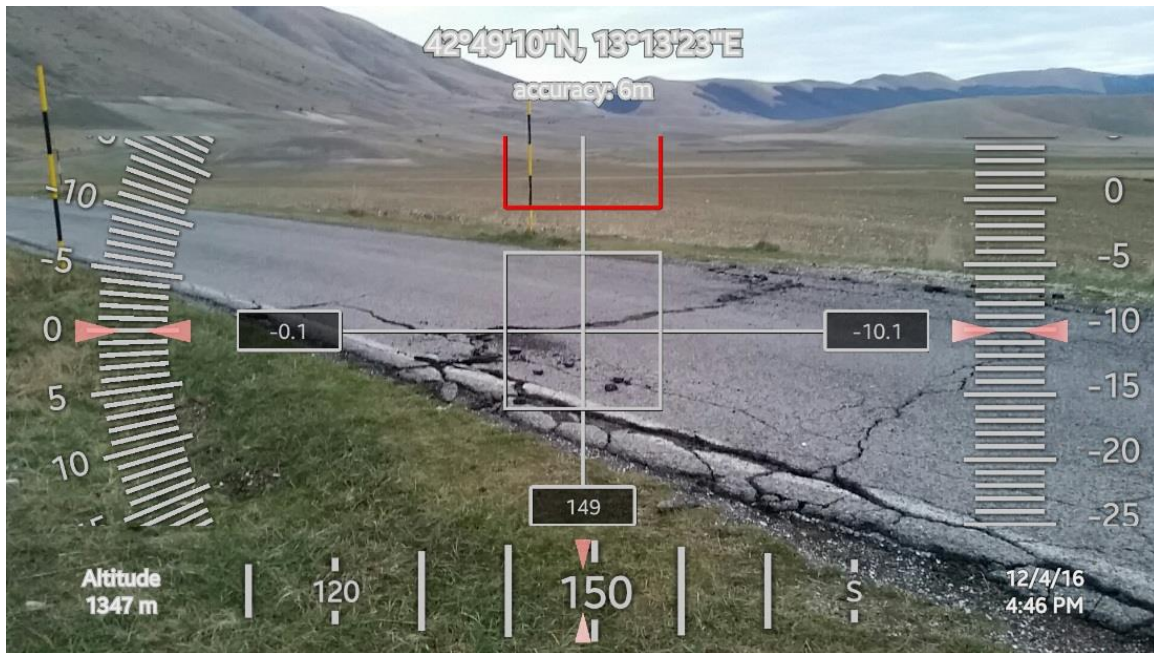
Figure 2.20. Secondary fault offset across a road on the Piano Grande at the base of the Mt. Vettore Massif. August 2016 event offset of 0cm. October 2016 event offset of 7 to 18 cm.

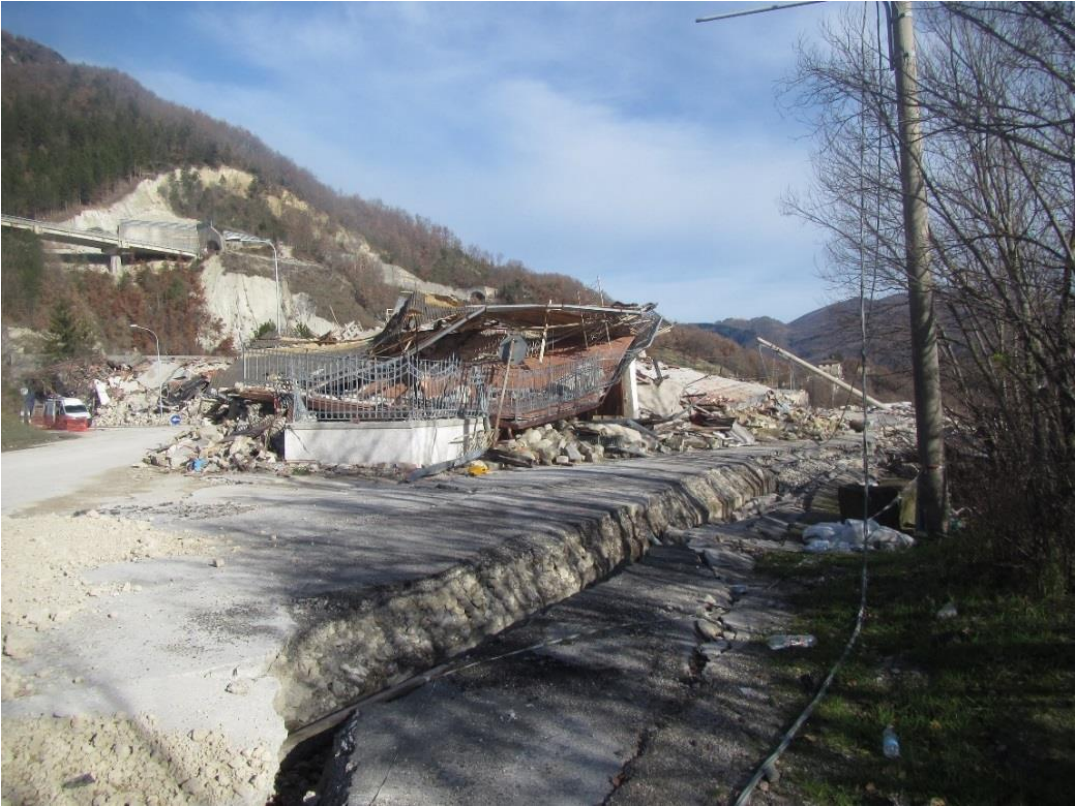
Figure 4.16. Pavement and road base damage induced by underlying stability failure of fill material (Location 3c).

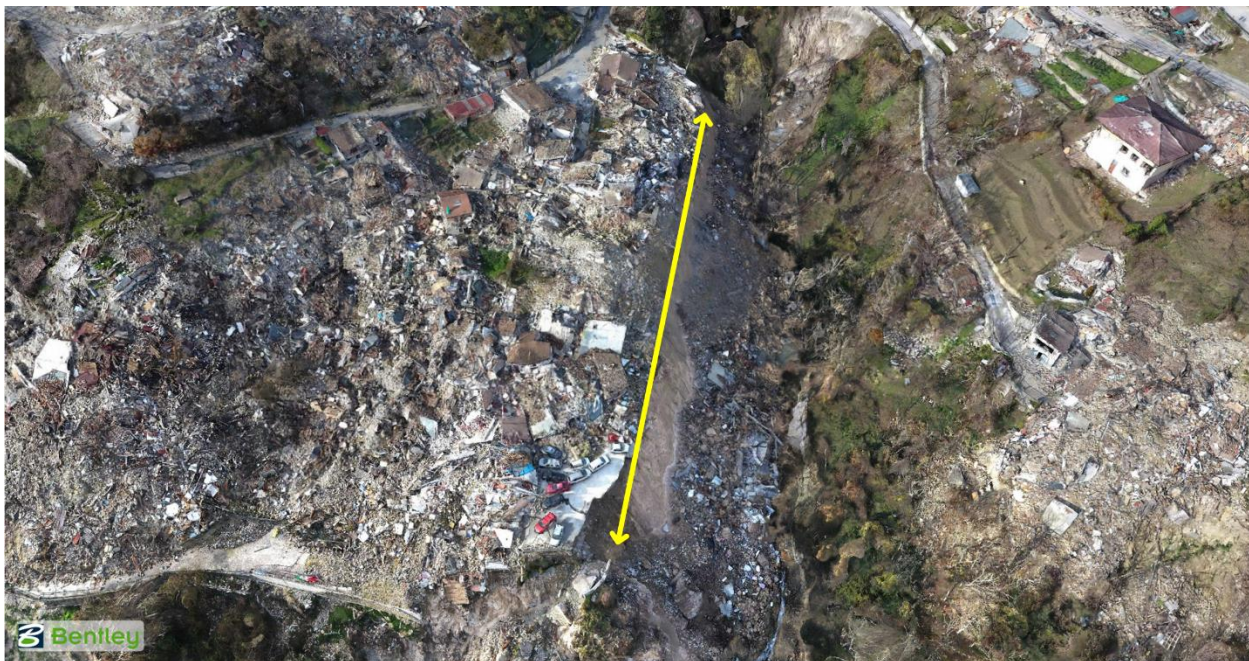
Figure 4.25. 3D SfM model view of scarp linearity behind failed lower retaining wall in Pescara del Tronto.

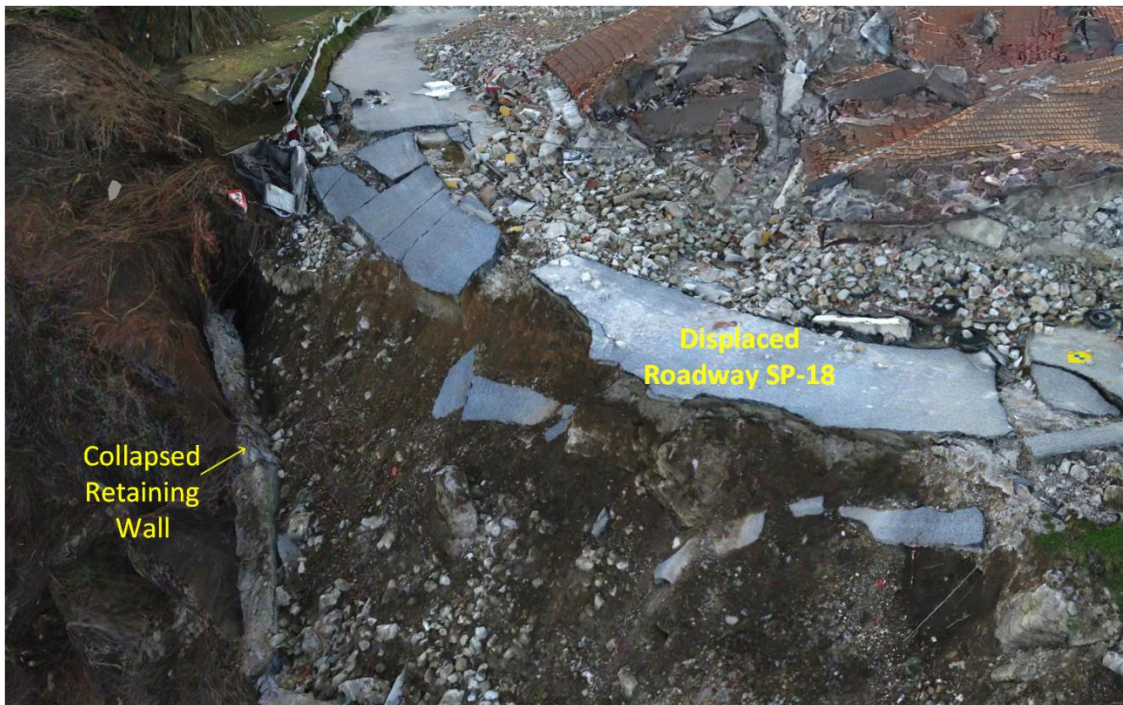
Figure 4.33. 3D model screenshot of the destroyed roadway Frazione Fonte del Campo (i.e., SP-18).

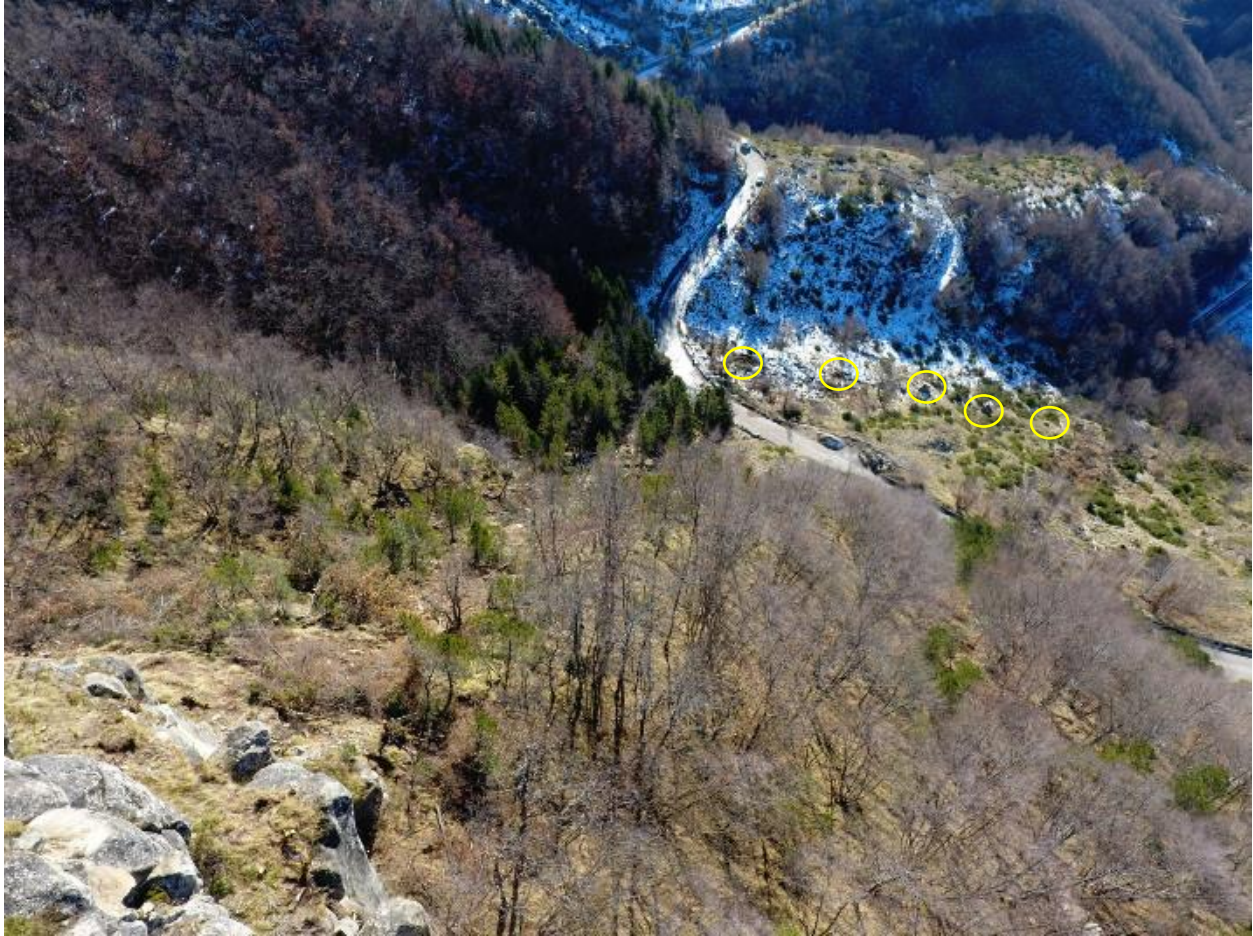
Figure 4.51. UAV image of rockfall site near Crognaleto village from the source area at the top of slope looking down to road along runout chute. Note several large 1 to 3 meter boulder fragments in the drainage below the road (yellow circles).

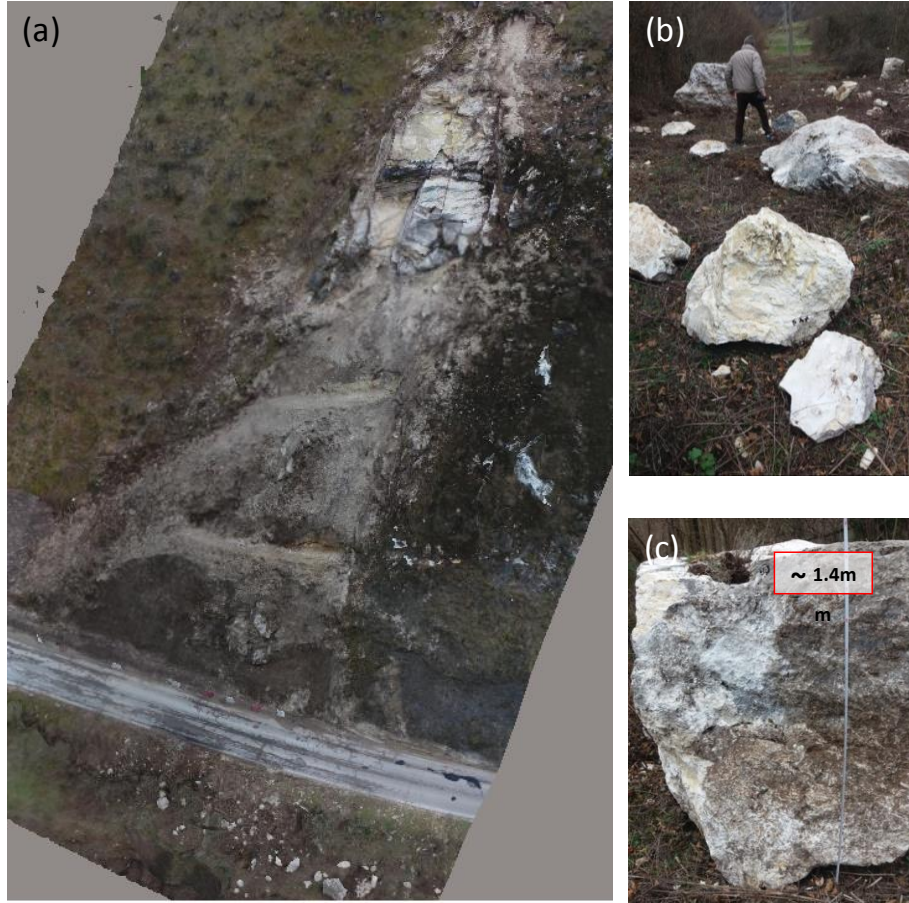
Figure 4.64. General oblique view from the drone of the rock slide on the right flank of the Nera valley (km 4 of SP134 motorway); the rock avalanche invaded the motorway and the valley bottom below for a stretch of about 70 m spreading large blocks (b-c).

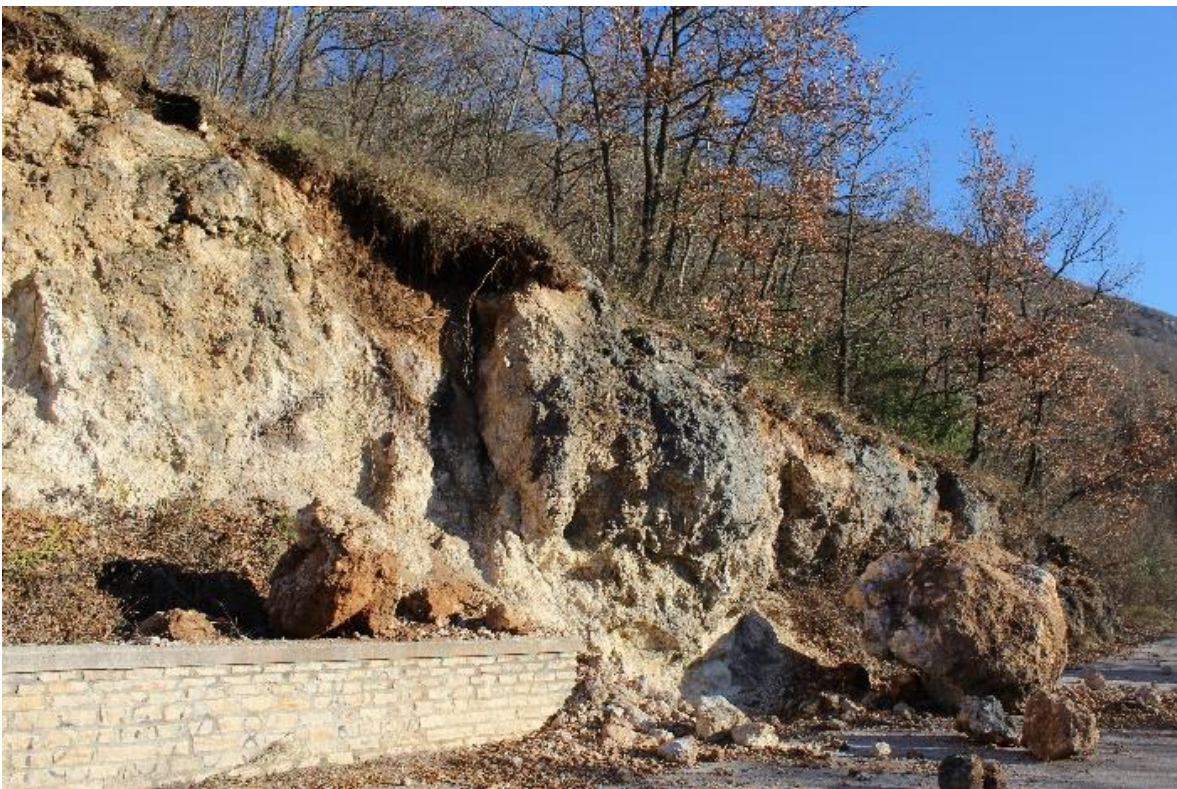
Figure 4.74. Rockfalls with boulders on the road.

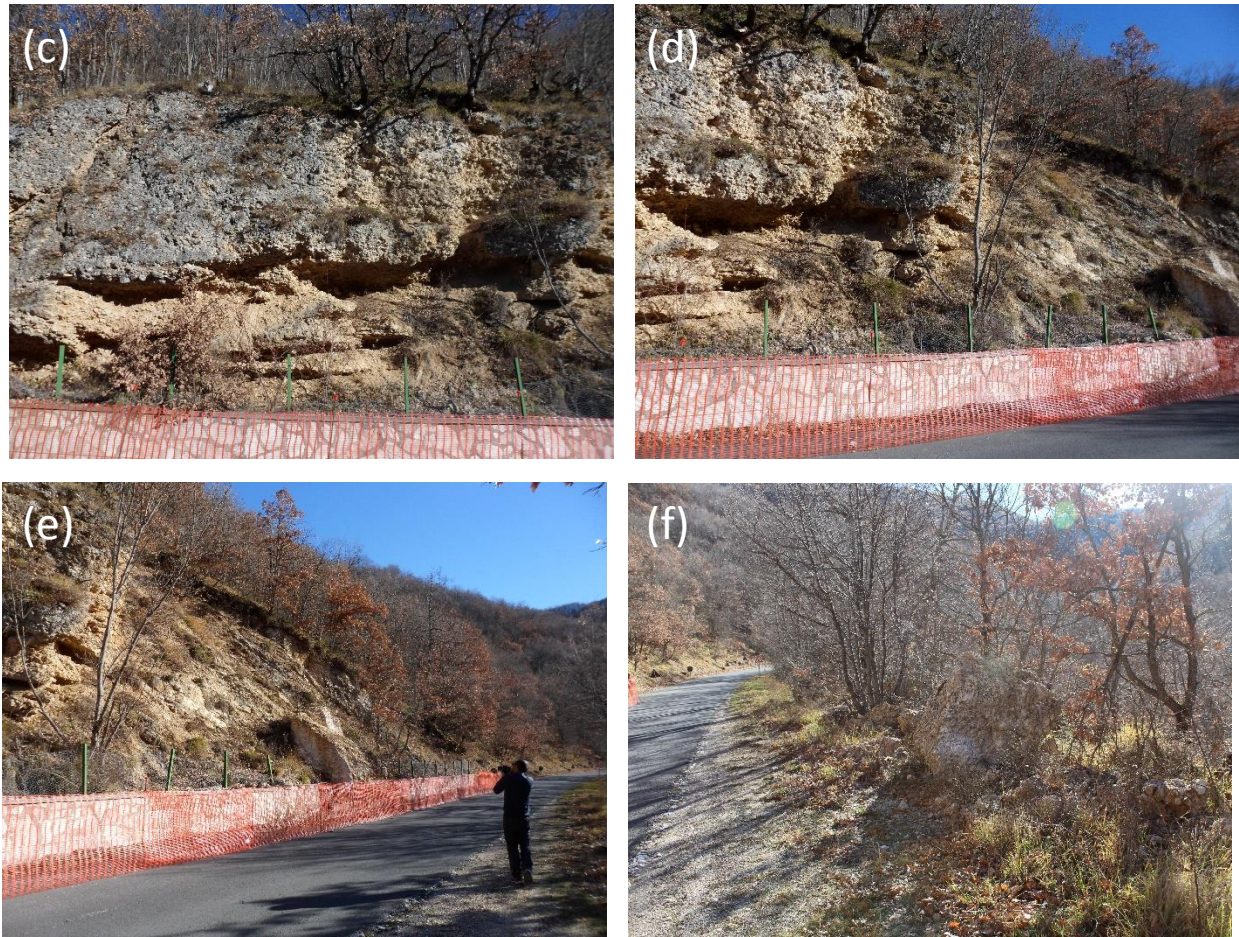
Figure 4.89. Failure in calcareous breccia between Cittareale and Norcia along the SP746: from (a) to (e) view of the all facade; (f) rockfall on the road.
