Engineering Reconnaissance Following the October 2016 Central Italy Earthquakes - Version 2

Engineering Reconnaissance Following the October 2016 Central Italy Earthquakes *Version 2*

Geotechnical Extreme Events Reconnaissance Association
Report No. GEER-050D
8 May 2017

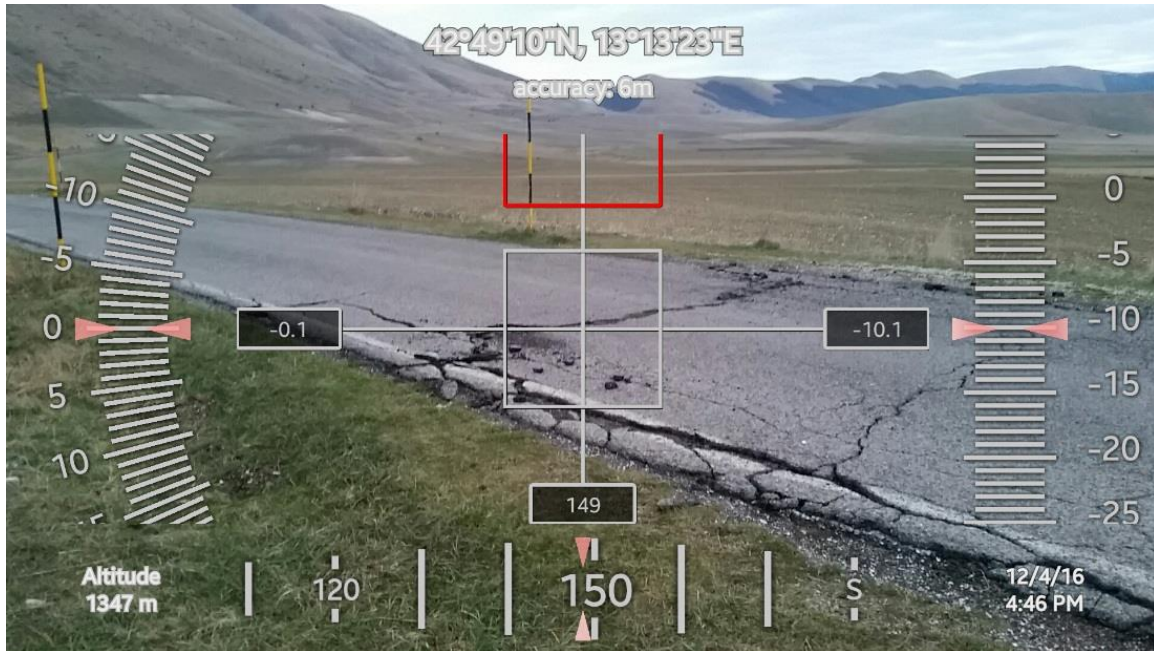
Figure 2.20. Secondary fault offset across a road on the Piano Grande at the base of the Mt. Vettore Massif. August 2016 event offset of 0cm. October 2016 event offset of 7 to 18 cm.

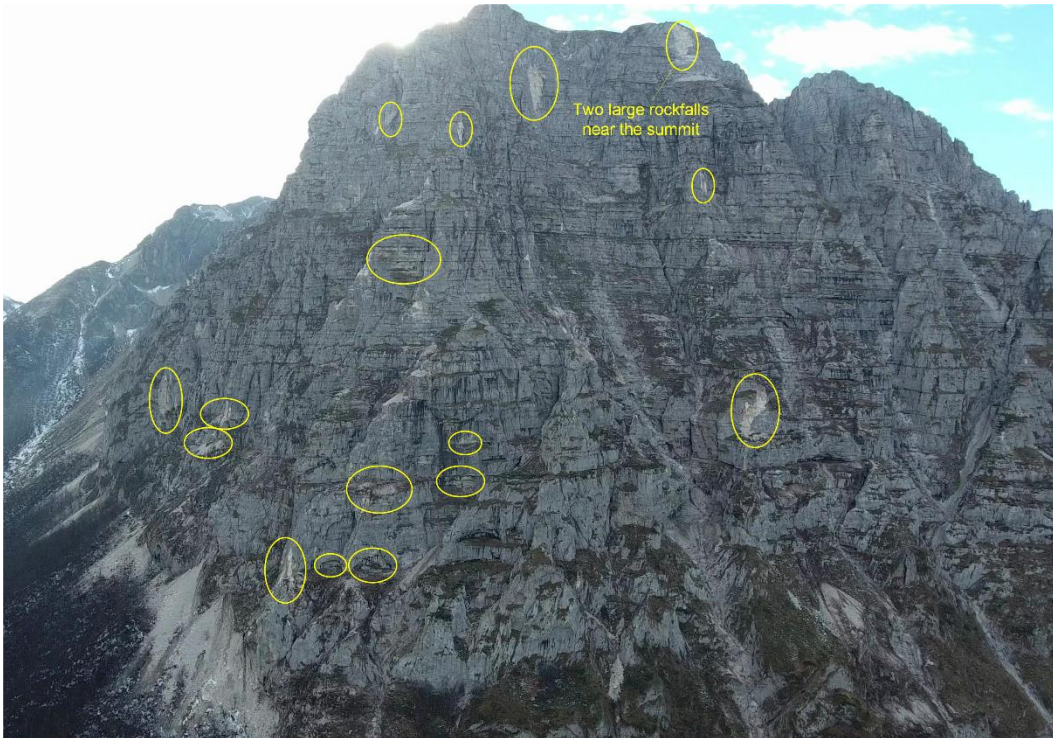
Figure 4.9. Phantom 4 UAV image of Monte Bove. Suspected rockfall sources are circled in yellow.

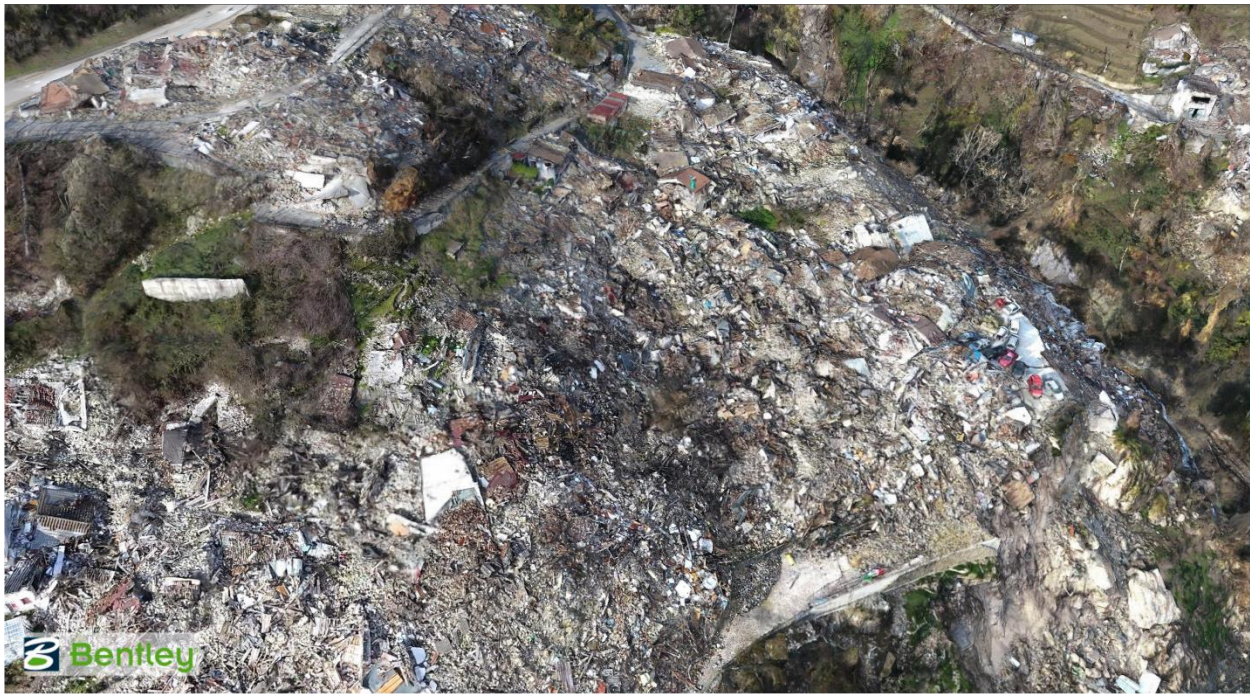
Figure 4.14. 3D SfM model of main damaged building area overlying talus deposits (Location 3a).

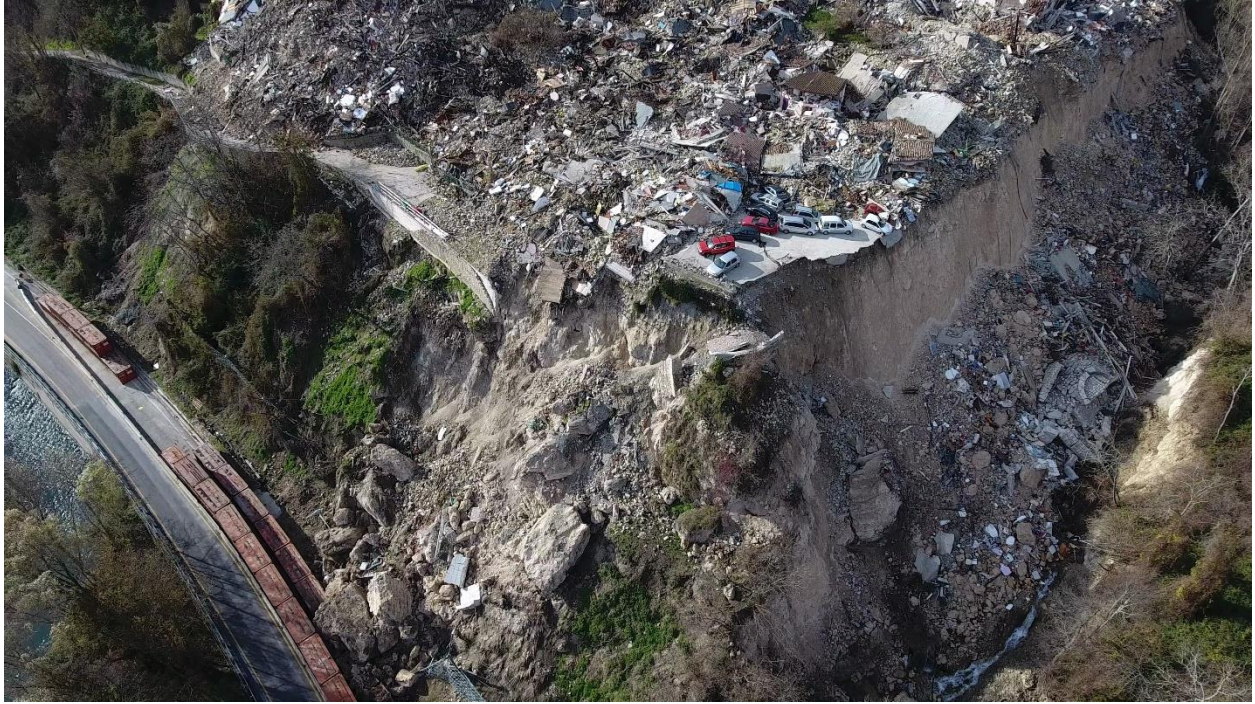
Figure 4.18. Aerial photograph of landslide impacting Strada Statale No. 4 below Pescara del Tronto (Location 3d).

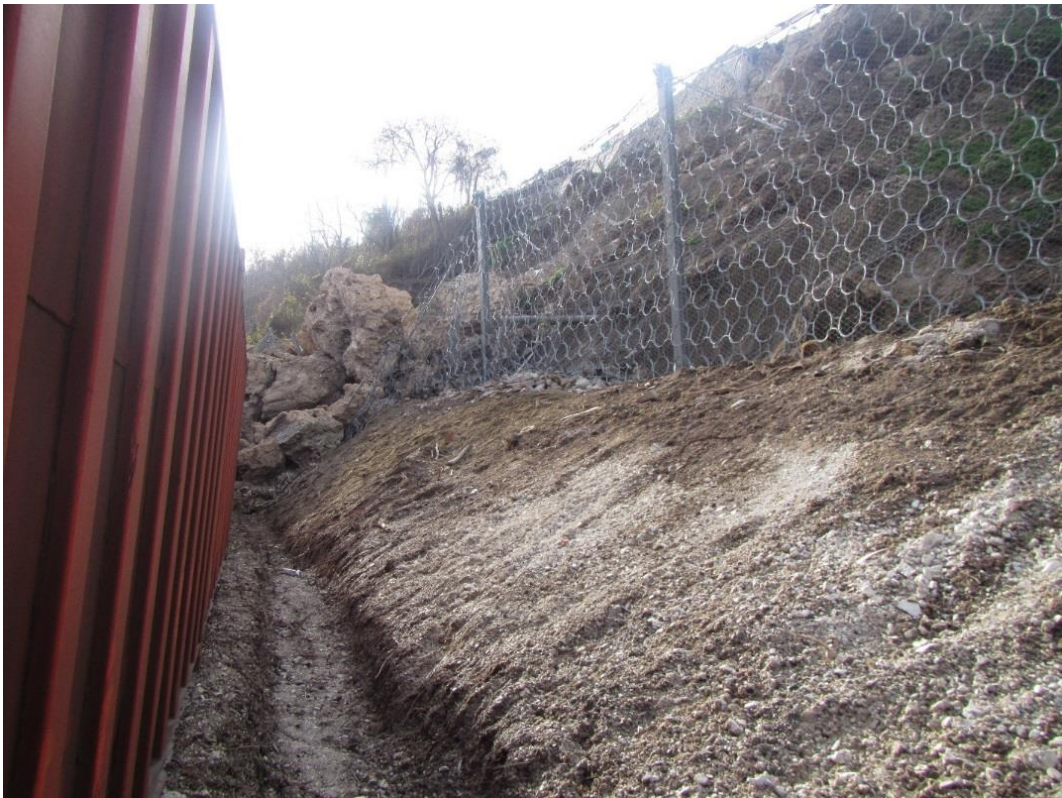
Figure 4.19. View of damaged rockfall netting caused by loose debris material from the landslide above Strada Statale No. 4 (Location 3d).

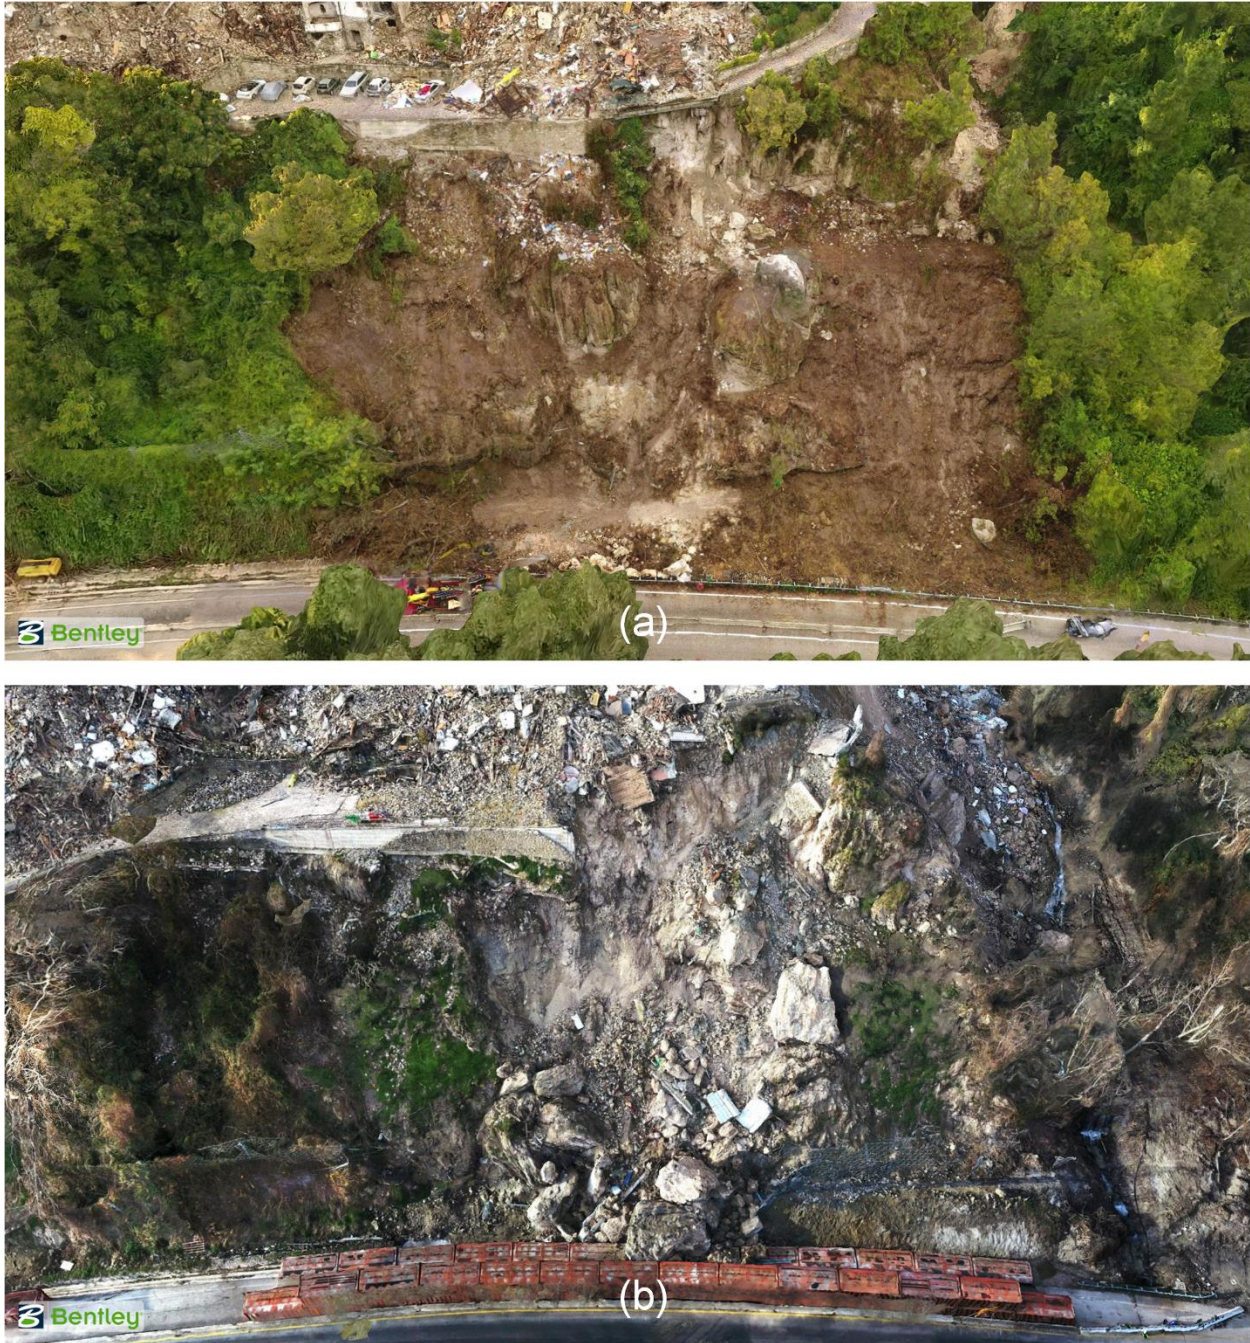
Figure 4.22. 3D model comparison of the landslide below Pescara del Tronto between September 2016 (a) and December 2016 (b).

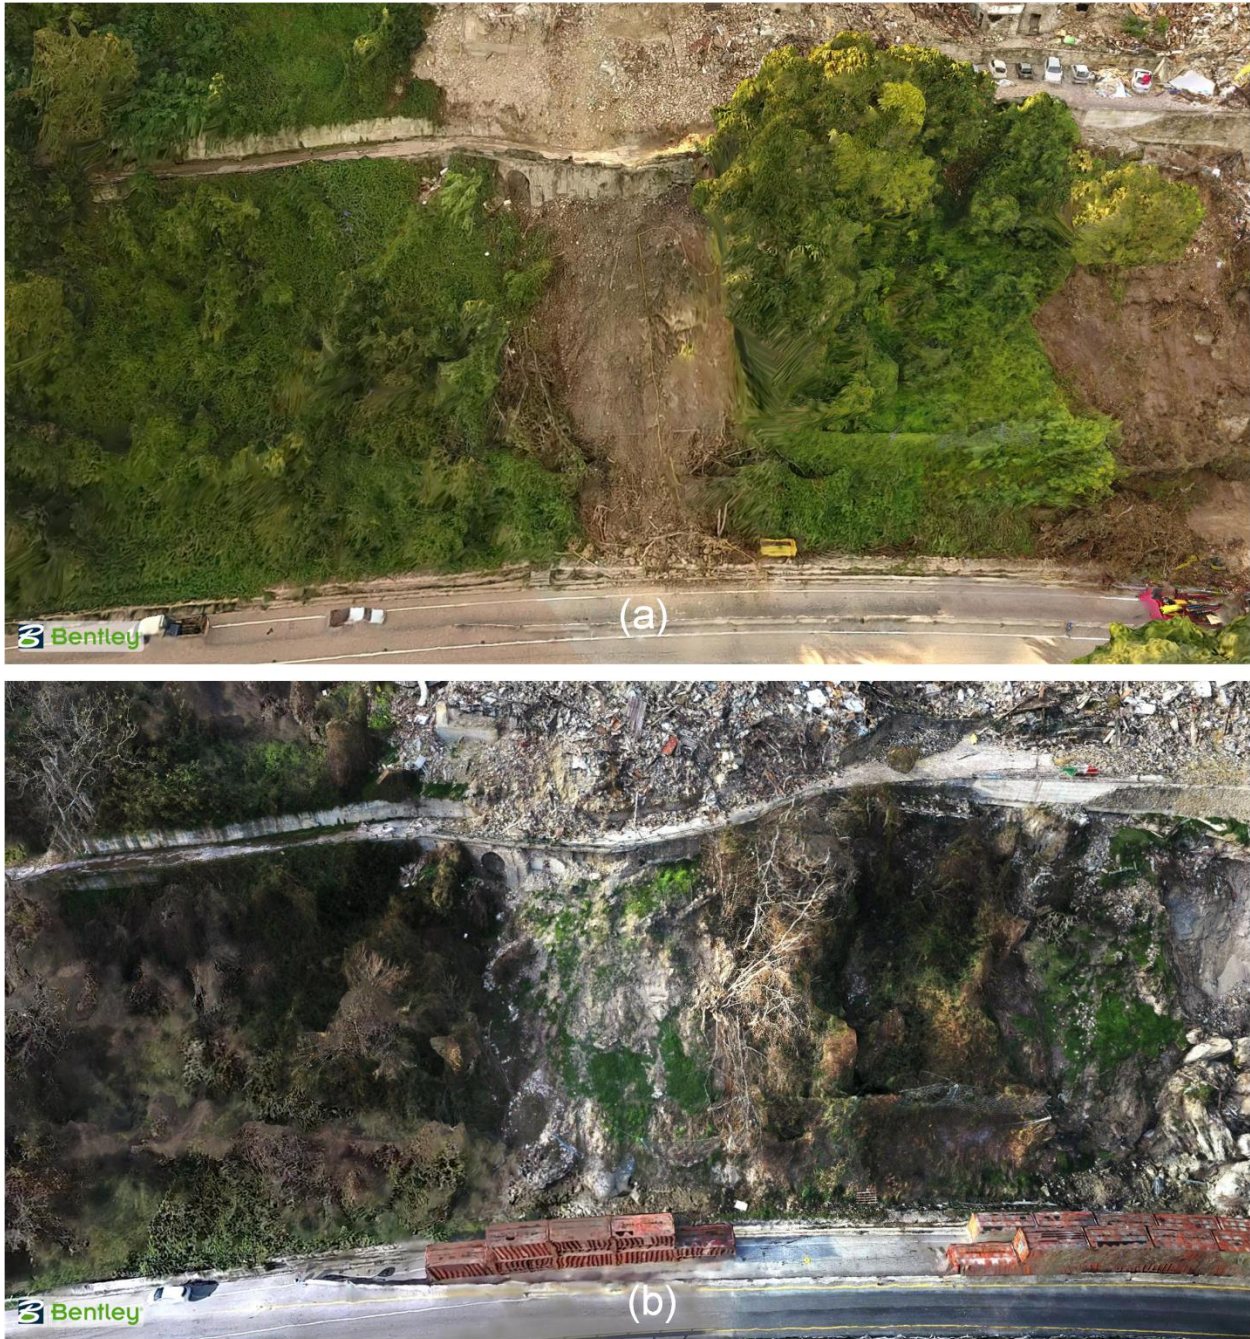
Figure 4.23. 3D model comparison of the smaller landslide below Pescara del Tronto between September 2016 (a) and December 2016 (b).

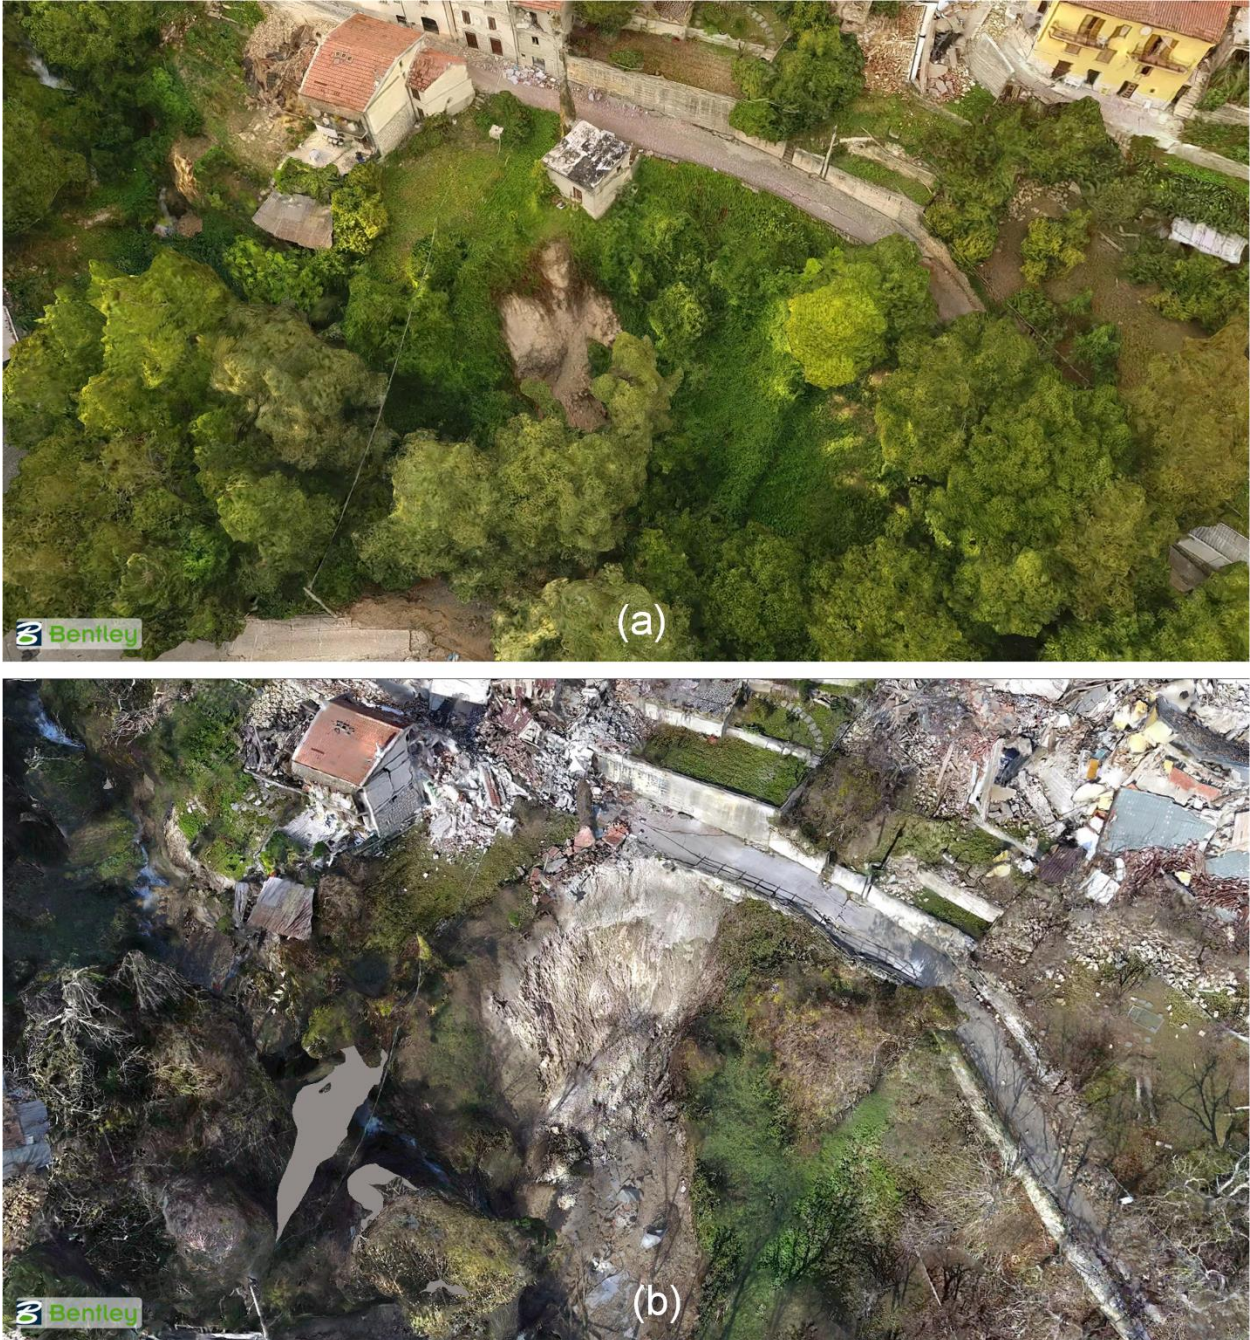
Figure 4.26. 3D model comparison of the landslide near the head of the gully in Pescara del Tronto between September 2016 (a) and December 2016 (b).

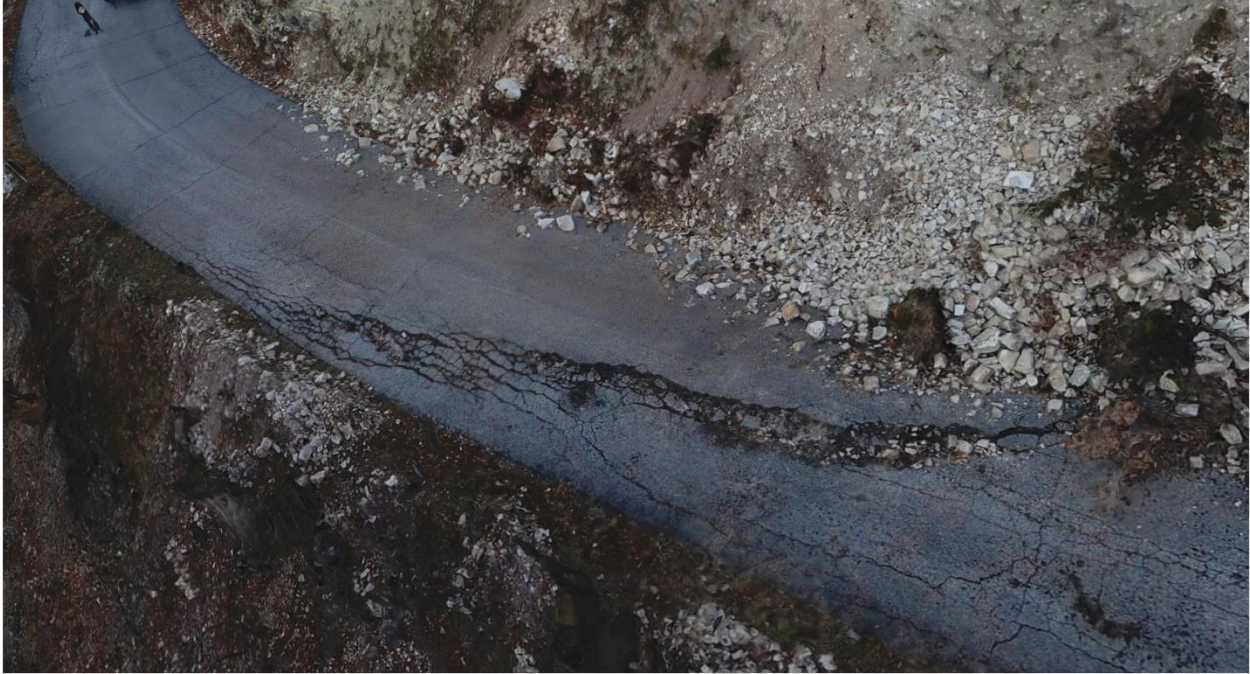
Figure 4.39. 3D model of the western half of the Valle di Panico landslide headscarp.

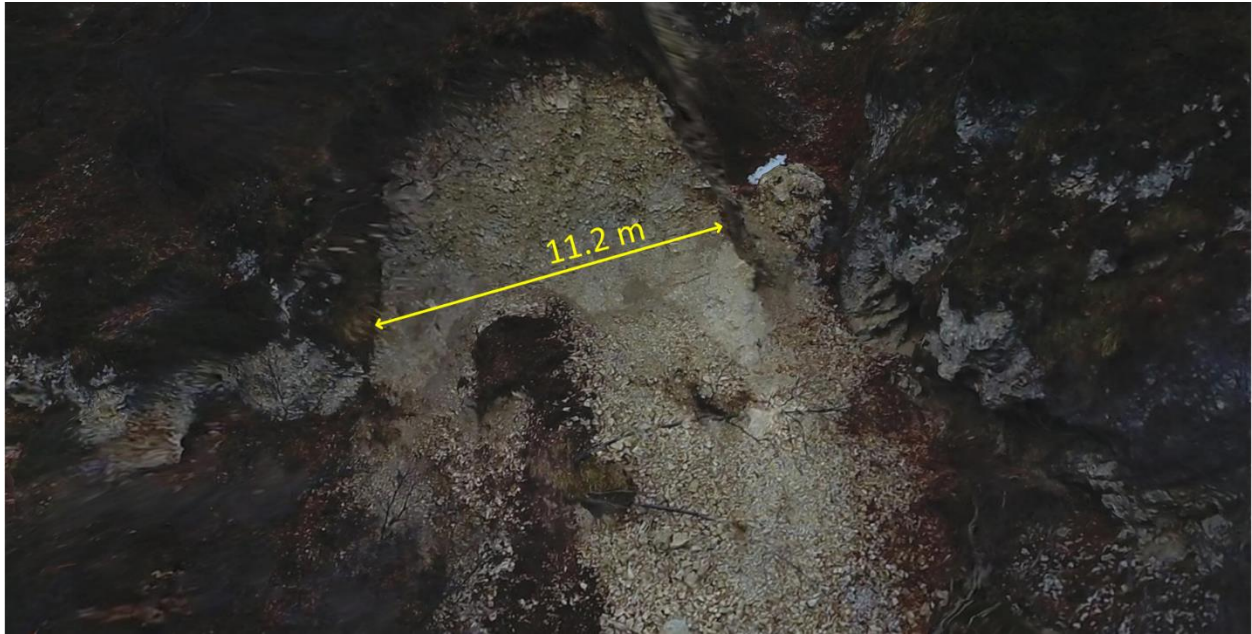
Figure 4.42. 3D model of the source of the Valle di Panico rockfall, located 90 meters above the mountain road.

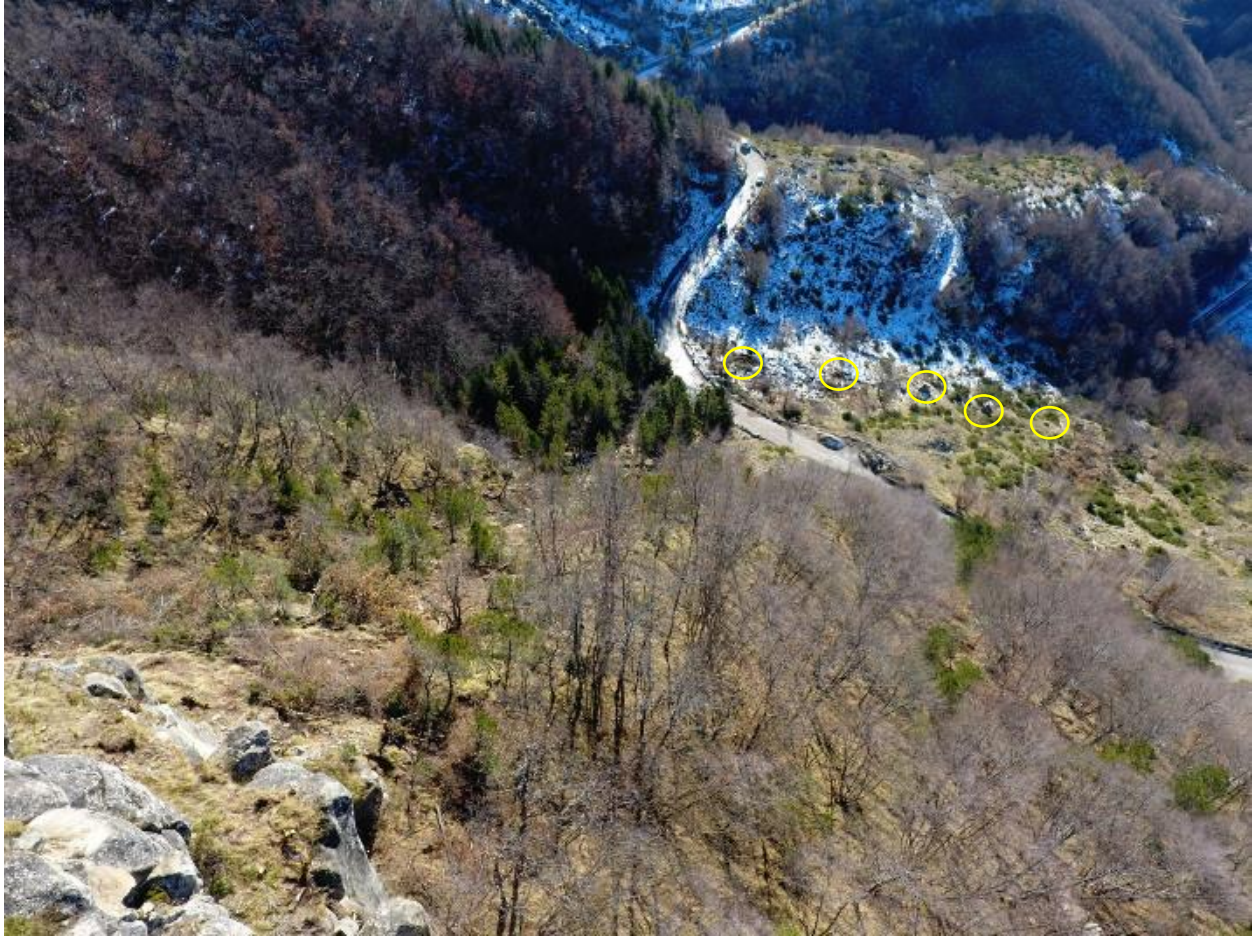
Figure 4.51. UAV image of rockfall site near Crognaleto village from the source area at the top of slope looking down to road along runout chute. Note several large 1 to 3 meter boulder fragments in the drainage below the road (yellow circles).

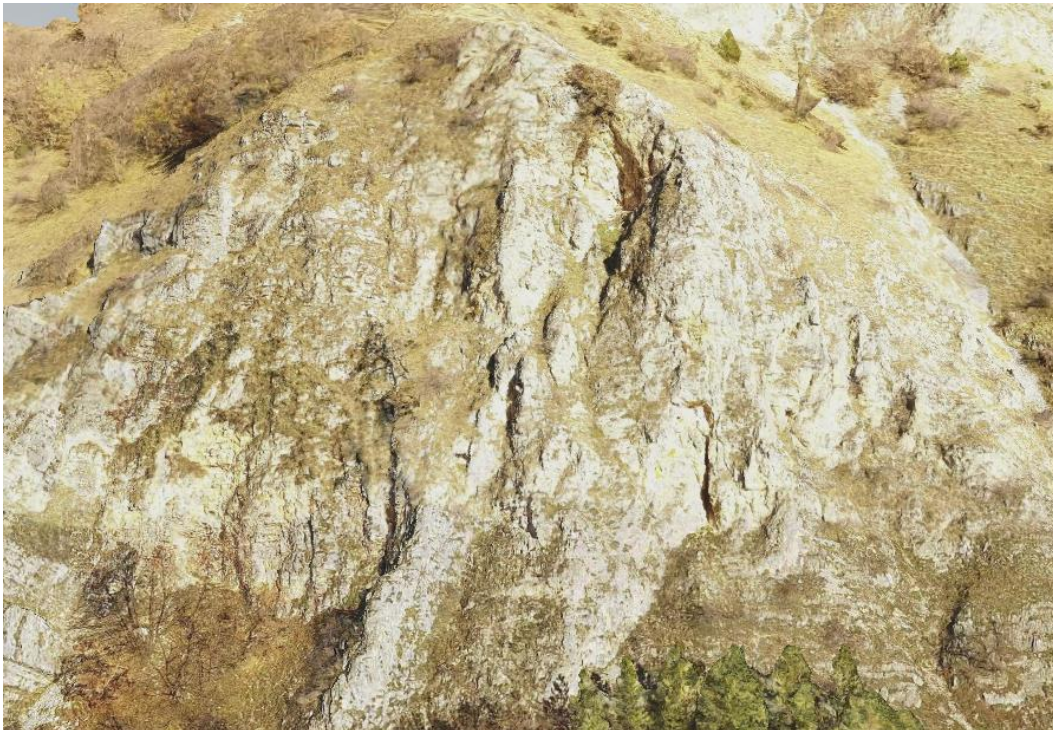
Figure 4.57. 3D SfM orthophoto of the rockfall source at site 9a.

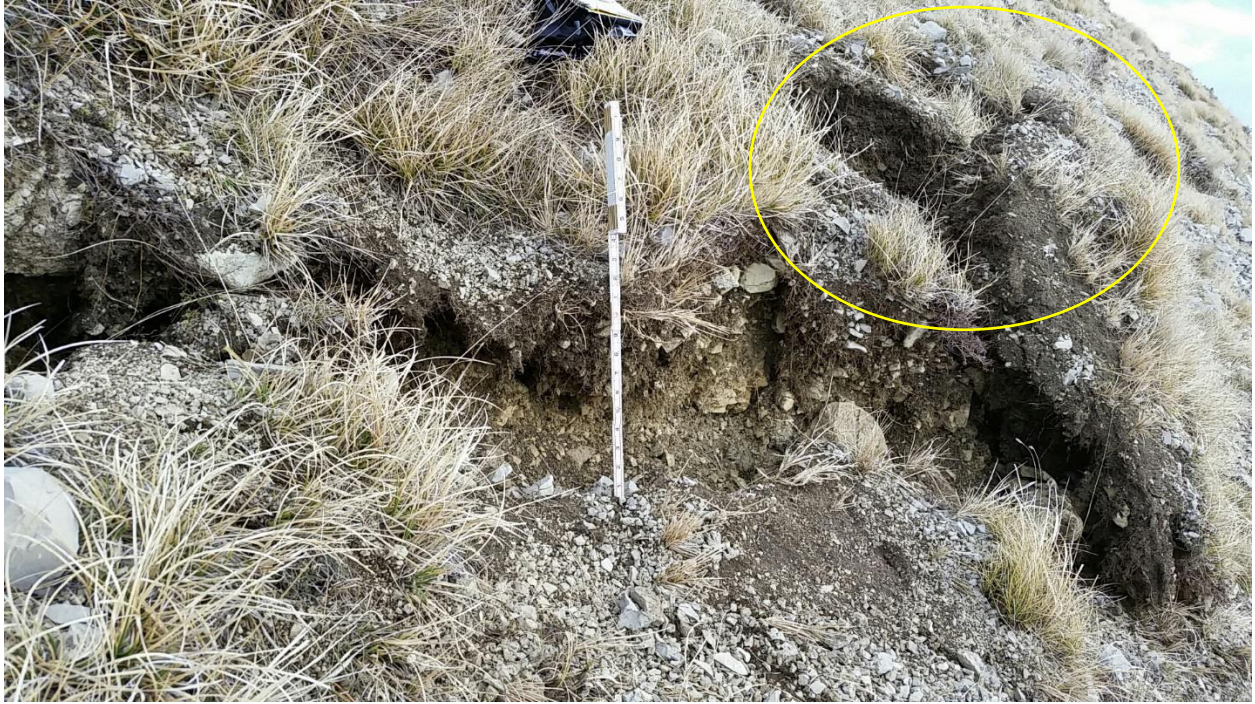
Figure 4.70. Image of fault scarp and associated nearby slope instabilities (yellow).

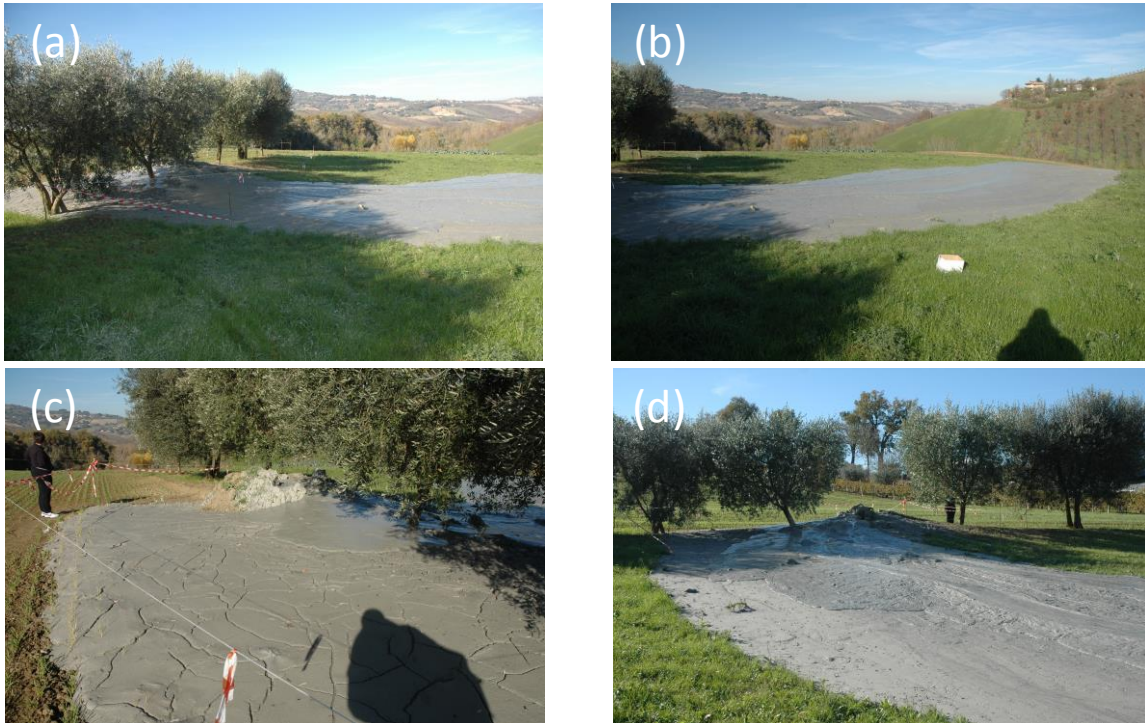
Figure 5.9. Overview of the mud new volcano in Santa Vittoria in Matenano.

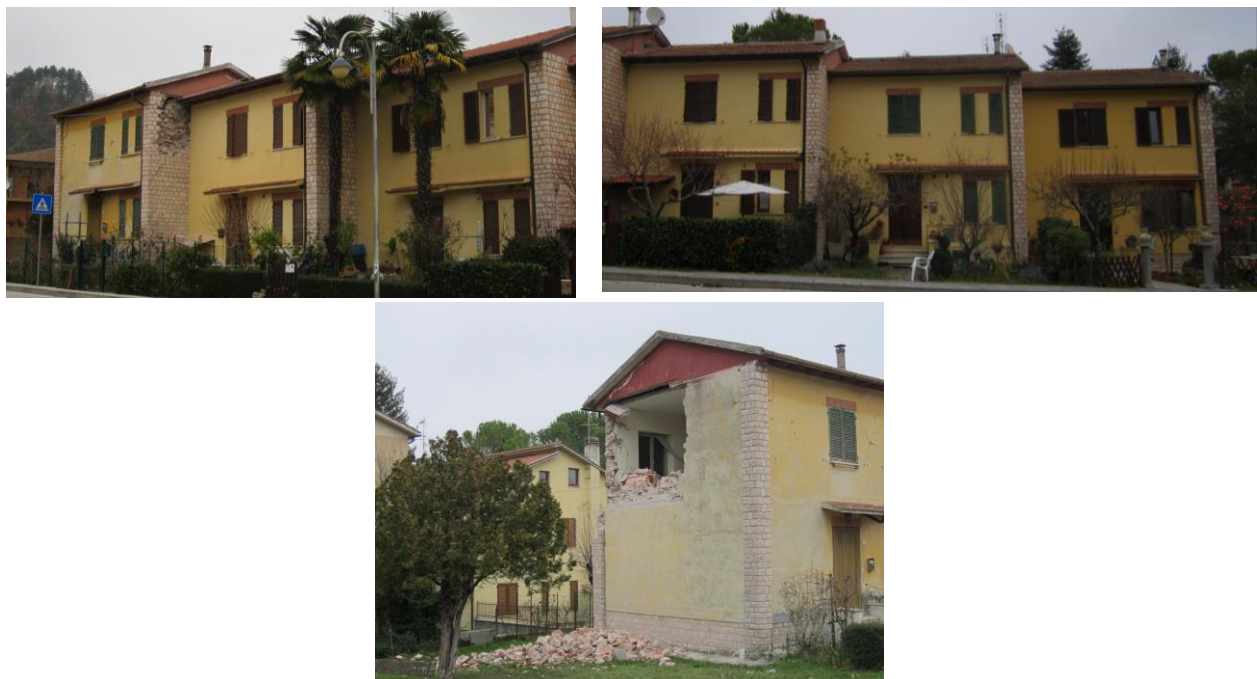
Figure 6.91. Representative pictures taken in Pieve Torina.
