Engineering Reconnaissance Following the October 2016 Central Italy Earthquakes - Version 2

GEER Team Leaders: Jonathan P. Stewart and Giuseppe Lanzo

Geotechnical Extreme Events Reconnaissance Association
Report No. GEER-050D
8 May 2017

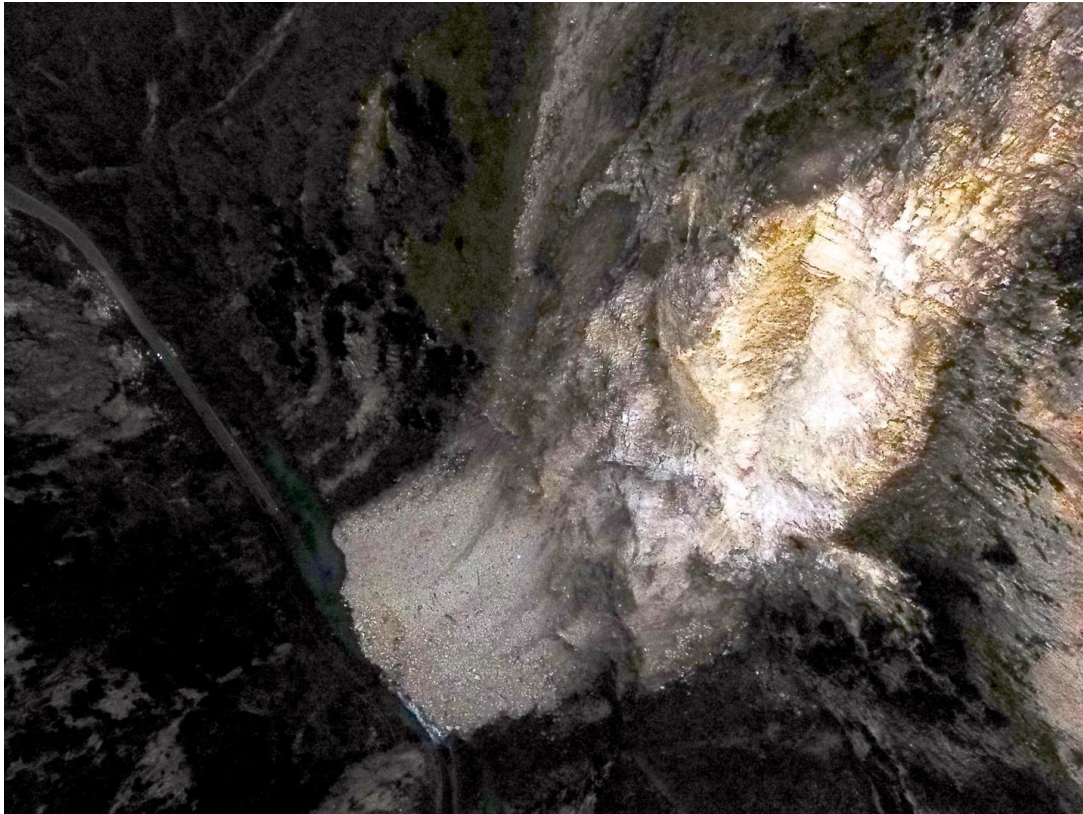
This large rock fall damaged national road SS-209 and formed a small landslide lake as shown in Figure 4.5. The rockfall severed road transportation between Visso and the Spoleto Valley. Access to Visso, the Nera river valley and the landslide was from the eastern Adriatic coast.

Figure 4.5. Nera rock avalanche photographed from the UCLA DJI Phantom 4 drone at an elevation of 400 meters above Route SS209. The primary rock-fall was a wedge that detached on the right side of the image and disintegrated into talus debris as it fell 330 meters to the river valley floor. The limestone bedding is visible in the scar of the wedge detachment
