Considerations over the Italian road bridge infrastructure safety after the Polcevera viaduct collapse:
past errors and future perspectives

Fabio Bazzucchi, Luciana Restuccia, Giuseppe Andrea Ferro

Politecnico di Torino, Turin, Italy

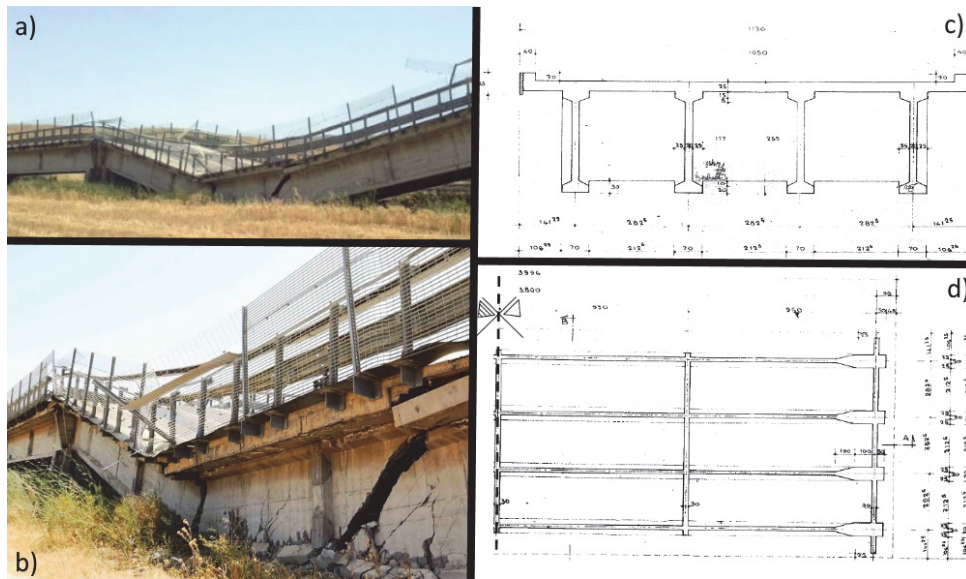
The Petrulla viaduct is situated along the S.S. 626 "Valle del Salso", at km 4+500, in Sicily. The viaduct consists in a series of 12 simply supported beams, each of them with a 40 m span (Fig. 1(a)). On July 7, 2014, one span collapsed, injuring 4 persons. The breakage occurred in mid-span circa, and then, shear failure occurred where the deck impacted ground (Fig. 1(b)). The deck, 11.30 m wide, was made of 4 precast and prestressed concrete I-beams equally spaced by 2.850 m. Five transverse beams realized the girder that supported the pavement slab (Fig. 1(c)). The investigation, conducted after the collapse, evidenced an exceeding state of material decay for the steel components: diffused oxidation in the prestressing cables, severe corrosions of the metallic sheathing and large absence of the protective grout inside the cables (Fig. 2(a), Fig. 2(b)). Since the bridge was built in the mid-80s, this degradation pattern was not compatible with 30 years of service life, especially because the concrete exhibited good signs preservation (Fig. 2(c)). The investigations have evidenced several construction flaws, in particular related to finishing operations of the prestressing. The grout injection was superficially carried out and the vent pipes were not accurately sealed (Fig. 2(d)). Under these circumstances, humidity found a preferential way into the cables, and its continuous content variation generated an aggressive environment for steel oxidation. Other additional deficiencies for this particular degradation scenario were addressed to:

- not sufficient cover due to malposition of the prestressing cables;
- not adequate workability and fluidity of the concrete;

- inadequate waterproofing covering of the joints.

Figure 1: Overview of the Petrulla viaduct (a); collapsed structure (b); original design of the deck (c,d).

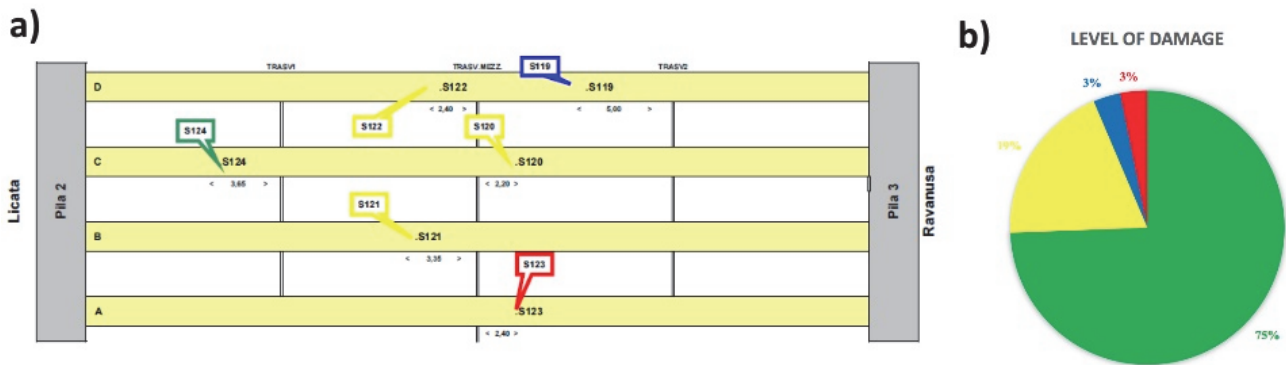
A visual inspection campaign was carried out for all the others remaining beams that constituted the Petrulla viaduct. Four level of damage degree were defined, from no noticeable damage (green) to exposed prestressing cables with visible signs of oxidation (red). In Fig. 3(a), the visual inspection location with its relative degree of damage for the bridge n. 2 has been reported. In Fig. 3(b), results for the entire viaduct have been summarized. It is worth to note that, even if less than 7% of the cases had a high degree of damage (blue and red), they represented 8 different visual inspections, which meant 8 possible beams with no active prestressing forces. This viaduct has been object of reparation and after four years has become operative again. It is reasonable to say that the investigation, repair, and public costs due to the inoperable structure are significantly higher than the ones associated with careful construction procedures. The adopted safety solutions are discussed in the next section (par 6).

Figure 3: Example of the deck visual inspections (a); damage degree results survey (b).

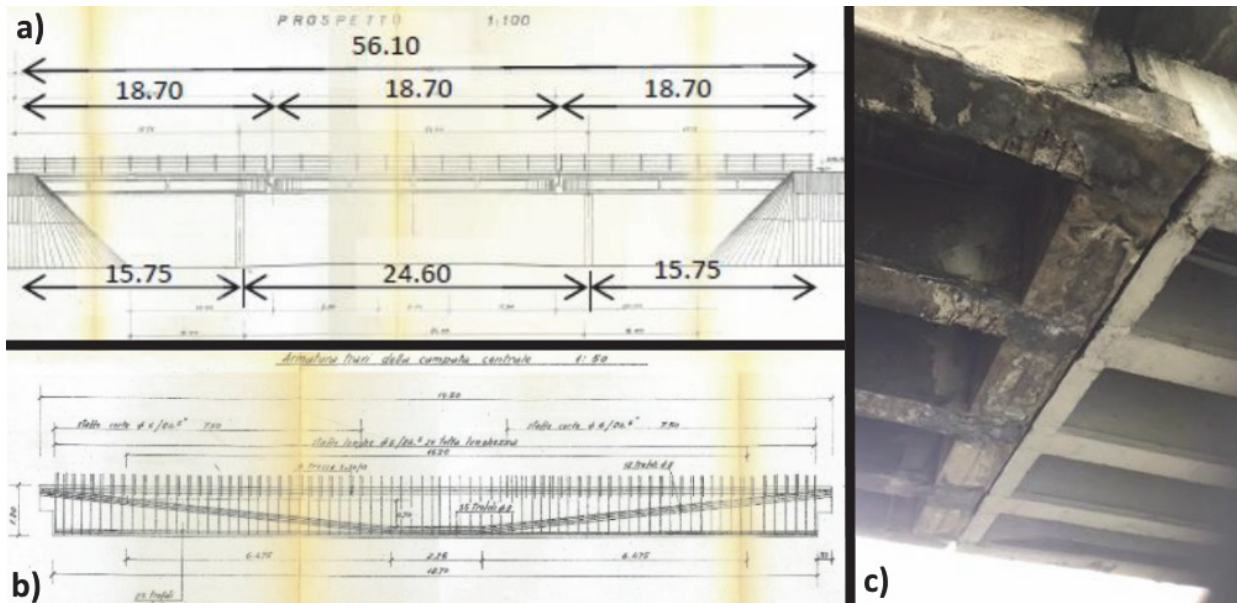
The collapse of the Annone overpass, Lecco, at km 42.000 along the S.S. 36 “del Lago di Como e dello Spluga”, occurred on October 18, 2016. The failure had a high impact on the Italian society since it caused the death of a car driver and several wounded. The bridge was built between the 1960 and 1962, with a Gerber scheme deployed over 4 supports (Fig. 4(a)). The central deck, 24.60 m long and 4.40 m wide, was constituted by 5 precast and prestressed I-beams. Gerber supports were 0.575 m high, with an ordinary reinforcement as shown in Fig. 4(b) and Fig. 4(c). Before the collapse, the bridge was subjected to several impacts by underlying moving vehicles [1]. This was due to a non-adequate free height of the overpass (< 5 m). After these events, the saddle was repaired with rebars and CFRP installments (Fig. 5(a)). However, those interventions could not renovate the shear fracture propagated over the saddle and significant presence of humidity was often detected when inspected (Fig. 5(b)). This was mainly due to the produced misalignment in the dapped-end (2.5 cm) due to the repairs, which constituted a stagnation point for running water [2].

Figure 4: Overview of the Annone overpass [1] (a); Gerber support reinforcement, design (b) and investigation (c).

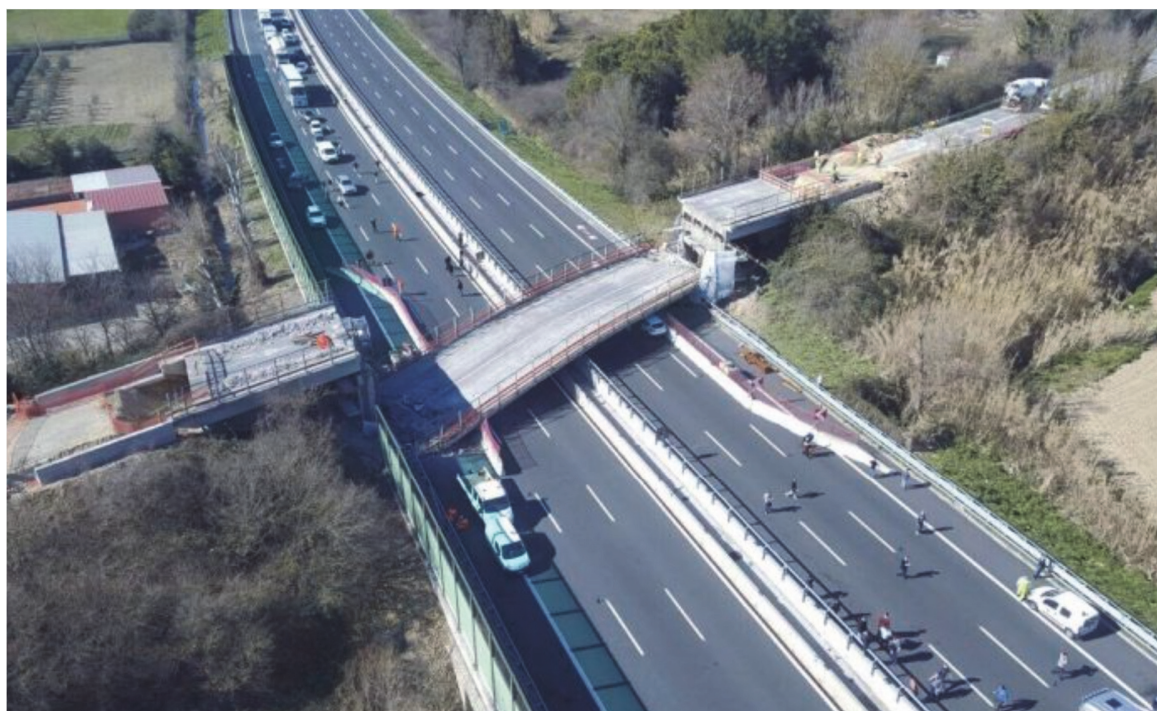
Figure 6: Ancona overpass after the collapse (from web site www.cronacheancona.it).

This collapse occurred on 9 March 2017, near Ancona, along the A14 Italian Highway. The bridge (167 at km 235+800) was constituted by a steel-concrete composite deck 16.5 m wide and 36 m long with a simply supported beam scheme (Fig. 6). When collapsed, the deck was uplifted for maintenance operation and it was supported by a temporary structure. The deck fell on the underlying highway, causing the death of 2 people that were transiting underneath.

The case of the collapse of the overpass on the A14 motorway near Ancona is quite different from the others and was caused only by a resounding error during the execution phase. The works involved the adjustment of the altimetric height of the overpasses, consisting of raising the decks, creating an extension of the support structures and the re-profiling of the associated ramps. The lifting took place through the use of hydraulic jacks with few centimeters steps, after positioning of steel plates for distribution. The appointed subcontractor to perform this specific process decided to replace the supporting steel plates with similar plates in neoprene, much lighter to move. Numerical analyses conducted during investigations by prof. Tarantino highlighted how a difference between the temporary supports of a few millimeters generates horizontal forces not compatible with the shear deformability of the numerous neoprene plates stacked on top of each other. This generated an unexpected bridge horizontal displacement and the collapse occurred. Further details are under investigation.

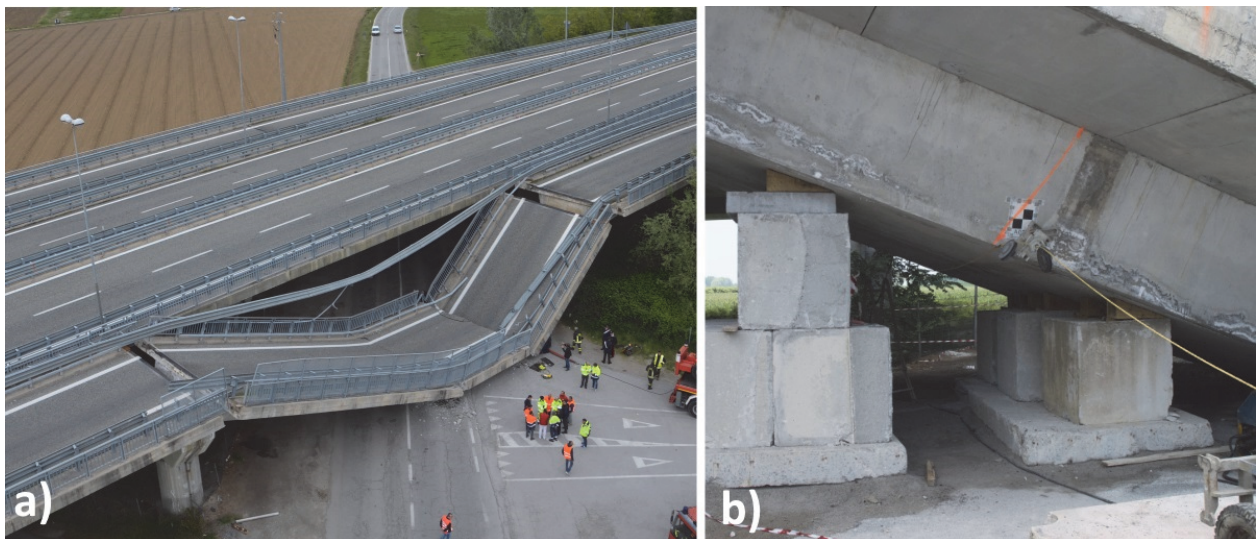
Figure 7: Overview of the collapsed Fossano bridge (a) and structural scheme (b).

The collapsed overpass is one of the 108 that constitutes the Fossano (Cuneo) bypass road. This road has several viaducts, and the one involved in the failure is one of the ramps of La Reale Viaduct, where it crosses the S.P. 165. The collapse occurred on April 18, 2017, and luckily (2.45 p.m.) no vehicles were going across or underneath the structure. The sudden collapse took place without out-of-plane displacements (Fig. 7(a)). A modest slip ahead in one of the bearings has been identified in the collapsed configuration. The structure was a simply supported beam, 30.80 m long and 8.90 m wide, constituted by a multiple-box post-tensioned beam and by an in-situ casted slab. The section was realized by connecting two concrete precast U-elements by a shear-key casted in situ. In the longitudinal direction, the bridge was built in 3 segment, the central one 11.50 m long and the lateral ones 9.35 m long. The connection between the segments was realized by an in-situ casted concrete joint 0.5 m wide (Fig. 7(b)). Post-tensioning system constituted in 8 parabolic cables, each of them made by 19 0.8" strands. Total weight of the structure was about 400 t. The collapsed structure evidenced an intact joint and a collapsed one, together with an evident shear failure where the bridge impacted the ground. For this event, several information can not be given at the moment due to secrecy related to the running investigations. Visual inspections consented to affirm that the collapse mechanism was triggered by a shear failure in one of the joint due to the absence of the equilibrating action of the prestressing (Fig. 8). This means that in some part between the support and the intact joint, the cables were damaged. Visual inspections immediately also demonstrated that the cables did not have sufficient grout protection in the collapsed joint area (Fig. 9(a)). The damage was not compatible with a 20 years old

Considering now the case of La Reale Viaduct (Fig. 7(a)). Durability problems are overcome by the peculiar shape of the deck and its modular assemblage. To avoid a fragile collapse, the structure must improve its robustness. Since the analyses of the safety of the infrastructure are still under exploitation, different levels of intervention are suggested towards the observed damage pattern. For the spans that will evidence lack of cable protective grout, epoxy injection would be necessary to stop the advancement of corrosion. This operation could result particularly difficult to do because of the inaccessible boxed section. A frequent problem in bridge concrete walls is concrete spalling and exposure of reinforcement. This situation is particularly dangerous when the exposed reinforcement realizes the primary load carrying system, i.e. dapped-end corbels (Fig. 5(a), Fig. 5(b)). Under these circumstances, health of the steel is essential to exclude a sudden collapse due to shear failures. Considering the numbers of the existing artifacts, sometimes just blocking the advance of corrosion represents a good strategy to keep reasonable safety factors while retrofitting is pending. This strategy can be implemented by the use of sacrificial anodes (galvanic protection) directly connected to exposed reinforcements (Fig. 16) [24]. These anodes, usually realized in zinc-based compounds, guarantee local protection to the

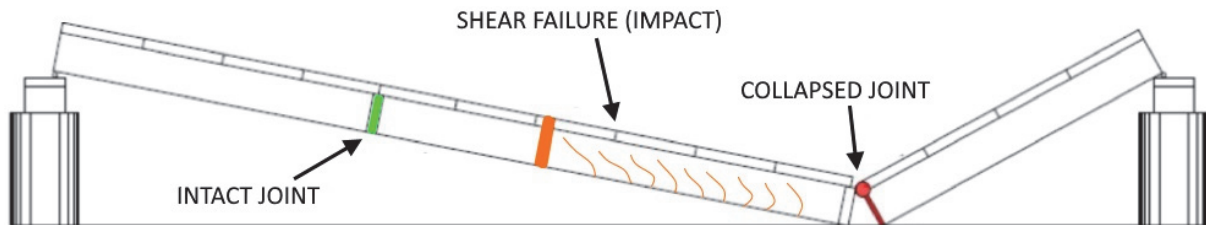
- absence of ductility and structural robustness, there is no redundancy in the prestressing device;
- inadequate grout injection inside the cables, which led the water to a preferential way inside the sheathing;
- total non-accessibility for structural inspections.

Figure 8: Collapse mechanism.

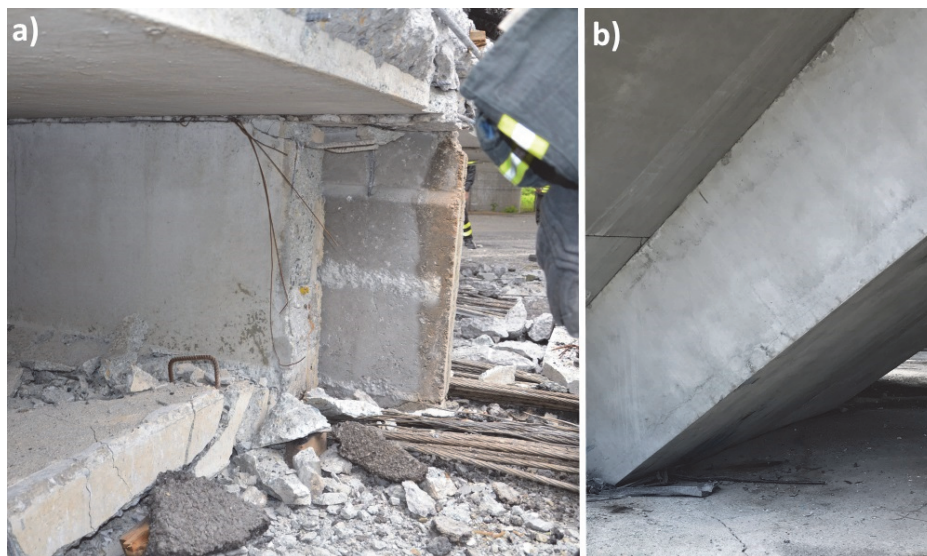
concrete structure damage scenario, and moreover, the overall external condition appeared healthy (Fig. 9(b)). This unusual structural failure, and the fear of a systematic bias, has been followed by detailed analyses and the structure has been dissected in order to establish the causes. To date, the vulnerabilities of this structure can be summarized as follows:

Figure 9: Prestressing cables in the collapsed joint area (a); external concrete conditions (b).

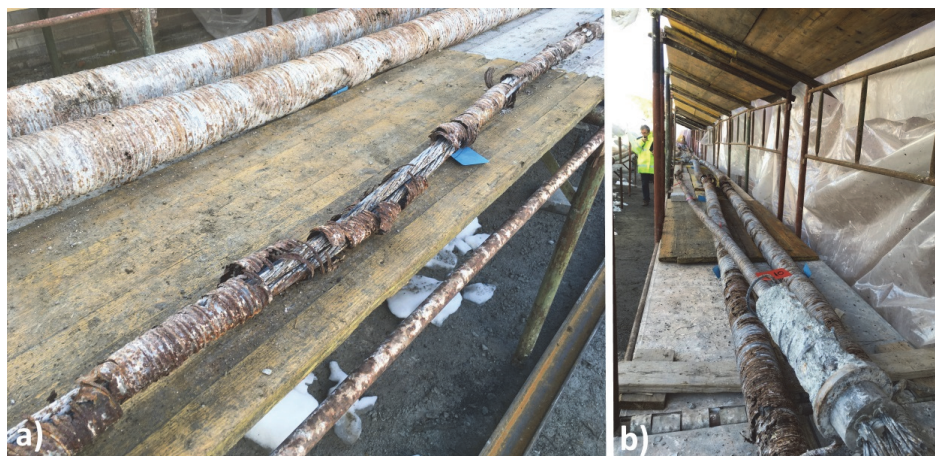
Figure 10: prestressing cables, extracted and analyzed. It is possible to note the direct correlation between grout content and oxidation rate of both sheathing and strands.

The number of the analyses that have been carried on investigating this collapse was enormous: simulated rain tests to locate the water gateways, chemical tests for the crystallized residuals and molds, and each segment was carefully demolished and each cable was extracted and inspected (Fig. 10). A complete autopsy was conducted on the bridge. When the investigations will be finished, the civil engineers will learn a lot from the final reports of the investigation committees.

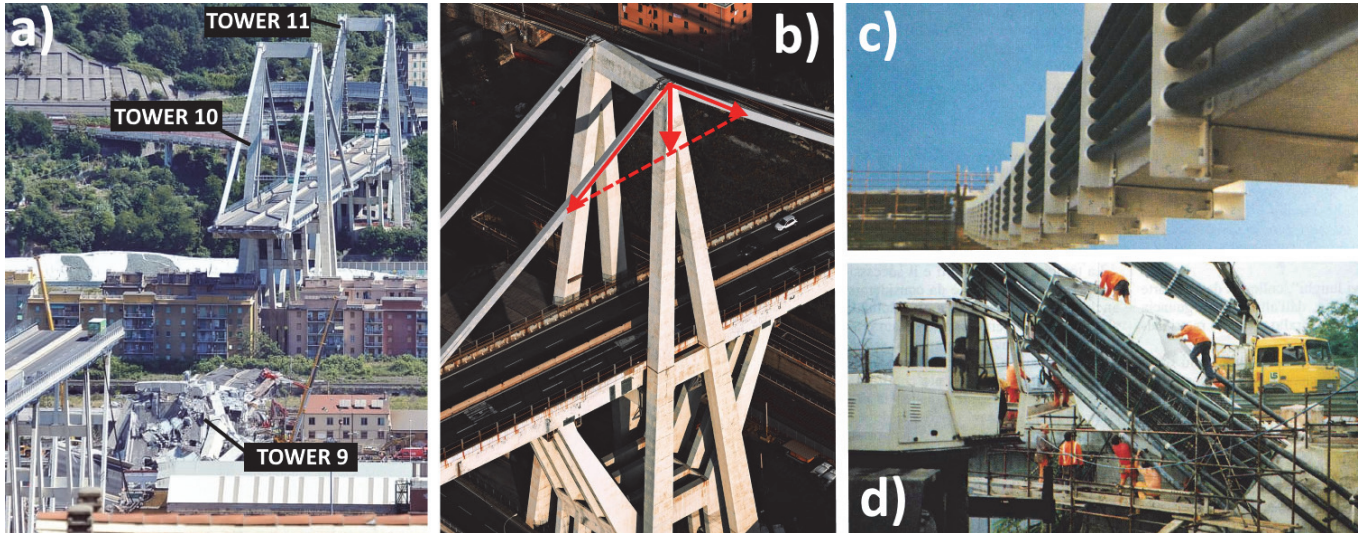
Figure 11: overview of the Polcevera bridge collapse (a); structural scheme of the tower (b); stay cables replacement intervention (1993) (c,d) [4].

On August 14, 2018, the Tower 9 of the Polcevera bridge, abruptly collapsed on the underlying industrial hub, Polcevera river and rail track of the city of Genoa (Fig. 11(a)). This collapse represents a categorical failure for the Italian Structural Engineering community. Whatever the causes of the collapses would be addressed to, object of the undergoing investigations, it is evident how there have been errors in the check procedure. Starting from the design (1960), the structural system (“*cavalletto*” [4]) that realized the tower relied on the balanced compressive force along the lateral columns (Fig. 11(b)) coming from the stays. The assembled framed tower, plus a four-point supported deck, exhibits a complete absence of robustness and structural redundancy, which means that in case of failure of one of the components, there was no control in preventing a catastrophic collapse [5]. Many colleagues affirmed and condemned the designer for the collapse. As written in the introduction, we can affirm that the lack of robustness was normal for the typological structures of that era and consequent to the available tools in the 60'. It is easy today to perform analyses for highly indeterminate structures by using computers, but it was not at that time. The structures were designed by using the simplest possible schemes, in order to have easier calculation to be made. Consequently, no ductility expedient, at any scale, was adopted to exclude fragile collapse [6]. Robustness and ductility are two design control parameters for structural safety in the ultimate state of collapse. Moving forward along the chain, maintenance and monitoring are two control activities that usually go along with an important bridge structure. Because of its audaciousness, Polcevera bridge has been continuously investigated and consolidated over the years. Along the 70s, the designer himself, started with regular visual inspections [7], while over the '80s a distributed restoration of the concrete components was carried out [4] starting from the towers and then moving through the deck. In 1993, a detailed inspection through the insertion of an endoscopy inside the stays of the Tower 11, evidenced a severe oxidation of the metallic protective membrane and of the strands themselves. Additionally, significant presence of humidity and absence of grout were reported. Moreover, some of the strands appeared slacked or sheared, sign of a tensile rupture due to steel cross-section reduction [7,8]. This preoccupying scenario advised the entire structure management authorities over the risks of material decay due to micro-cracking in the prestressed concrete. In fact, the concrete section of the stays was designed to be subjected to light but continuous decompression-compression cycles due to live loads. The peculiar cables disposition, core of the M5 patent [9], had the aim to avoid large stress variations in the steel strands, but this was possible only with a magnitude of the tendon force close to the ultimate one. All the described conditions led the structure to a quickened state of material decay and the entire sets of stays of the Tower 11 were replaced with an external prestressing system (Fig. 11(c), Fig. 11(d)). After this massive intervention (12 cables $\phi 150$ mm with 22 0.6” diameter strands for each stay and 4 months of work with reduced

traffic), many other maintenance and monitoring activities have been performed over the viaduct [10]. Most of the monitoring regarded the health condition of the strands of the remaining towers [11], while the repairing affected the carriageway slabs. When Tower 9 collapsed, a replacement intervention of its strands was planned for the following two months, and ongoing maintenance was present on the deck.

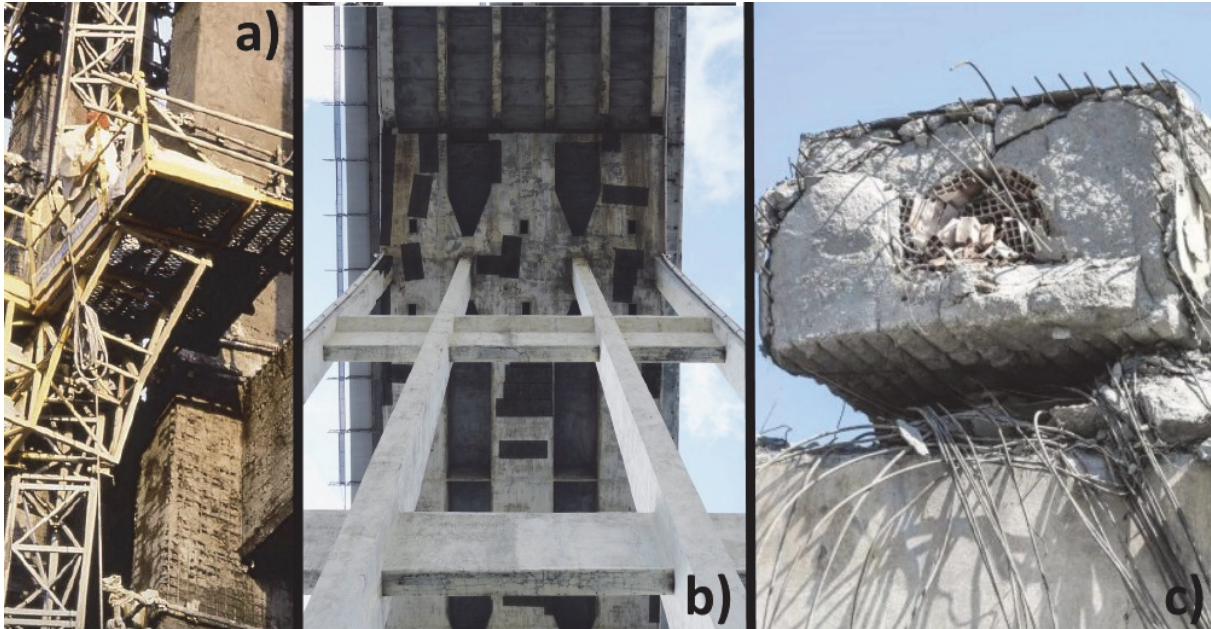
One of the main factors that influences corrosion of reinforcement is the porosity of the mixture. This allows the aggression of the iron by the external chlorides and promote carbonation. Porosity has a direct correlation with water content and increasing aggregated grain sizes [16]. The promoted studies in the early 1970 [17, 18] set a milestone in concrete technology, evidencing the carbonation phenomenon and the quantitative role of porosity. Furthermore, they facilitated the introduction of super-fluidifying solutions, which exploited the power of chemical additives in reducing drastically the water content with an appreciable workability. At the same time, minimum concrete cover prescription and efficient detailing for diverting running water were introduced in the upcoming building codes [19]. In 1979, Morandi published an update [20] on the Polcevera bridge behavior after twelve years of service. It was then clear that the wall cracking represented a problem for long-term performance of the structure, especially for an aggressive environment like the one where the bridge was situated. Polcevera viaduct is 1 km distant from the sea and in the underlying industrial hub there was, until 2005, a steel production plant. This means that the wind that climbs back the city coast brought not only chlorides, but also sulphur dioxide in contact with the structure. Sulphur dioxide, when combined with carbon dioxide, becomes sulphuric acid that reacts with cement transforming lime in salt composites that can be washed out by rain. As suggested by Morandi in [20], and as illustrated in section 1, in the 80s the concrete of the Polcevera towers had a surface polishing and restoration treatment. Literature does not report any details about this repair intervention, but we know from [20] that the Author suggested the exposure of reinforcement, rust removal, epoxy covering and the addition of a protective layer with a wire mesh. Form picture of this intervention (Fig. 12(a)) it is possible to see that, in some parts, an actual wire mesh was embedded in the new surface concrete layer. From Italian building magazines [20,21] we know that

the epoxy covering was substituted with the Emaco S88 retained shrinkage grout and an Emaco Bianco white painting (Fig. 12(b)). Images of the collapsed Tower 9 prove the presence of this protective layer, but at the same time is possible to observe a neat discontinuity between the old and the new surfaces (Fig. 12(c)). Today, the state of the art for the same intervention prescribes that the removal must occur for all the thickness of the corrupted concrete, and complete bonding has to be assured between old and new surfaces to avoid stagnation and contaminant penetration [22].

Figure 12: Repairing of one of the tower of the Polcevera viaduct [17] (a); white covering of Tower 9 (b); ruins of Tower 9 (c).

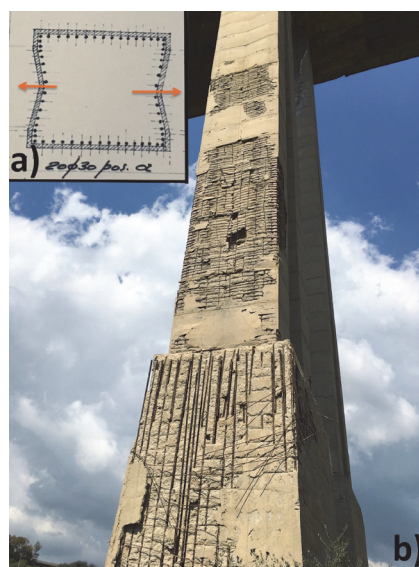
Throughout the same years, the Akragas Viaduct (S.S. 115-AG, Agrigento, 1970) was erected in Sicily. The design, by Morandi, considered a total length of 1400 m skewed viaduct with 31 spans, each 44 m long (Fig. 13(a)). The deck, 10 m wide, was realized by a grillage of 3 unbonded prestressed I-beams, 5 transverse beams, and a precast pavement (Fig. 13(b)) [23]. Support for each beam consisted in a couple of reinforced concrete A columns, with a maximum height of 60 m. To date, these latter elements represent the key vulnerability of the structure. Each column was erected through a concrete concave precast box that works both as scaffolding (in the pouring phase) and as shear resisting element (Fig. 14(a)). It is reasonable to think that visible damage is due to the concave shape of the external box. When shear forces required confinement, the bars pushed against the box bulged the internal part as visible in Fig. 14(b). Together with the static problems, the retrofitting intervention has the aim of improving the seismic behavior by providing sufficient shear strength and ductility: a new element and the recovering of a confined state for the concrete of the core.

Figure 14: Column details (a); state of decay of the columns (b).

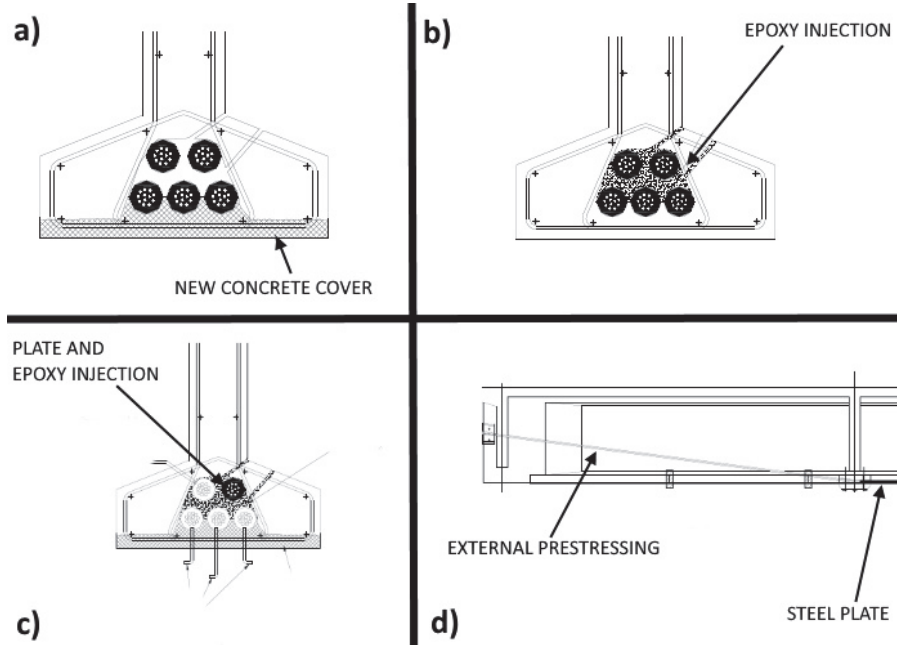
Figure 15: Suggested retrofitting. Level 1 damage (a); Level 2 damage (b); Level 3 damage (c); Level 4 damage (d).

Petrulla Viaduct characteristics have been discussed in section 1. The oxidation of the reinforcing and of the prestressing cables (Fig. 2(a), Fig. 2(b)) occurred due to an inadequate protection by carbonation and water seepage. Through the results of the vulnerabilities, four different restoration interventions have been proposed, corresponding to the observed damage degree (Fig. 3(a), Fig. 3(b)). For the level one (G), the removal of the actual concrete coverage and corroded bars, followed by their complete refurbishment, was suggested (Fig. 15(a)). Considering the second level (Y), to assure the adequate safety factor, the installment of a metallic plate was suggested to reinstate the base of the I-beam. This plate was supposed to be connected to the web through two lateral bolts and a glued to the base of the I, previously abrase. The injection of epoxy resins realized the final sealing and the protection from further corrosion. For the third level (B), the intervention is the same of the discussed previous one with the additional injection into the prestressing cables with low-viscosity epoxy (Fig. 15(c)). Concerning the worst damage case (R), the corroded section area of the strand must be recovered to fulfill the safety factor. In order to do so, an external prestressing was suggested, connected to the sealing steel plates and the cable header (Fig. 15(d)).

The retrofit intervention proposed for the Petrulla viaduct (Fig. 15) had also the purpose of increasing the robustness of the structure. Local plates and the external prestressing made recover structural continuity to the beams. Furthermore, the external cables are easy to inspect and check for integrity. This opportunity represents also a form of robustness because of the redundancy of controls. On the contrary, structural arrangement like the one of the Fossano Bridge requires to retriever firstly the structural coherence. The joints represent a discontinuity towards the fragile shear mechanism. This means that, if the cables are unbonded across the joint area, there is no possibility for the vertical loads to reach the supports once the cables are broken. This could be easily testified by looking at the intact joint that resisted the impact on the ground when bridge failed (Fig. 7(a)). Moreover, inspections in the web and epoxy void injections seems unfeasible due to the section shape. In the same way, external prestressing is rather impassable, since it is unknown the adequate force and steel to apply. A promising solution is represented by resurfacing the concrete beam with a steel carter that works both in shear and flexural regime (Fig. 19). The mandatory condition for this repair intervention is the absolute adherence between the steel sheathing and the concrete, in regard to congruent strains and humidity proofing [27].

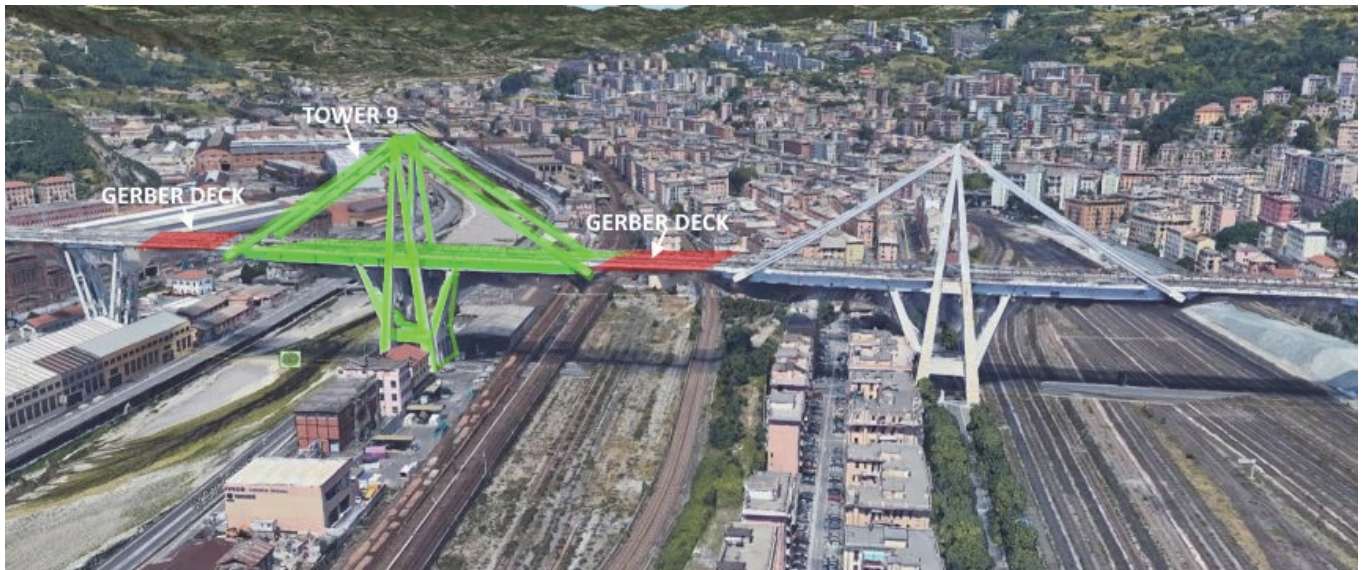
Figure 17: Involved structure in the collapse: tower and Gerber decks.

One of the shocking aspects of the Polcevera Viaduct collapse was its catastrophic nature. Even if the causes are currently under investigation, it is clear that the failure of one component has been followed by the entire structure, composed by the tower (green, Fig. 17) and two simply supported Gerber decks (red, Fig. 17). As anticipated, the equilibrium of the system rests upon the balance between the symmetry axes of the tower (Fig. 18a). A lack of balance in one of the two directions of the equatorial planes induces a flexural moment in the deck plane that can lose in-plane stability and could break due to unbalanced compressive forces (blue, Fig. 18(a)). Under these circumstances, the in-plane twisting could cause the slip of the Gerber decks, that without a vertical support become free to fall. At the same time, a disequilibrium in the plane of the bridge direction induces torsion and bending moment to the double framed A tower (red, Fig. 18a). This structure could not have the ductility capacity to resist at such asymmetric stress, because of the limited rotational capacity at the base (wider) and the lack of redundancy for force redistribution. Moreover, unbalanced forces in the plane of the stays causes deck uplifting on one side and subside to the other. This mechanism, could be again

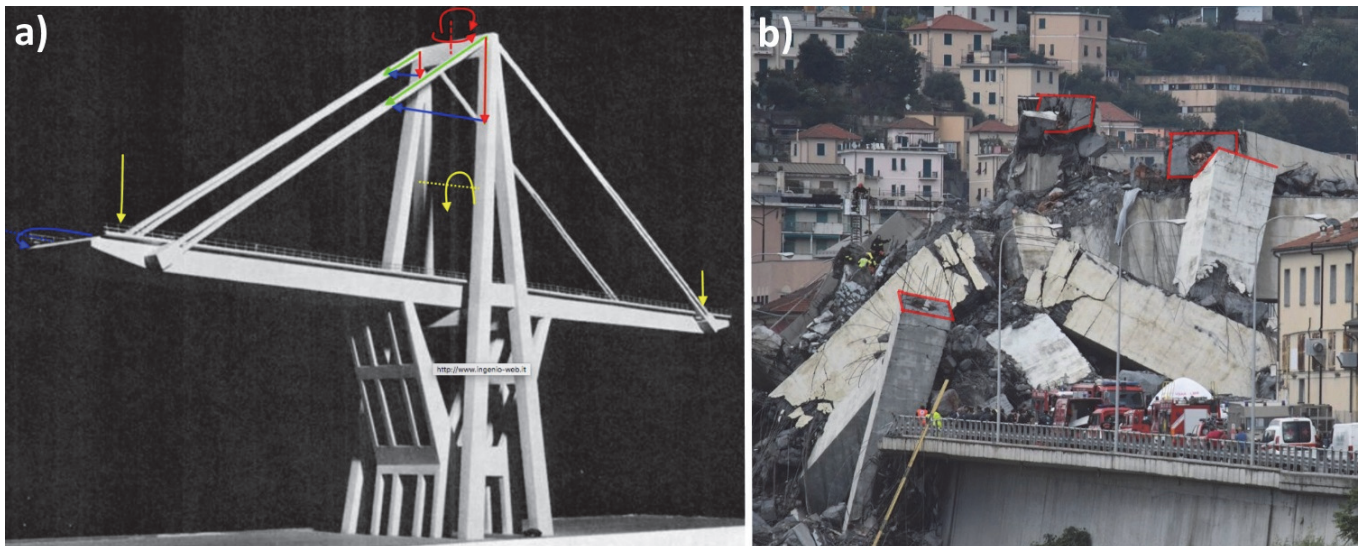
Figure 18: resisting mechanism of the Polcevera Tower: equilibrium in the three planes [www.ingenio-web.it]. (a); planar failure surfaces (b).

responsible for the support loss of the Gerber deck and the rupture of the deck due to bending in its plane (yellow, Fig. 18a). An asymmetric fall of the deck causes and inevitable impact with the intermediate deck support that would find themselves dragged into the collapse. Finally, the observation of the Tower 9 ruins allows an additional comment: many of the parts of the tower broke with planar surfaces, evidencing low or nonexistent process zone and plastic hinge creation. These planar surfaces represent probably the casting phases of the vertical structure. This would imply that (i) no sufficient rebars content was present in that zones, or (i) the boxed section had not sufficient plasticity reserve (red, Fig. 18b). In the end, at this level of knowledge, the lack of structural robustness can be addressed to these factors:

- the low number of stays elements that causes zero redundancy in deck support;
- the low rotation capacity of the A framed lateral tower and its limited redistribution;
- the statically determined scheme for the entire viaduct, which causes higher displacements (and cracking as a consequence) and domino effect collapse;
- the low ductility at member scale;
- the intrinsic sudden loss of strength of prestressing technology.

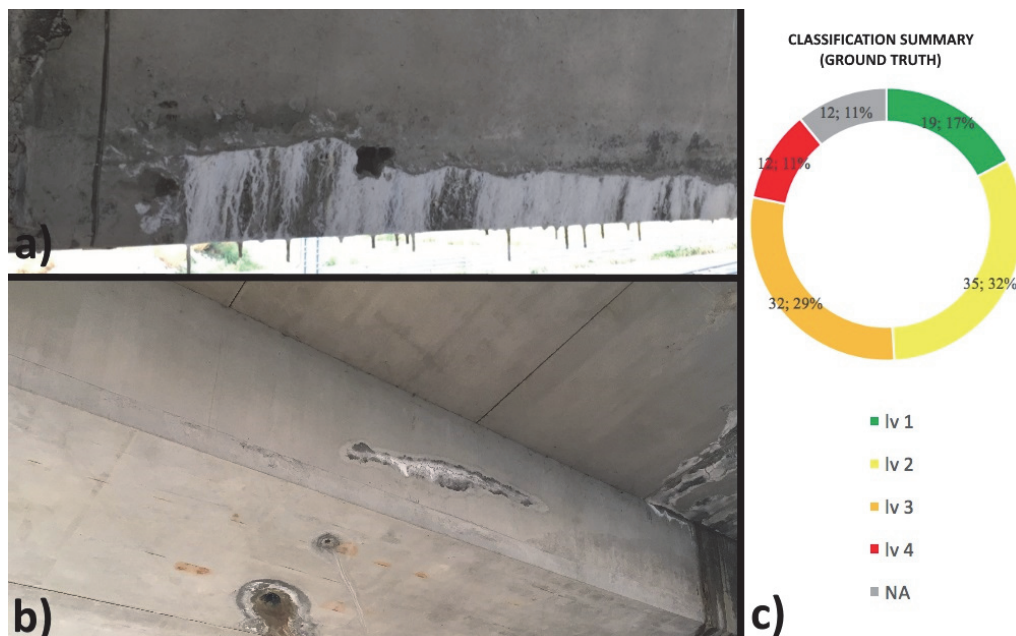
Figure 22: White stains due to grout drainage (a); red-brown stains due to corrosion (b); results from classification (c).

The spot in Fig. 22(a) exhibits a with a pale color and a layered aspect. This stain testifies a drainage of the grout by water seepage inside the cables. This obviously implicates inadequate water protection but also suggest that the cables lie in

bonded condition. At the contrary, red-brow stains (Fig. 22(a)) suggest unprotected cables and rust transport by continuous water gradient. This latter condition represents of course the worst scenario, with maximum damage and lower robustness. The presence of this particular damage has been catalogued as Lv.4 (red) for the entire bridge. Extended and joint-diffused white stains have been catalogued as Lv.3 (orange), while local or isolated as Lv.2 (yellow). Lastly, a clear external surface of the bridge deck has been assigned to a Lv.1 degree of damage (green). After the first photographic campaign, an image classification (labeling) has been carried out manually by experts. Results of this classification are shown in Fig. 22c. These results have been used as ground truth for the building of the image layer of a DCNN CV detector Fig. 23(a). The set has been splitted in 65%-35% for training and validation. Before training, each picture has been filtered for red-contrast enhancement. A random set of 200 images from Kaggle has been used as false test. Training lasted 21 hours on a 2014 MacBook Pro. DCNN has been implemented with Pytorch and Anaconda 3.5.2.0. Other two layers have been implemented in the net, one based on the results of the load test and one on the dynamic properties of the bridge, both computed by a FEM tuned model Fig. 23(b). To date, other two photographic campaigns (tablet-based) have been carried out by A.N.A.S. technicians, and Fig. 24(a) shows the results of the application of the DCNN on the bridge n. 48. The system correctly spotted a red stain and classified the bridge as a Lv.3. Analogously, for bridge n. 52 (Fig. 24(b)), a Lv.4 classification has been successfully matched. Regarding instead span n. 85, classified Lv.3 manually, the DCNN detected a Lv.2. damage degree Fig. 25(a).

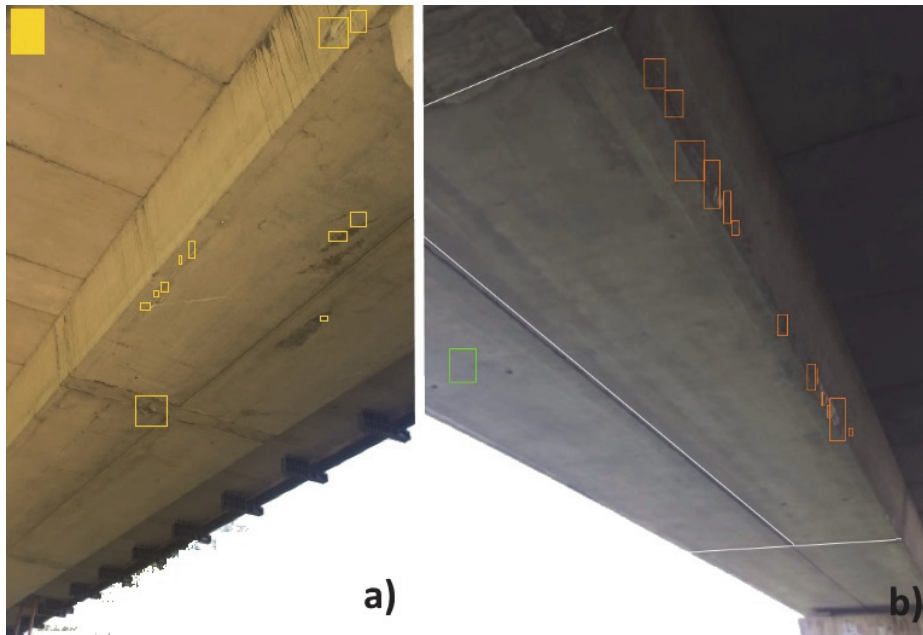
Figure 25: mismatch of damage degree (a); element-scale analysis (b).
