Considerations over the Italian road bridge infrastructure safety after the Polcevera viaduct collapse: past errors and future perspectives

Fabio Bazzucchi, Luciana Restuccia, Giuseppe Andrea Ferro

ABSTRACT. In the last four years, Italy experienced the collapse of five road bridge: Petrulla viaduct (2014), Annone (2016) and Ancona (2017) overpasses, Fossano viaduct (2017) and Polcevera (2018) bridge.

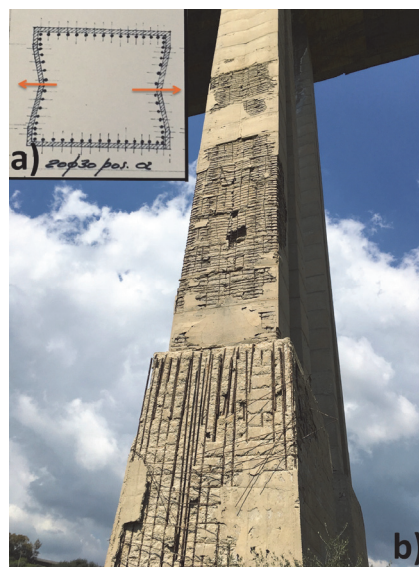
Figure 14: Column details (a); state of decay of the columns (b).
