Considerations over the Italian road bridge infrastructure safety after the Polcevera viaduct collapse:
past errors and future perspectives

Fabio Bazzucchi, Luciana Restuccia, Giuseppe Andrea Ferro

Politecnico di Torino, Turin, Italy

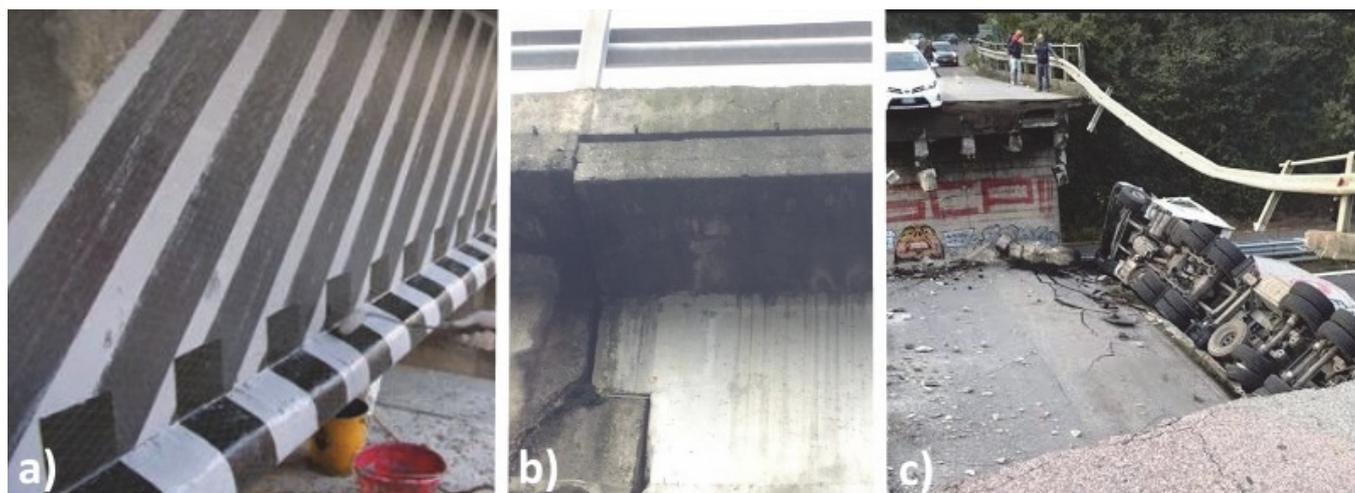
The collapse occurred when a 107.6 t heavy 8-axels truck went across the deck with a low moving speed (Fig. 5(c)). Once the load was carried entirely by the central beam, the external repaired dapped end corbel collapsed due to the vertical reaction established for supporting the beam. Total weight on the structure was approximately 172 t, which is 10 % higher than the maximum design load adopted equal to 155 t. However, this excess should have been overcome in the safety factor. This bridge was catalogued as category II by Italian Building Codes [3], but the safety requirements were not fulfilled by the structural properties. Investigation [1] have demonstrated that this failure was compromised by:

- an initial design flaws in the dapped-end corbel that significantly reduced the ultimate load;

- reinforcement in the precast beams was not enough to ensure a category II bridge classification;
- the presence of a shear fracture along the dapped end corbel promoted the oxidation of the reinforcement bars in the joint;
- the passage of II category loads (more than 100 per year) puts frequently the structure close to its ultimate bearing capacity.
- the eccentricity produced by a transit misaligned by the carriageway central line significantly increased the loading in the external dapped end joint.

Figure 5: Dapped end corbel conditions before the collapse (a); humidity presence and water stagnation (b); failure loading configuration (c) [1].

These results have been produced by detailed destructive analyses that can not be carried out for an existing structure. This means that the only control parameter that we can adopt in these cases is load checking and protective device installments for delicate parts, as Gerber supports.

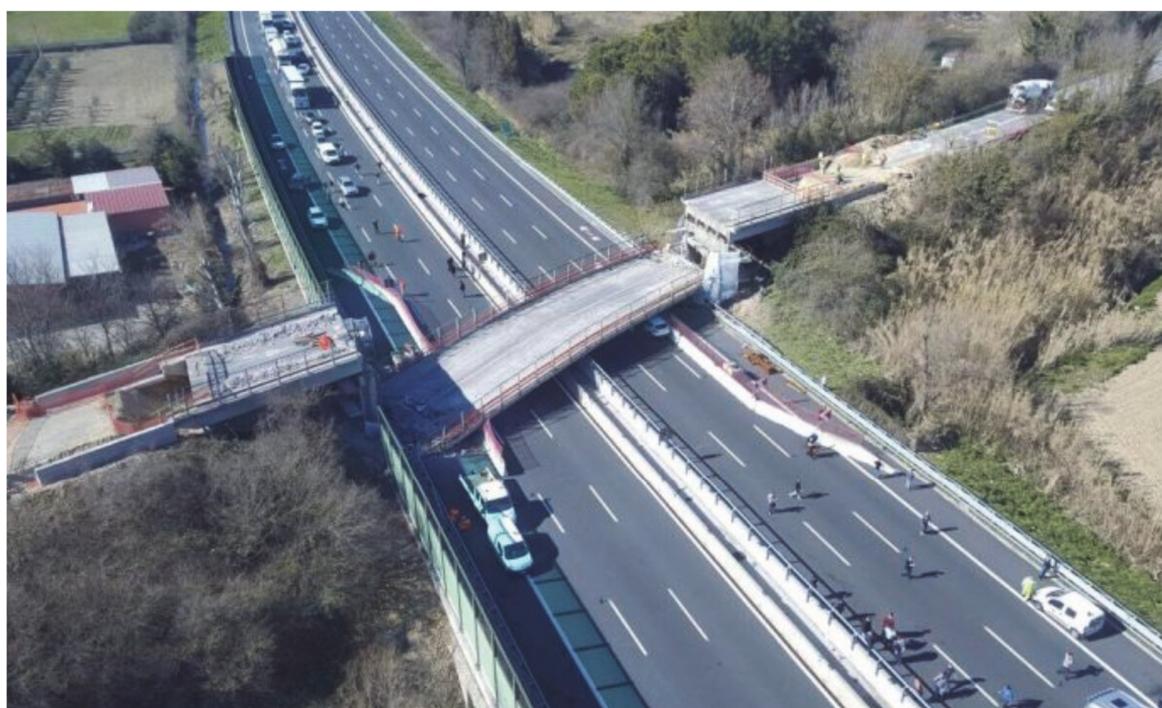
Figure 6: Ancona overpass after the collapse (from web site www.cronacheancona.it).

This collapse occurred on 9 March 2017, near Ancona, along the A14 Italian Highway. The bridge (167 at km 235+800) was constituted by a steel-concrete composite deck 16.5 m wide and 36 m long with a simply supported beam scheme (Fig. 6). When collapsed, the deck was uplifted for maintenance operation and it was supported by a temporary structure. The deck fell on the underlying highway, causing the death of 2 people that were transiting underneath.

The case of the collapse of the overpass on the A14 motorway near Ancona is quite different from the others and was caused only by a resounding error during the execution phase. The works involved the adjustment of the altimetric height of the overpasses, consisting of raising the decks, creating an extension of the support structures and the re-profiling of the associated ramps. The lifting took place through the use of hydraulic jacks with few centimeters steps, after positioning of steel plates for distribution. The appointed subcontractor to perform this specific process decided to replace the supporting steel plates with similar plates in neoprene, much lighter to move. Numerical analyses conducted during investigations by prof. Tarantino highlighted how a difference between the temporary supports of a few millimeters generates horizontal forces not compatible with the shear deformability of the numerous neoprene plates stacked on top of each other. This generated an unexpected bridge horizontal displacement and the collapse occurred. Further details are under investigation.

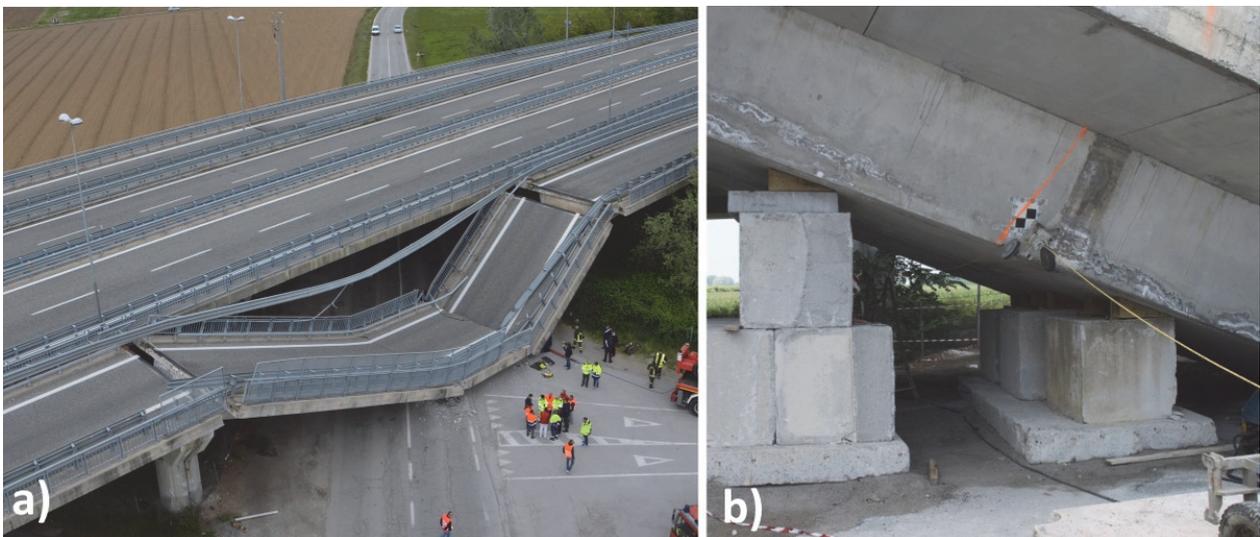
Figure 7: Overview of the collapsed Fossano bridge (a) and structural scheme (b).

The collapsed overpass is one of the 108 that constitutes the Fossano (Cuneo) bypass road. This road has several viaducts, and the one involved in the failure is one of the ramps of La Reale Viaduct, where it crosses the S.P. 165. The collapse occurred on April 18, 2017, and luckily (2.45 p.m.) no vehicles were going across or underneath the structure. The sudden collapse took place without out-of-plane displacements (Fig. 7(a)). A modest slip ahead in one of the bearings has been identified in the collapsed configuration. The structure was a simply supported beam, 30.80 m long and 8.90 m wide, constituted by a multiple-box post-tensioned beam and by an in-situ casted slab. The section was realized by connecting two concrete precast U-elements by a shear-key casted in situ. In the longitudinal direction, the bridge was built in 3 segment, the central one 11.50 m long and the lateral ones 9.35 m long. The connection between the segments was realized by an in-situ casted concrete joint 0.5 m wide (Fig. 7(b)). Post-tensioning system constituted in 8 parabolic cables, each of them made by 19 0.8" strands. Total weight of the structure was about 400 t. The collapsed structure evidenced an intact joint and a collapsed one, together with an evident shear failure where the bridge impacted the ground. For this event, several information can not be given at the moment due to secrecy related to the running investigations. Visual inspections consented to affirm that the collapse mechanism was triggered by a shear failure in one of the joint due to the absence of the equilibrating action of the prestressing (Fig. 8). This means that in some part between the support and the intact joint, the cables were damaged. Visual inspections immediately also demonstrated that the cables did not have sufficient grout protection in the collapsed joint area (Fig. 9(a)). The damage was not compatible with a 20 years old

Considering now the case of La Reale Viaduct (Fig. 7(a)). Durability problems are overcome by the peculiar shape of the deck and its modular assemblage. To avoid a fragile collapse, the structure must improve its robustness. Since the analyses of the safety of the infrastructure are still under exploitation, different levels of intervention are suggested towards the observed damage pattern. For the spans that will evidence lack of cable protective grout, epoxy injection would be necessary to stop the advancement of corrosion. This operation could result particularly difficult to do because of the inaccessible boxed section. A frequent problem in bridge concrete walls is concrete spalling and exposure of reinforcement. This situation is particularly dangerous when the exposed reinforcement realizes the primary load carrying system, i.e. dapped-end corbels (Fig. 5(a), Fig. 5(b)). Under these circumstances, health of the steel is essential to exclude a sudden collapse due to shear failures. Considering the numbers of the existing artifacts, sometimes just blocking the advance of corrosion represents a good strategy to keep reasonable safety factors while retrofitting is pending. This strategy can be implemented by the use of sacrificial anodes (galvanic protection) directly connected to exposed reinforcements (Fig. 16) [24]. These anodes, usually realized in zinc-based compounds, guarantee local protection to the

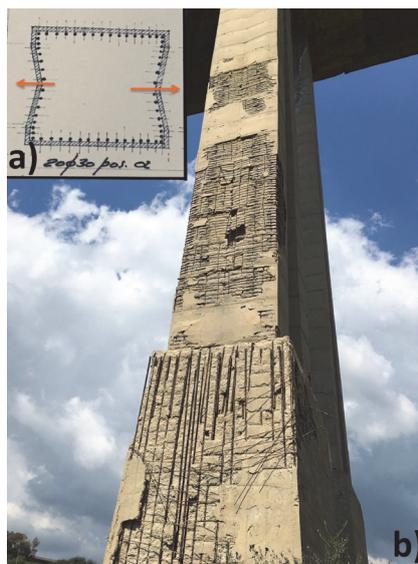
Figure 14: Column details (a); state of decay of the columns (b).

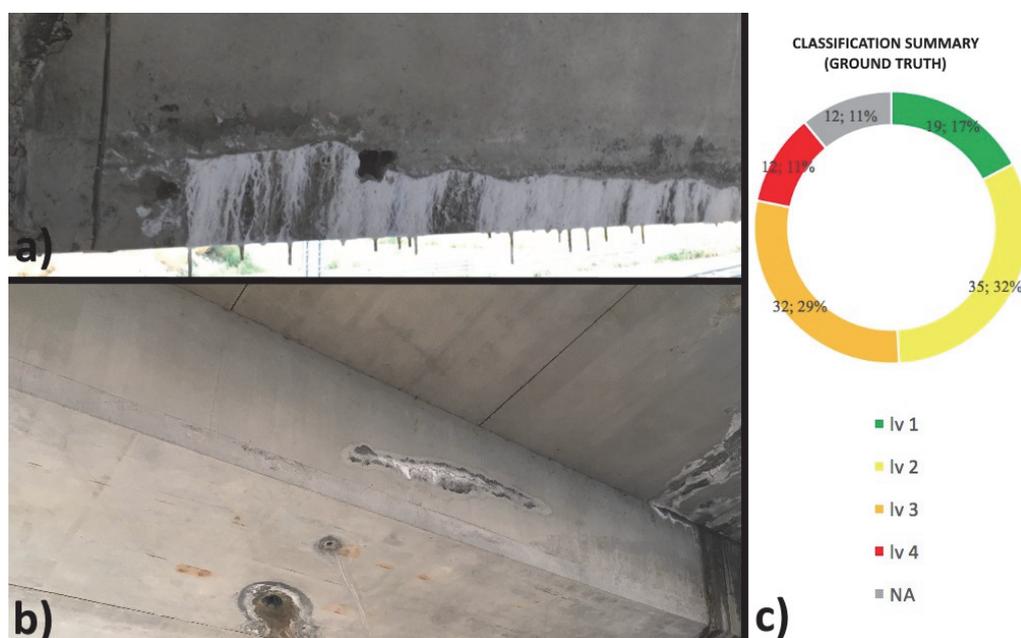
Figure 22: White stains due to grout drainage (a); red-brown stains due to corrosion (b); results from classification (c).

The spot in Fig. 22(a) exhibits a with a pale color and a layered aspect. This stain testifies a drainage of the grout by water seepage inside the cables. This obviously implicates inadequate water protection but also suggest that the cables lie in

bonded condition. At the contrary, red-brown stains (Fig. 22(a)) suggest unprotected cables and rust transport by continuous water gradient. This latter condition represents of course the worst scenario, with maximum damage and lower robustness. The presence of this particular damage has been catalogued as Lv.4 (red) for the entire bridge. Extended and joint-diffused white stains have been catalogued as Lv.3 (orange), while local or isolated as Lv.2 (yellow). Lastly, a clear external surface of the bridge deck has been assigned to a Lv.1 degree of damage (green). After the first photographic campaign, an image classification (labeling) has been carried out manually by experts. Results of this classification are shown in Fig. 22c. These results have been used as ground truth for the building of the image layer of a DCNN CV detector Fig. 23(a). The set has been splitted in 65%-35% for training and validation. Before training, each picture has been filtered for red-contrast enhancement. A random set of 200 images from Kaggle has been used as false test. Training lasted 21 hours on a 2014 MacBook Pro. DCNN has been implemented with Pytorch and Anaconda 3.5.2.0. Other two layers have been implemented in the net, one based on the results of the load test and one on the dynamic properties of the bridge, both computed by a FEM tuned model Fig. 23(b). To date, other two photographic campaigns (tablet-based) have been carried out by A.N.A.S. technicians, and Fig. 24(a) shows the results of the application of the DCNN on the bridge n. 48. The system correctly spotted a red stain and classified the bridge as a Lv.3. Analogously, for bridge n. 52 (Fig. 24(b)), a Lv.4 classification has been successfully matched. Regarding instead span n. 85, classified Lv.3 manually, the DCNN detected a Lv.2. damage degree Fig. 25(a).
