Considerations over the Italian road bridge infrastructure safety after the Polcevera viaduct collapse:
past errors and future perspectives

Considerations over the Italian road bridge infrastructure safety after the Polcevera viaduct collapse: past errors and future perspectives

Fabio Bazzucchi, Luciana Restuccia, Giuseppe Andrea Ferro

ABSTRACT. In the last four years, Italy experienced the collapse of five road bridge: Petrulla viaduct (2014), Annone (2016) and Ancona (2017) overpasses, Fossano viaduct (2017) and Polcevera (2018) bridge.

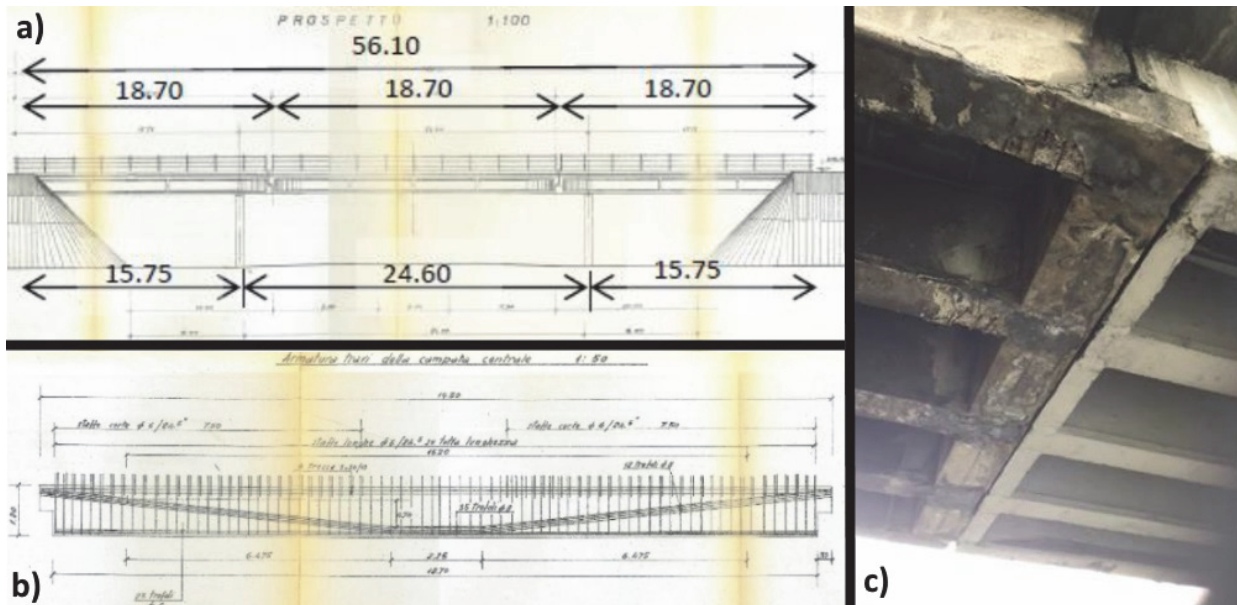
The collapse of the Annone overpass, Lecco, at km 42.000 along the S.S. 36 “del Lago di Como e dello Spluga”, occurred on October 18, 2016. The failure had a high impact on the Italian society since it caused the death of a car driver and several wounded. The bridge was built between the 1960 and 1962, with a Gerber scheme deployed over 4 supports (Fig. 4(a)). The central deck, 24.60 m long and 4.40 m wide, was constituted by 5 precast and prestressed I-beams. Gerber supports were 0.575 m high, with an ordinary reinforcement as shown in Fig. 4(b) and Fig. 4(c). Before the collapse, the bridge was subjected to several impacts by underlying moving vehicles [1]. This was due to a non-adequate free height of the overpass (< 5 m). After these events, the saddle was repaired with rebars and CFRP installments (Fig. 5(a)). However, those interventions could not renovate the shear fracture propagated over the saddle and significant presence of humidity was often detected when inspected (Fig. 5(b)). This was mainly due to the produced misalignment in the dapped-end (2.5 cm) due to the repairs, which constituted a stagnation point for running water [2].

Figure 4: Overview of the Annone overpass [1] (a); Gerber support reinforcement, design (b) and investigation (c).

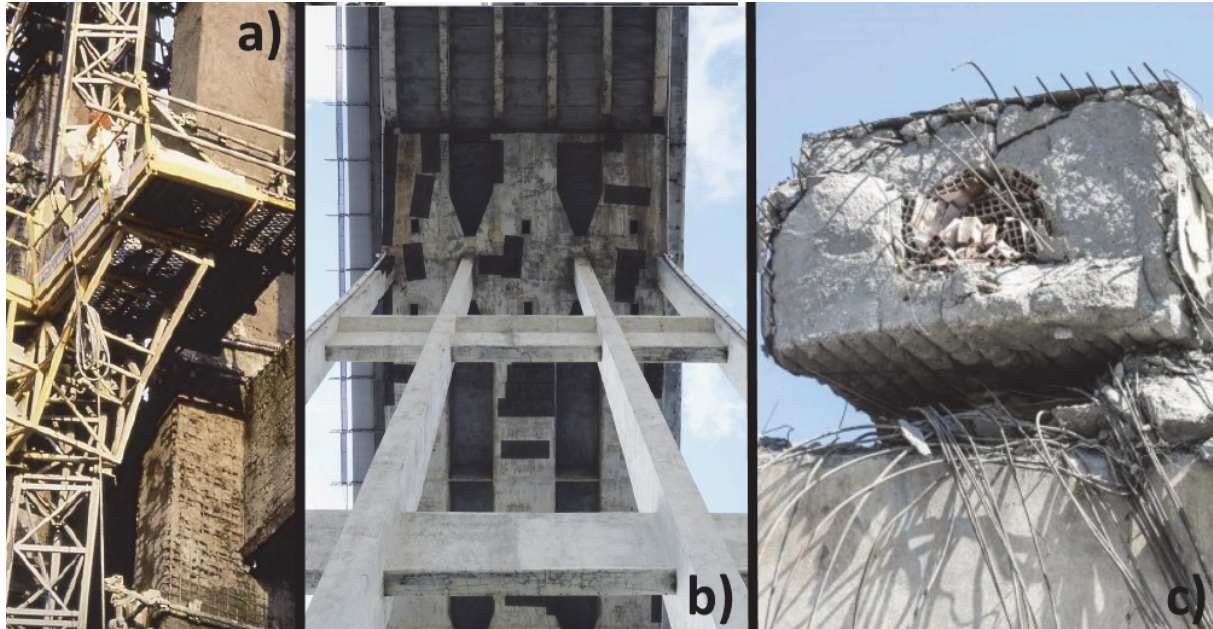
the epoxy covering was substituted with the Emaco S88 retained shrinkage grout and an Emaco Bianco white painting (Fig. 12(b)). Images of the collapsed Tower 9 prove the presence of this protective layer, but at the same time is possible to observe a neat discontinuity between the old and the new surfaces (Fig. 12(c)). Today, the state of the art for the same intervention prescribes that the removal must occur for all the thickness of the corrupted concrete, and complete bonding has to be assured between old and new surfaces to avoid stagnation and contaminant penetration [22].

Figure 12: Repairing of one of the tower of the Polcevera viaduct [17] (a); white covering of Tower 9 (b); ruins of Tower 9 (c).

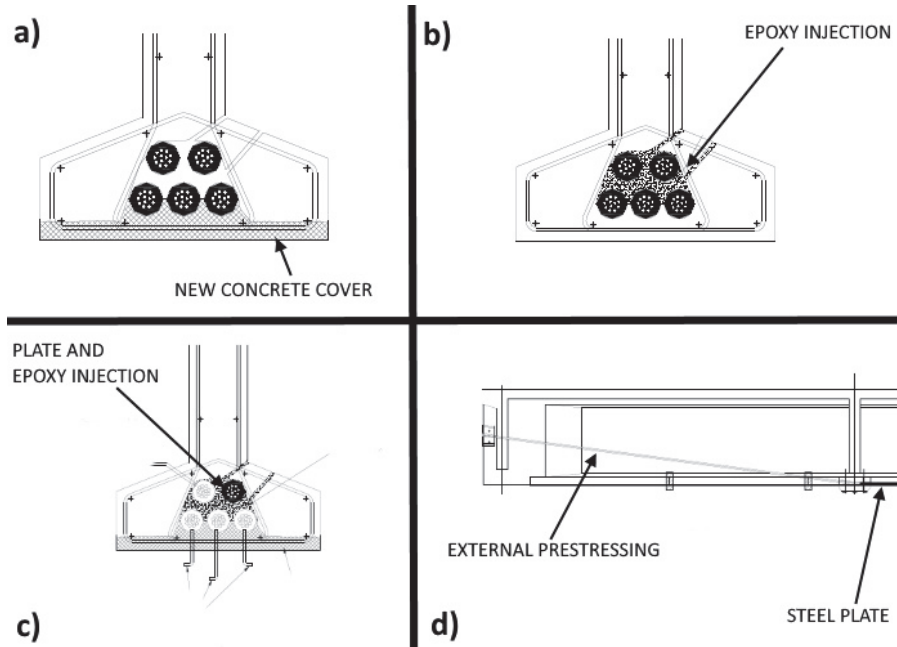
Figure 15: Suggested retrofitting. Level 1 damage (a); Level 2 damage (b); Level 3 damage (c); Level 4 damage (d).

Petrulla Viaduct characteristics have been discussed in section 1. The oxidation of the reinforcing and of the prestressing cables (Fig. 2(a), Fig. 2(b)) occurred due to an inadequate protection by carbonation and water seepage. Through the results of the vulnerabilities, four different restoration interventions have been proposed, corresponding to the observed damage degree (Fig. 3(a), Fig. 3(b)). For the level one (G), the removal of the actual concrete coverage and corroded bars, followed by their complete refurbishment, was suggested (Fig. 15(a)). Considering the second level (Y), to assure the adequate safety factor, the installment of a metallic plate was suggested to reinstate the base of the I-beam. This plate was supposed to be connected to the web through two lateral bolts and a glued to the base of the I, previously abrase. The injection of epoxy resins realized the final sealing and the protection from further corrosion. For the third level (B), the intervention is the same of the discussed previous one with the additional injection into the prestressing cables with low-viscosity epoxy (Fig. 15(c)). Concerning the worst damage case (R), the corroded section area of the strand must be recovered to fulfill the safety factor. In order to do so, an external prestressing was suggested, connected to the sealing steel plates and the cable header (Fig. 15(d)).

The retrofitting intervention proposed for the Petrulla viaduct (Fig. 15) had also the purpose of increasing the robustness of the structure. Local plates and the external prestressing made recover structural continuity to the beams. Furthermore, the external cables are easy to inspect and check for integrity. This opportunity represents also a form of robustness because of the redundancy of controls. On the contrary, structural arrangement like the one of the Fossano Bridge requires to retriever firstly the structural coherence. The joints represent a discontinuity towards the fragile shear mechanism. This means that, if the cables are unbonded across the joint area, there is no possibility for the vertical loads to reach the supports once the cables are broken. This could be easily testified by looking at the intact joint that resisted the impact on the ground when bridge failed (Fig. 7(a)). Moreover, inspections in the web and epoxy void injections seems unfeasible due to the section shape. In the same way, external prestressing is rather impassable, since it is unknown the adequate force and steel to apply. A promising solution is represented by resurfacing the concrete beam with a steel carter that works both in shear and flexural regime (Fig. 19). The mandatory condition for this repair intervention is the absolute adherence between the steel sheathing and the concrete, in regard to congruent strains and humidity proofing [27].

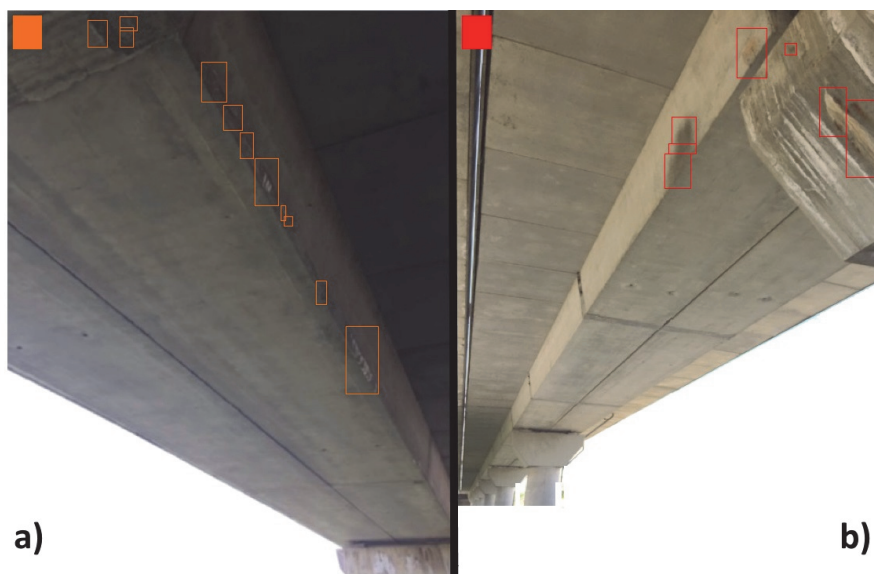
Figure 24: Detection of a Lv.3 damage (a); detection of a Lv.4 damage (b).
