# The anatomy of a collapse: forensic analyses, monitoring and restoration attempts of the Fossano Bridge

F. Bazzucchi & G. A. Ferro

*Department of Structural, Building and Geotechnical Engineering*

**ABSTRACT:** The collapse of the Fossano bridge (Italy) occurred on April 18th, 2017 and it put high pressure on the Italian society for infrastructural risk perception. First of all, this collapse was the third in the last sixteen months. Then, the bridge was relatively young, being erected in 2001. Additionally, this bridge was just one of the 108 spans that composed the entire viaduct of the Fossano bypass road. In this scenario, the Italian road authority (A.N.A.S.) conducted an in-depth investigation over the causes of the collapse and its implications on the existing remaining span. Moreover, study for monitoring and restorations were encouraged and supported. In this paper, we present the results of the forensic analyses, the studies over the entire infrastructure and the management of the data over a one year monitoring with and Artificial Intelligence framework for vulnerability assessment and risk prediction. Furthermore, we present study over the investigated structural s

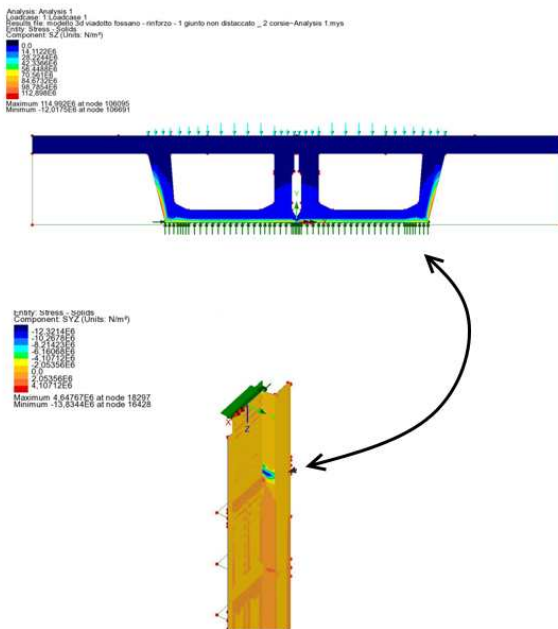
Figure 6: Numerical simulation of the steel U sleeve to attach at the deck.

While the first operation is now undergoing with epoxy resins injections and waterproofing pavement layers restorations, the second issue can be tackled only by the application of a structural component. In this case, a U steel sleeve has been designed to be attached across the joint to sustain both the shear and the flexural tensile force at the bottom. Connection has been designed with 56 M22 bolts per side. Each sleeve is designed with an embedded monitoring system for deformation to check if the prestressing force is diminishing by the progressive loading of the sleeve. Numerical simulations, i.e. reported in Figure 6, suggested that the system is able to bear the ultimate load with no operational limit state guaranteed.
