# The anatomy of a collapse: forensic analyses, monitoring and restoration attempts of the Fossano Bridge

F. Bazzucchi & G. A. Ferro

**ABSTRACT:** The collapse of the Fossano bridge (Italy) occurred on April 18th, 2017 and it put high pressure on the Italian society for infrastructural risk perception. First of all, this collapse was the third in the last sixteen months. Then, the bridge was relatively young, being erected in 2001. Additionally, this bridge was just one of the 108 spans that composed the entire viaduct of the Fossano bypass road. In this scenario, the Italian road authority (A.N.A.S.) conducted an in-depth investigation over the causes of the collapse and its implications on the existing remaining span. Moreover, study for monitoring and restorations were encouraged and supported. In this paper, we present the results of the forensic analyses, the studies over the entire infrastructure and the management of the data over a one year monitoring with and Artificial Intelligence framework for vulnerability assessment and risk prediction. Furthermore, we present study over the investigated structural solutions for safety refurbishment. We believe that this work will b

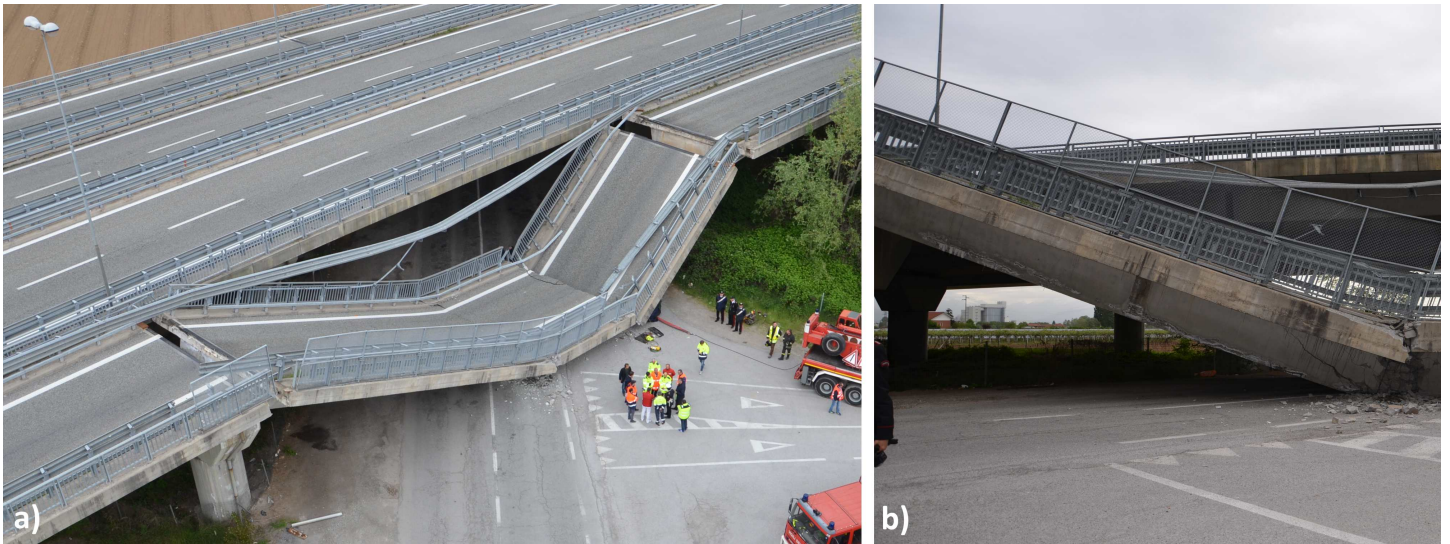
On the early afternoon of 18th of April 2017, one of 108 spans that constituted the Fossano bypass viaduct collapsed abruptly on the street below (Figure 1a). Luckily, the incident did not involve any person or moving vehicle, apart from a parked empty car under the bridge. At the time, this collapse represented the third in a row for the Italian infrastructure network on a time span of sixteen months (Bazzucchi, Restuccia, & Ferro 2018). The level of pressure affixed to the system by the civil society and road authorities concerning the safety of whole system was particularly high after the event, and it skyrocketed when the iconic Morandi bridge on the Polcevera river collapsed on August 2018.

Figure 1: a) collapsed structure. b) in-situ casted intact joint.

The collapsed bridge was constituted by a simply supported beam, 30.80m long and 8.90m wide, made by a multiple-box post-tensioned beam and by a in-situ casted slab. The section was realized by connecting two concrete precast U-elements by a shear-key casted in situ. In the longitudinal direction, the bridge was built in 3 segments, the central one 11.50m long and the lateral ones 9.35m long. The connection between the segments was realized by an in-situ casted concrete joint 0.5m wide (Figure 1b). Post-tensioning system constituted in 8 parabolic cables, each of them made by 19 0.8" strands (934cm<sup>2</sup>). Total weight of the artifact was about 400t. The collapsed structure evidenced an intact joint and a damaged one, together with an evident shear failure where the bridge impacted the ground.

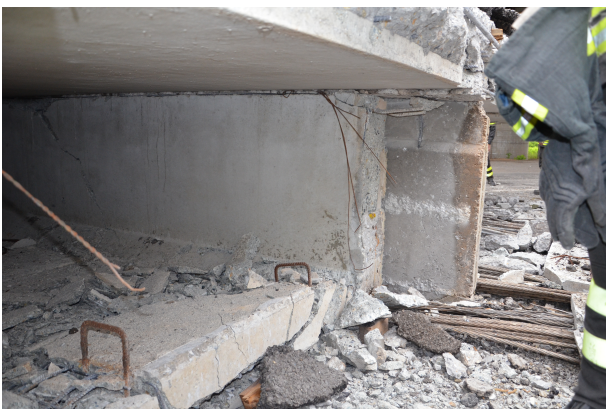
Figure 2: Collapsed joint.

Visual inspections consented to affirm that the collapse mechanism was triggered by a shear failure in one of the joint due to the absence of the equilibrating action of the prestressing. Same inspections immediately evidenced the lacking of the sufficient grout protection in the opened joint area (Figure 2). Corresponding level of cable oxidation was not compatible with such a *young* structure (20 years old) concrete

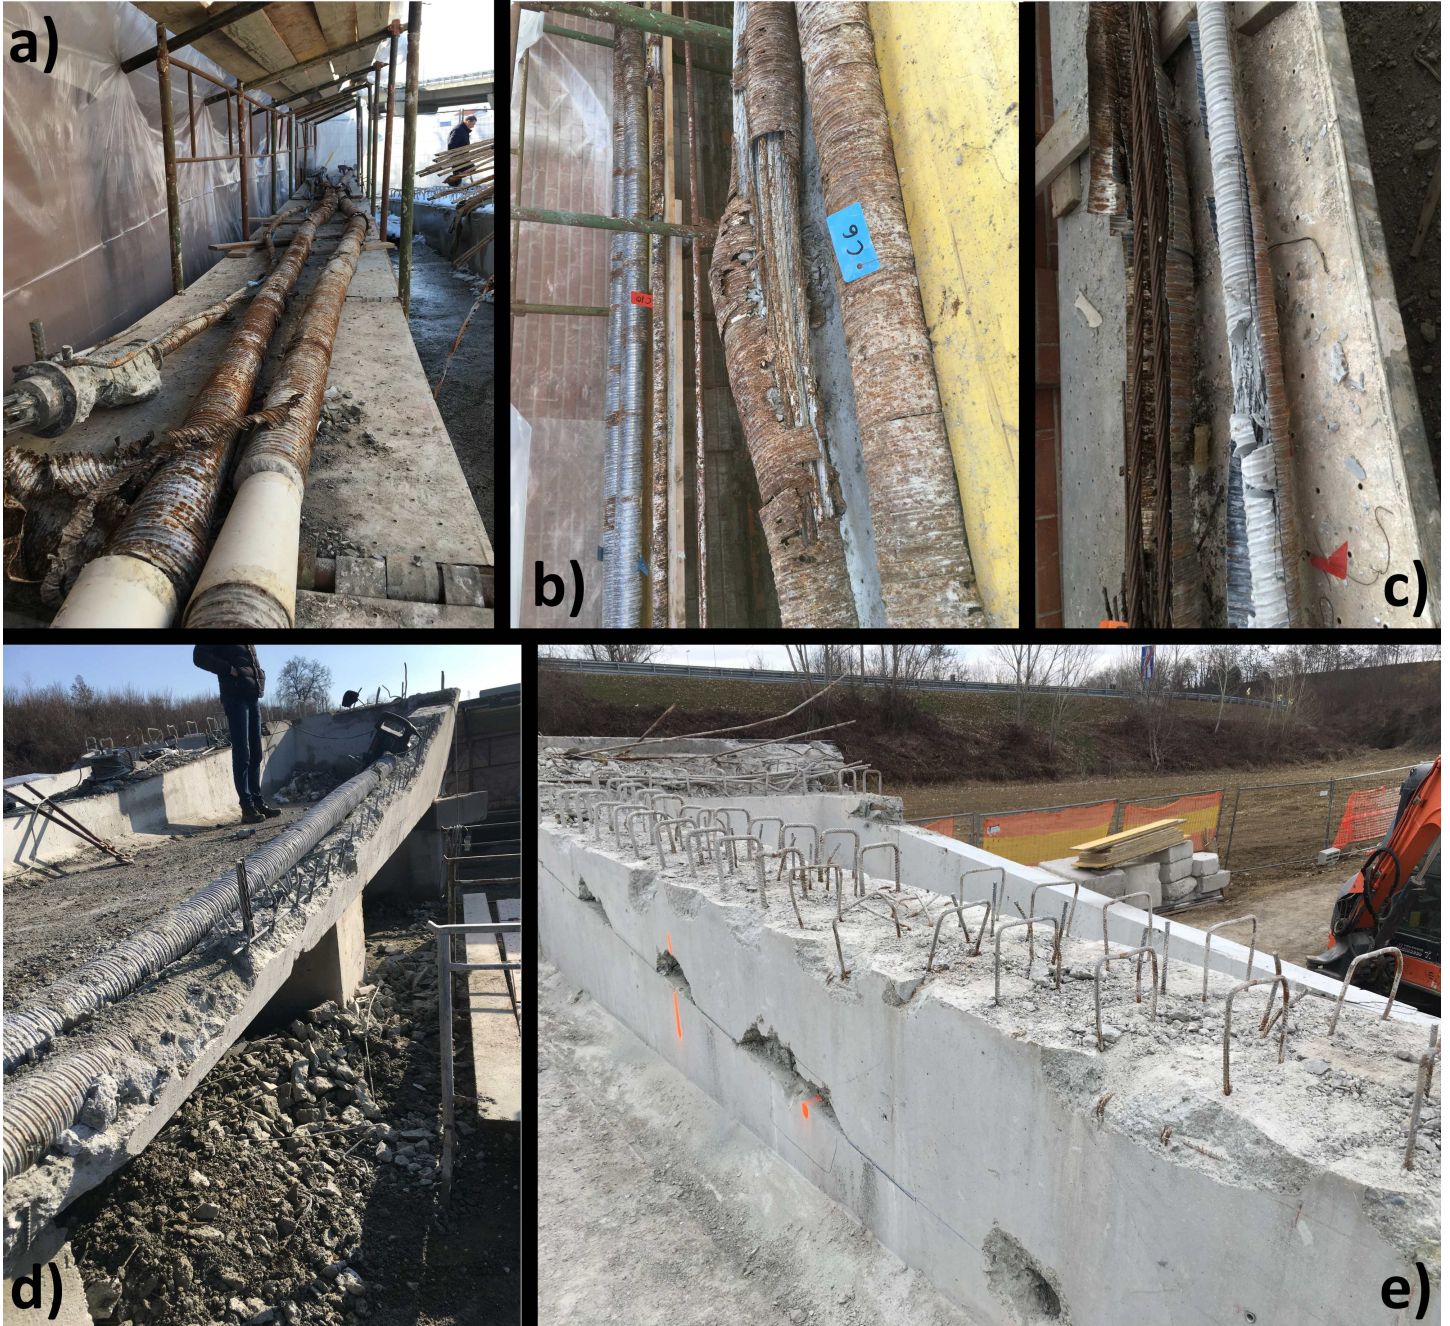
Figure 3a,b exhibits the oxidation pattern of the longitudinal trend of the cables. Compared to the smaller diameter ones (precasted inside the central segment (Figure 3c)), it can be seen how important is the protection and passivization role played by the grout to the steel. In Figure 3d, the extraction of the main lateral cables is shown from the side of the intact joint. Also in this case, state of conservation was considerably high. As a last act of the dissection, Figure 3e shows the detachment of the slab from the deck to examine the presence and the position of the connecting longitudinal stirrups.

Figure 3: a,b) oxidated cables. c) in situ casted cable. d) dissection and extraction of one of the main cables. e) extracted stirrups

- inadequate grout injection inside the cables;
- complete non-accessibility for structural inspections of the deck beams.

- stop the oxidation of the cables by injecting the sheatings and restore an high level of waterproofing;
- installing a ductile device that protect the structure from a fragile collapse due to the cobined action of flexural and shear failure at the joint section.

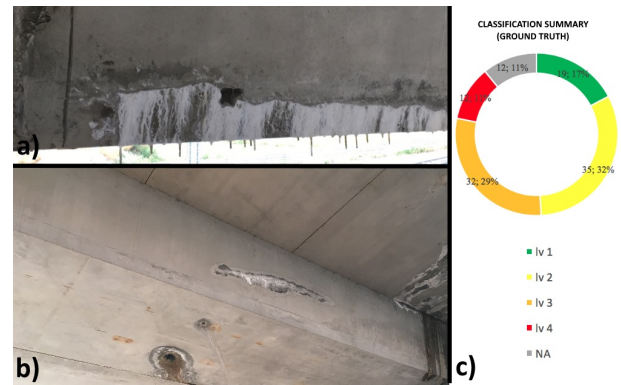
The forensic investigations evidenced a concise correlation between the external presence of a pattern of superficial stains and the expected level of damage of the cables. As evidenced in Figure 4a, crystallized matter accumulated along the cable trajectory by the absolving action affecting the grout of the infiltrated and pressurized water in the sheatings. Depending on the extension and the dimension of these superficial stains, two ascending levels of damage have been established (lv. 2 and lv. 3). A maximum level of damage (lv. 4, Figure 4b) has been created for red-brown stains along the cable trajectory, meaning that the oxidation is acting without any presence of the grout (unbonded cables). Obviously, no evident sign of degradation has been classified as level 1. Results of this preliminary classification are reported in Figure 4c. These results have been used as ground truth for the building of the image layer of a Deep Convolutional

Figure 4: a,b) lv. 3 and lv. 4 stains classification standards. c) Entire classification summary.

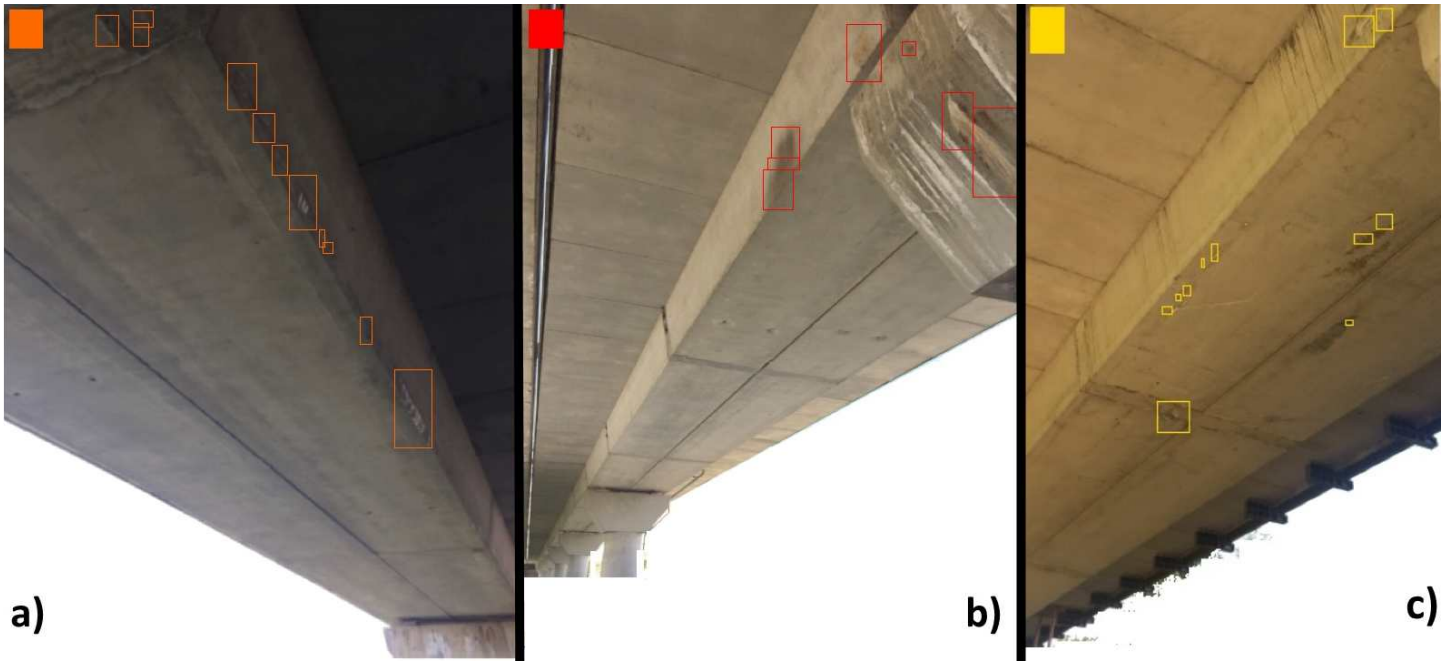
Four photographic campaigns have been carried out (tablet-based) as reported in Table ??, and every picture was geolocalized for an automatic processing. Figure 5a shows the results of the application of the DCNN on the bridge n. 48. The system correctly spotted a red stain and classified the bridge as a Lv.3. Analogously, for bridge n. 52 (Figure 5b), a Lv.4 classification has been successfully matched. Regarding instead span n. 85, classified Lv.3 manually, the DCNN detected a Lv.2. damage degree Figure 5c. To date, 73% of accuracy has been encountered, and after the second campaign no evolution from previous damage degree has been noticed. Incrementation of this accuracy is strictly dependent on the number of input data. Apart from the collecting of a larger set of images (work in progress) we are testing in the lab the possibility to create a collaborative system with a fiber optic device across the joints (Bragg's nets based).

Figure 5: a,b) lv. 3 and lv. 2 correctly classified decks. c) Incorrect lv. 2 classification.

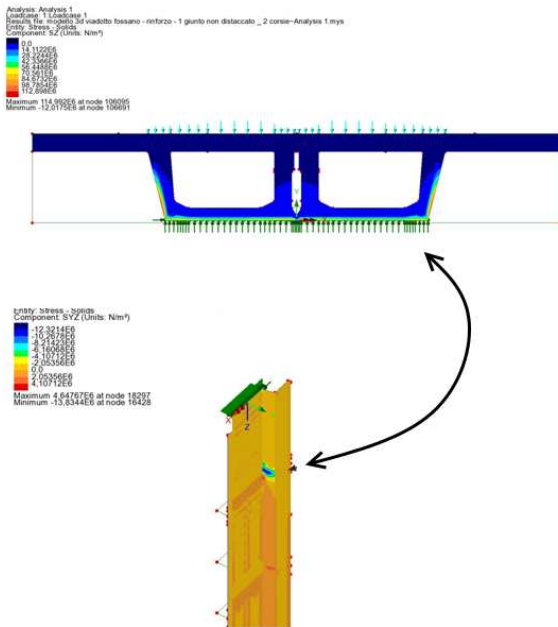
Figure 6: Numerical simulation of the steel U sleeve to attach at the deck.

While the first operation is now undergoing with epoxy resins injections and waterproofing pavement layers restorations, the second issue can be tackled only by the application of a structural component. In this case, a U steel sleeve has been designed to be attached across the joint to sustain both the shear and the flexural tensile force at the bottom. Connection has been designed with 56 M22 bolts per side. Each sleeve is designed with an embedded monitoring system for deformation to check if the prestressing force is diminishing by the progressive loading of the sleeve. Numerical simulations, i.e. reported in Figure 6, suggested that the system is able to bear the ultimate load with no operational limit state guaranteed.
