CFD simulation of multiple dust explosion occurred in a flour mill

## CFD Simulation of Multiple Dust Explosion Occurred in a Flour Mill

### 1. Case study

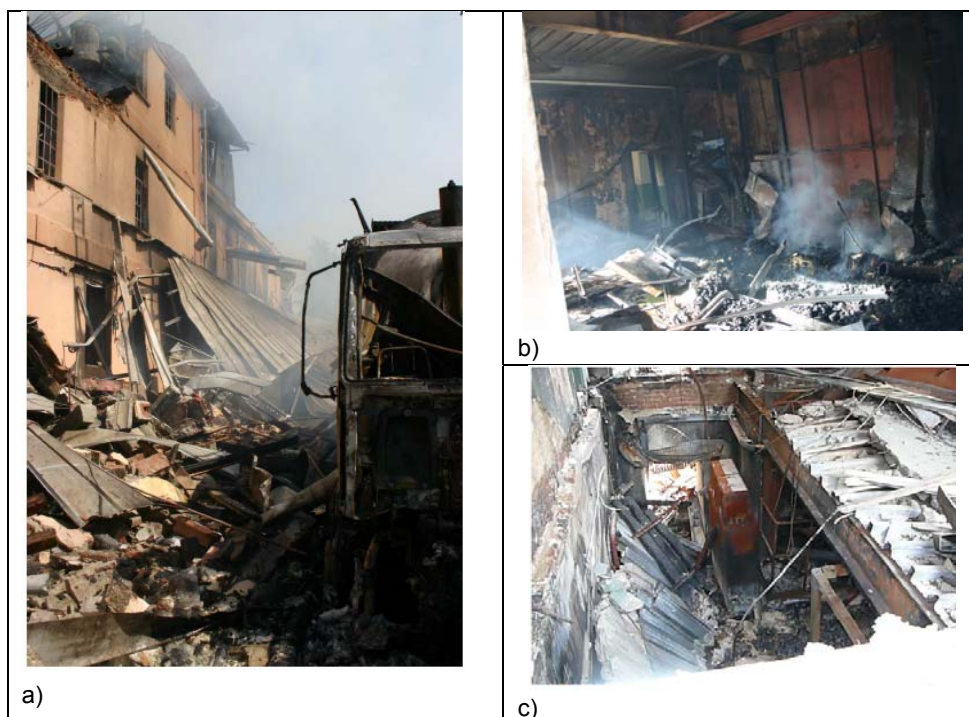
On the contrary, in the A area of the basement the walls and equipment were primary damaged by the fire, which had burned over a long period of time (Figure 2). The internal overpressure caused damage to the ceiling of A0 area as well as that of the A1 area (Figure 2). The hoist bay was destroyed by internal overpressure, while the overpressure from the hoist caused major damage to the structures on the side of the building.

The roof above north and south wings was torn away and projected at a considerable distance. Debris launch distance is much higher toward south than toward north as the rooms on the A side were certainly affected by a strong internal overpressure of intensity depending on the altitude, which caused obvious projections of the structures and debris towards the outside and upwards. On the contrary, the rooms B were mainly affected by a static collapse that has caused the collapse of the structure and the machines: in fact, most of the rubble is located within the perimeter or very short distance. All the other rooms were marginally affected by the explosion, while some, like the sacks warehouse, suffered from the long fire that followed the explosion.

Figure 2. Damage of the main building from the exterior (a) and inside the A area (b,c).
