# Engineering Reconnaissance of the 24 August 2016 Central Italy Earthquake. Version 2

Geotechnical Extreme Events Reconnaissance Association

Report No. GEER-050B

22 November 2016

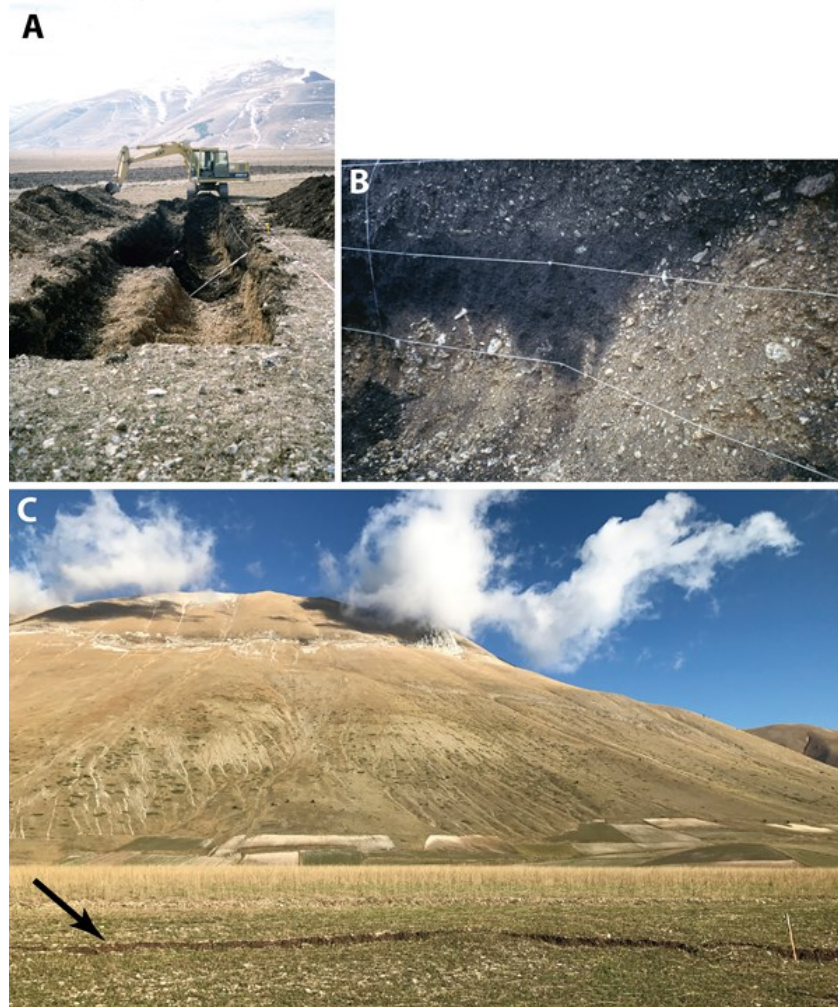
**Figure 2.3.** Castelluccio plain: a) view of one of the paleoseismological trenches excavated in 1999 by Galadini and Galli (2003); b) NW trench wall: the fault places Late Pleistocene-Holocene gravels in contact with Holocene paleosol and colluvium; c) 10-20 cm surface displacement caused by the 30 October 2016 earthquake (**M** 6.5) along the scarp trenched in 1999.

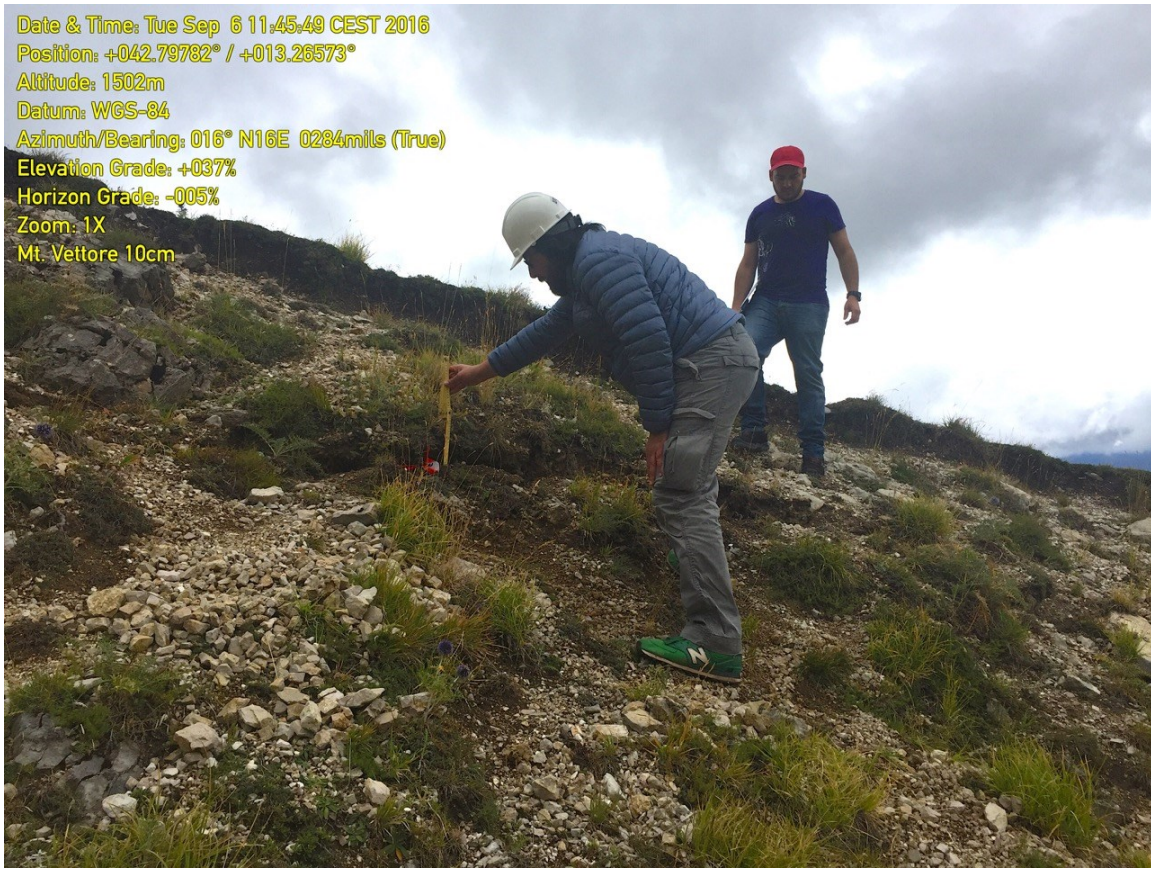
**Figure 2.19c.** Mt. Vettore fault Site 1 at a WGS84 ellipsoid elevation of 1502 m. The normal fault displacement at this site was 10 cm down toward the west (Latitude and Longitude are annotated on the image).

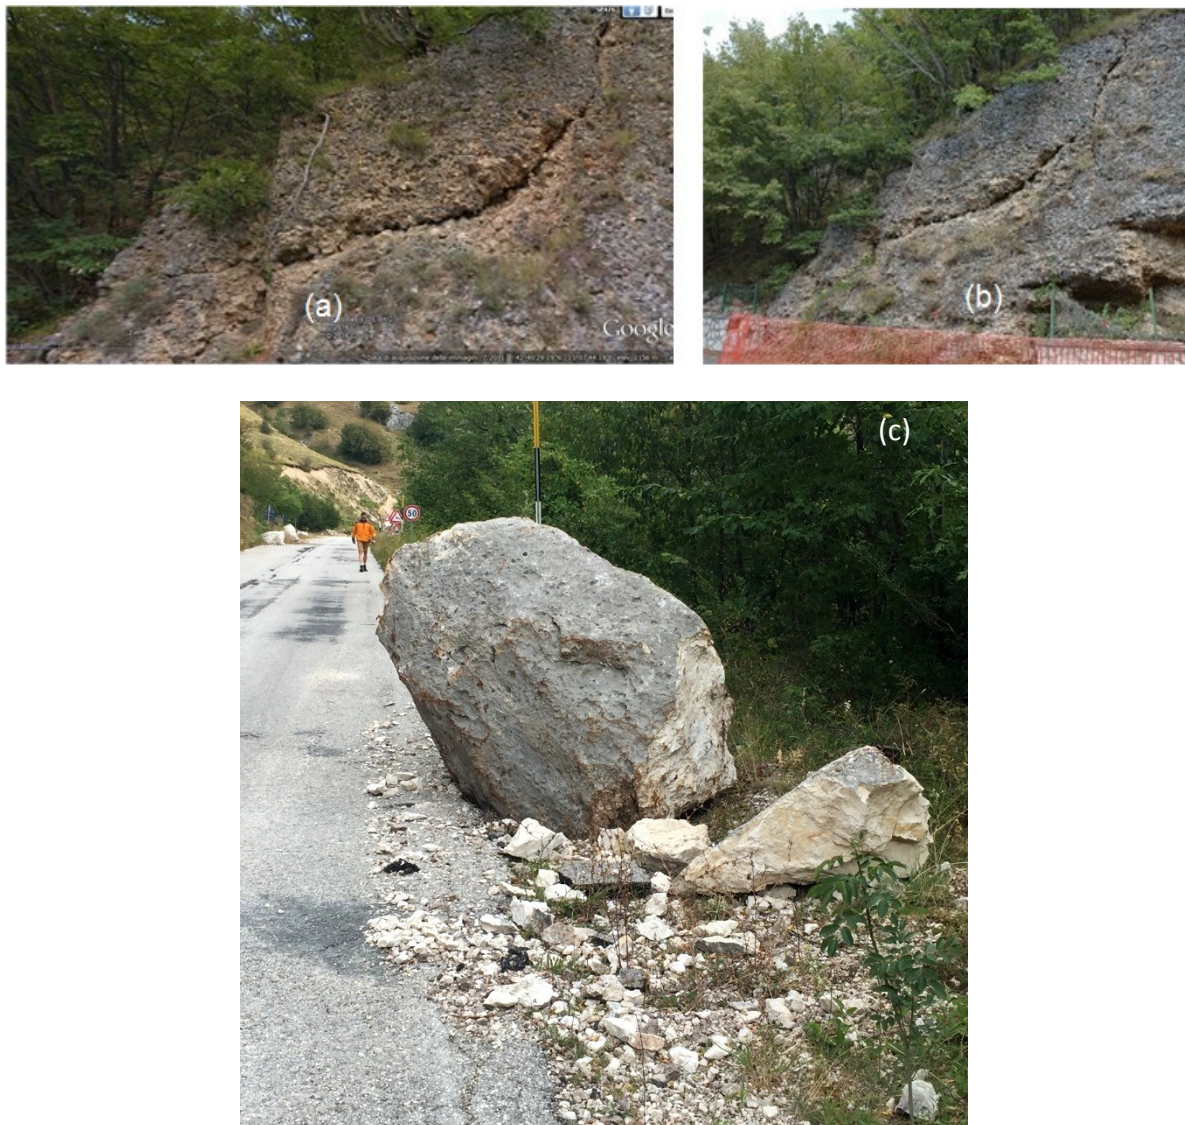
**Figure 4.17.** Large block of breccia (a) before the earthquake (image courtesy of Google 2016), (b) after the earthquake, and (c) example of rock fall below the Plano Grande on SP477. A large 2-m block of limestone crossed the road came to rest on the downslope side of the roadbed below a prominent outcrop of limestone (42.76729 N 13.16983 E).

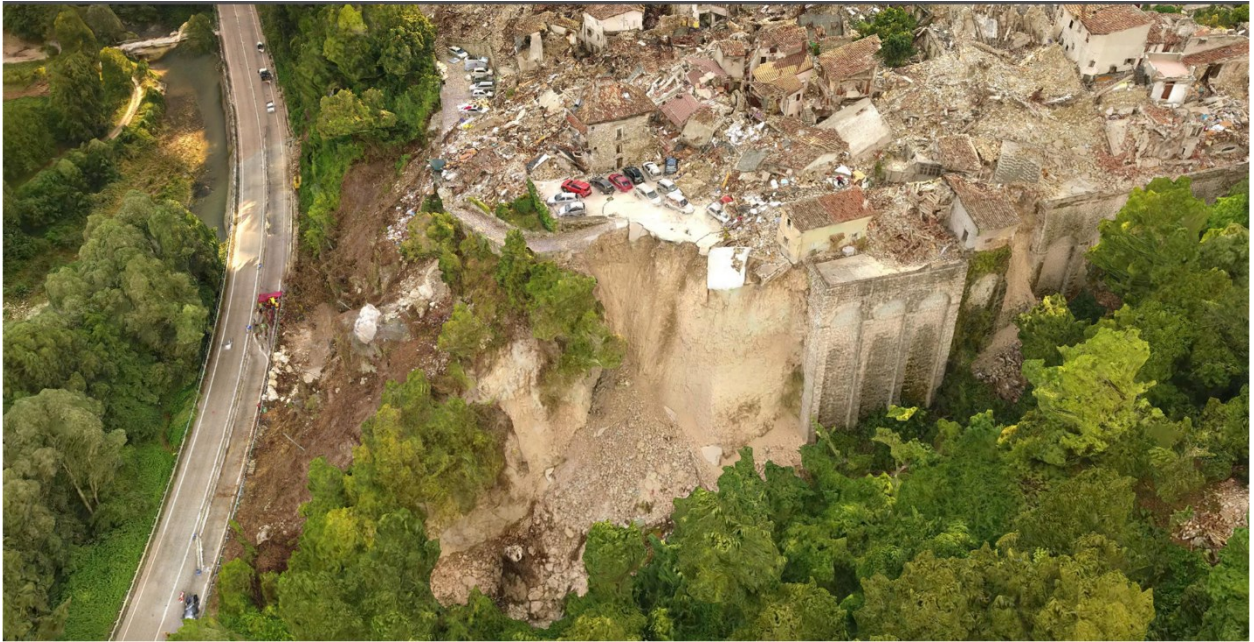
**Figure 4.30.** 3D model of a slope failure in Pescara del Tronto possibly caused by a retaining wall collapse (42.75109 N 13.27208 E).

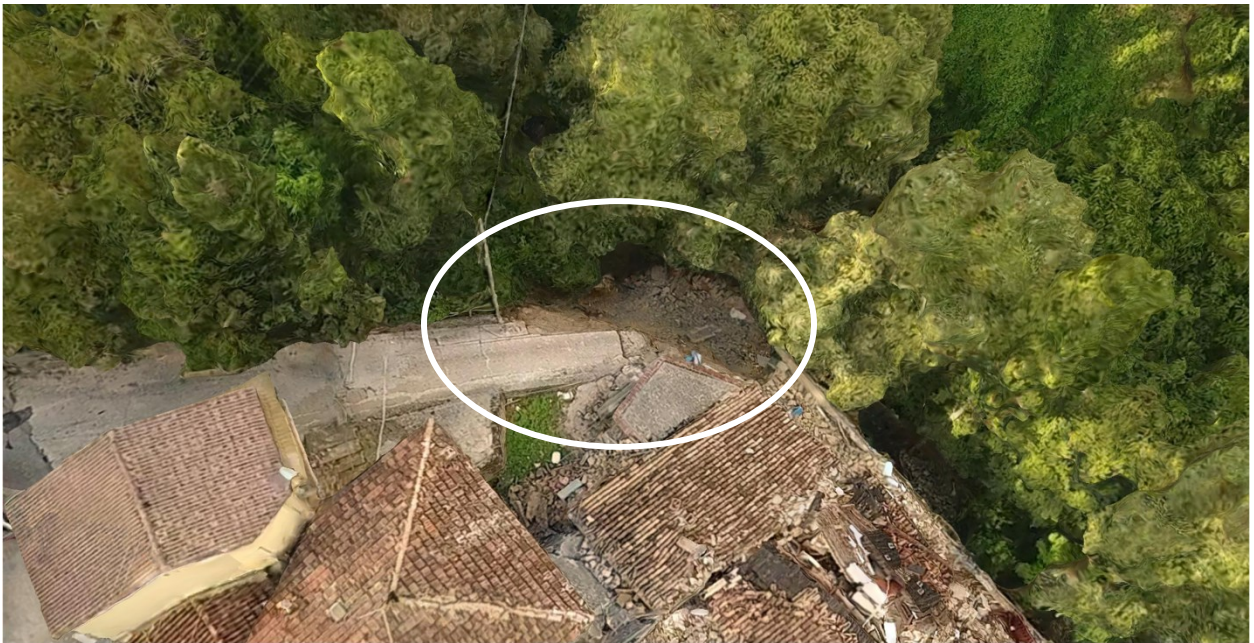
**Figure 4.33.** Model image of a landslide following a corner retaining wall failure in Pescara del Tronto (42.75166 N 13.27111 E).

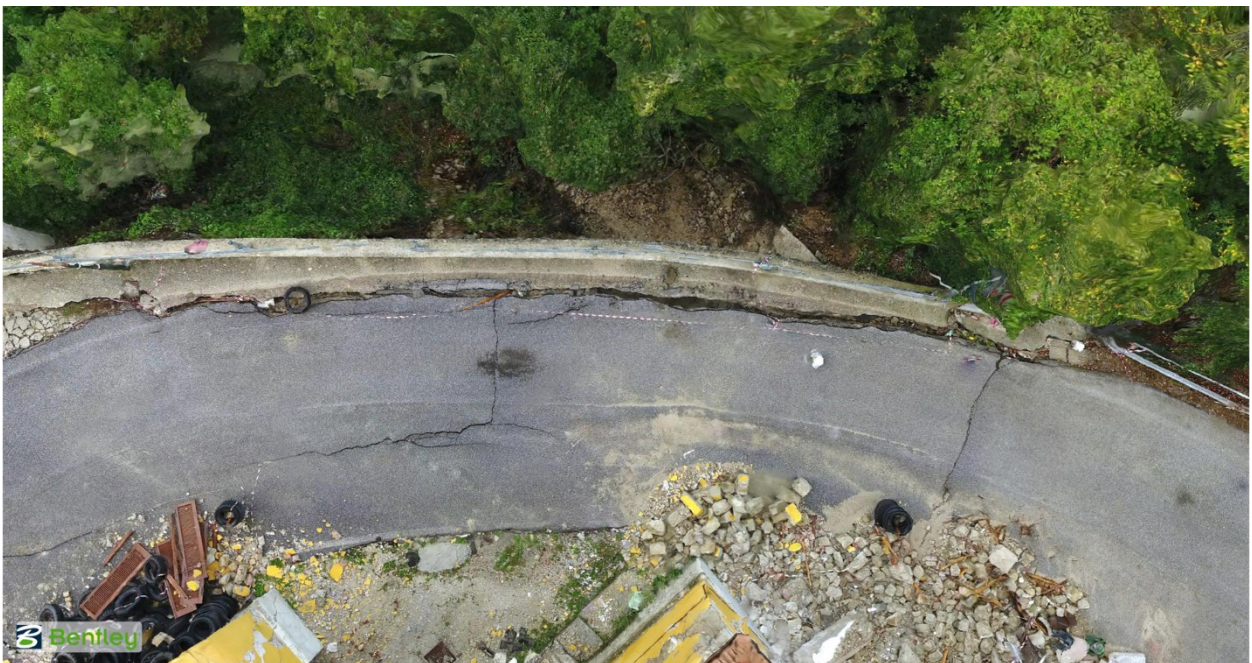
**Figure 4.44.** Rotated retaining wall below the road Frazione Fonte del Campo and subsequent cracks up to 25 cm in width (42.69438 N 13.24995 E).

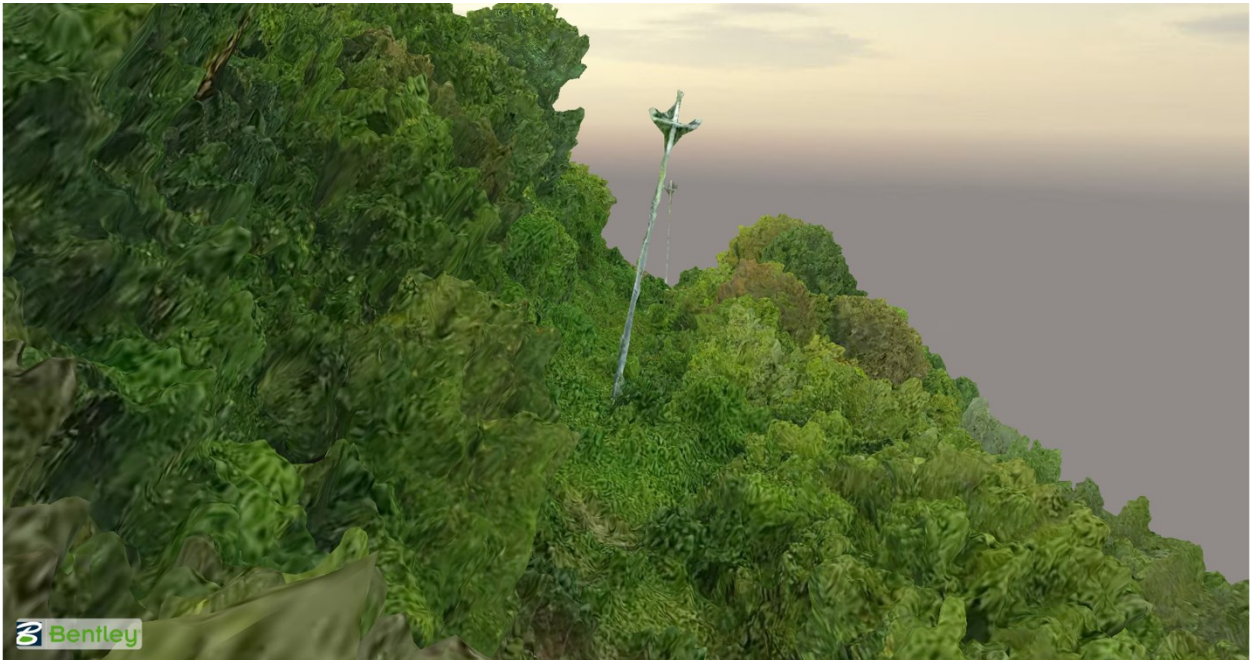
Figure 4.46. 3D model image of a rotated telephone pole in the slope below the cracks. The telephone pole is rotated 13 degrees from vertical, while the other telephone poles are approximately vertical.

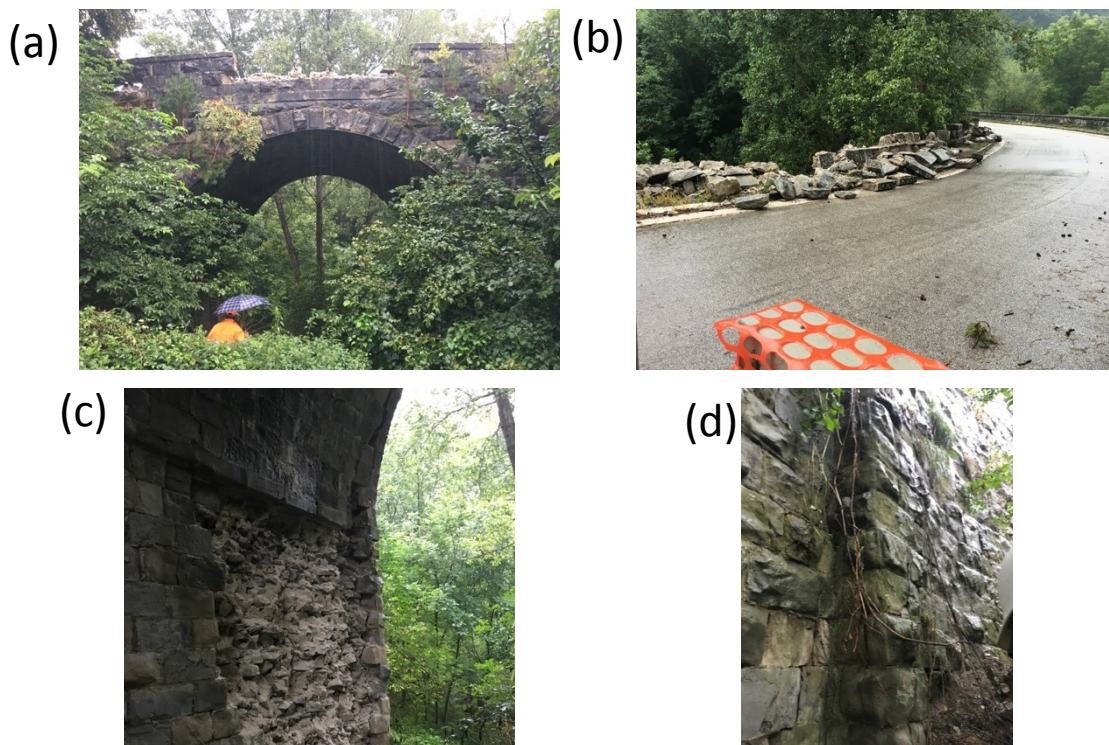
**Figure 6.8.** Central arch of the three arches masonry bridge along the Trisugo route (42.73538 deg, 13.253655 deg): partial collapse of the railing (a, b) spalling (c) and cracking (d) of some masonry elements.

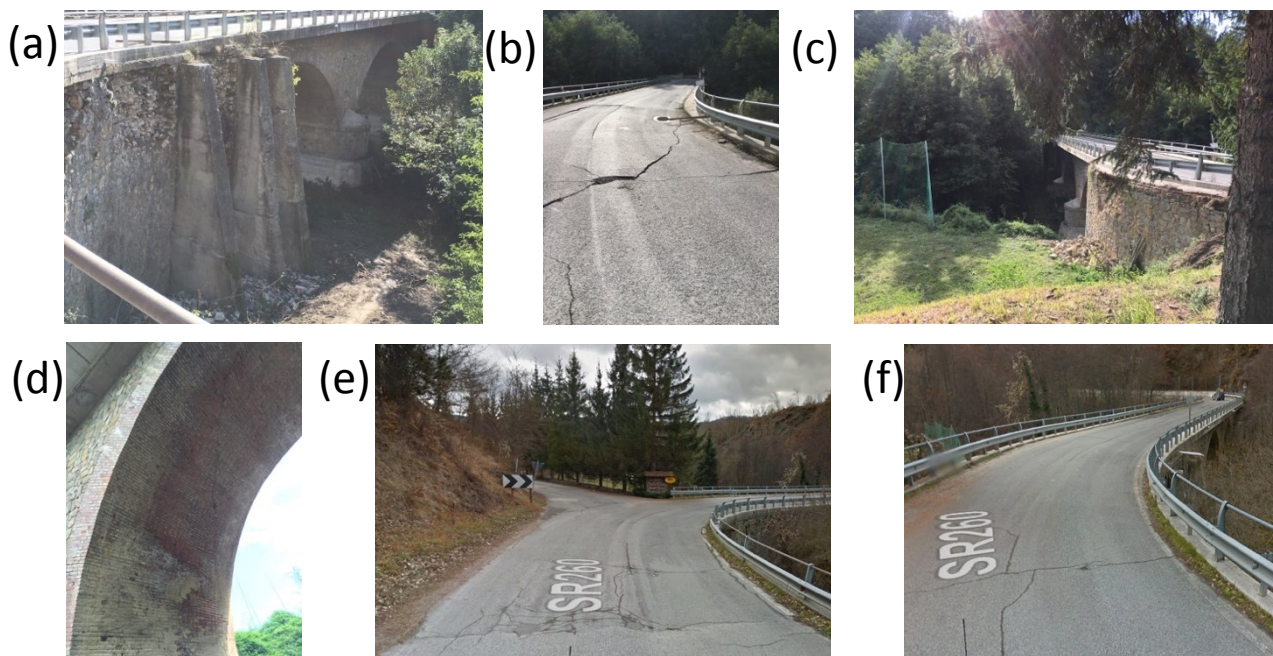
**Figure 6.9.** Ponte a Tre Occhi - Masonry bridge along the SR260 in Amatrice (42.620668 deg, 13.290176 deg): partial collapse of two side of the bridge (a, c), road settlement (b), cracks on the arch (d), pre-event cracks along the SR260 (e) and bridge-abutment connection (f) (source (e) and (f): Google maps).

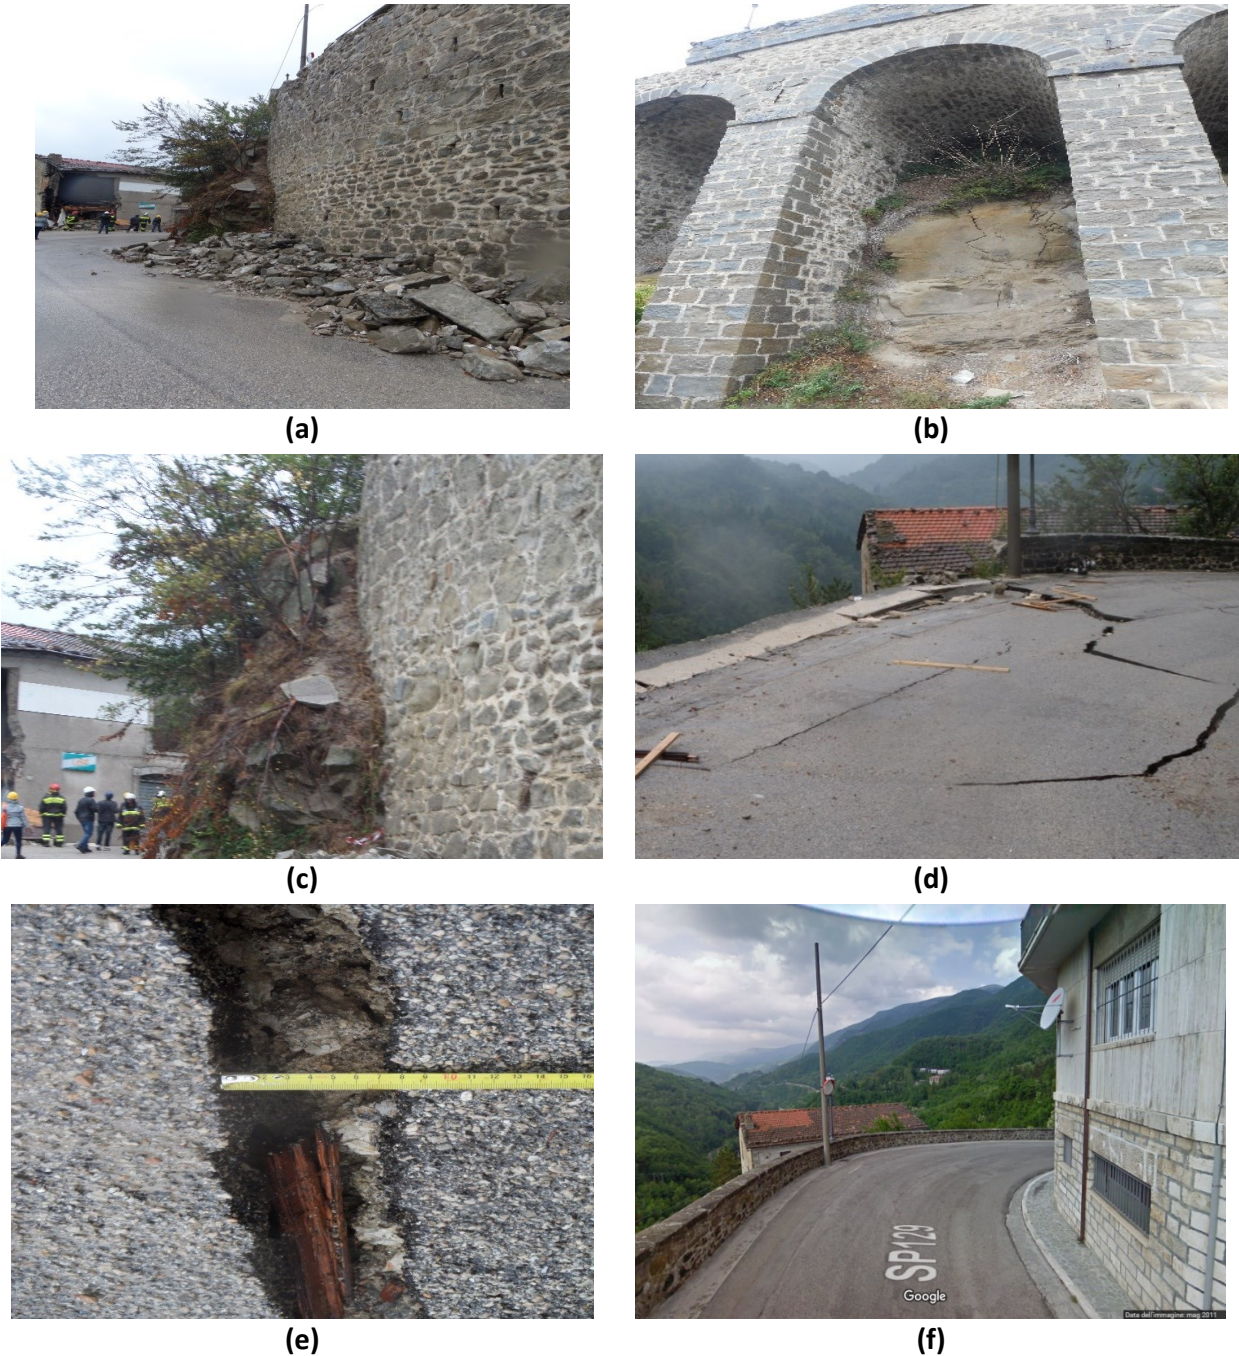
**Figure 7.4.** Masonry retaining wall in Arquata del Tronto (42.771898N, 13.296715E): (a) partial collapse of the wall parapet, (b) arch masonry structure, (c) marl blocks along the SP129 road, (d) road instability at the top of the wall, (e) opening of the cracks developing along the direction parallel to the road axis, (f) Google Earth view of the site (dated May 2011).
