Corrosion assessment of a bronze equestrian statue exposed to urban environment

The work presented in this paper deals with the characterization of the conservation state of an equestrian statue devoted to General Alfonso Ferrero della Marmora. The monument is located in a central square of Turin (Italy) and it was built up in 1891, thirteen years after the decease of the General. The monument was designed by Stanislao Grimaldi and the bronze statue was cast in Turin in the Regio Arsenale (Royal Arsenal).

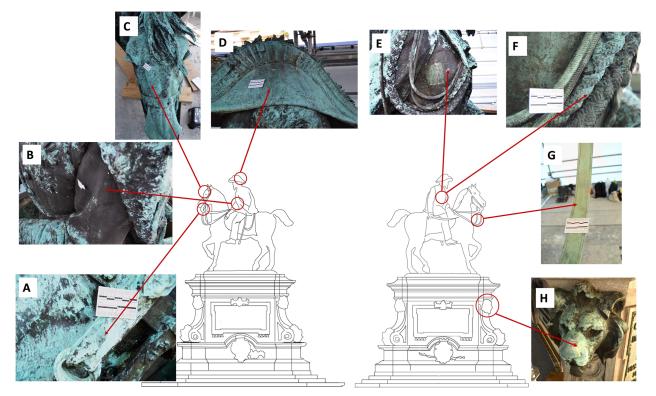
At visual inspection, the monument was characterized by the presence of patinas having different colours and aesthetical appearance, presumably corresponding to different conservation states. Colours ranged from light to dark green and some areas were covered by a blackish patina, presumably due to smog and particulate deposits. The initial survey was performed using XRF, in order to understand if the statue had been made from a single material or if different copper-based alloys were present. In some of the points, chosen considering the patina visual appearance, EIS and RS measurements were performed too, in order to have a complete characterization of the superficial layers. About 180 areas were analysed by means of XRF, and about 20 of them were also analysed using EIS and RS; the most significant ones are reported in Figure 2.

Fig. 2. Photographs of the most significant analysed areas, representative of the different colours and morphologies of the corrosion products, and their position on the statue

$10^6 \, \Omega \cdot \text{cm}^2$ at low frequencies and phase values of about -90° at high frequencies. These areas are characterized by a good protective effectiveness of the surface layers and thus by a low corrosion rate for the metal substrate (areas B and E in Figure 2). The second case, reported in Figure 4 (area G in Figure 2), is related to the areas with lower impedance module values (about $10^4 \, \Omega \cdot \text{cm}^2$) at low frequencies and phase values which remained below -50° in the whole analysed frequency range and reached a value of about -10° at low frequencies. So, these points are characterized by a higher corrosion rate (as can be deduced from the absolute impedance value) and are presumably no longer protected by any organic layer applied during the previous restorations (areas A, C, D, G, and H in Figure 2).

It is worth to notice that it was possible to correlate the impedance spectra collected in the different areas of the statue with the colour of the patina and its exposure to the environment. Actually, areas with a high impedance module had a blackish or dark brown appearance, while those with a low impedance module had a bright green appearance. Moreover, in virtually all cases, areas characterized by high impedance module were vertically oriented or in sheltered positions. On the other hand, patinas with bright green appearance were found in areas more exposed to rain washout, such as the bicorn, the horse head and the bridles. So, the formulated hypothesis was that in areas exposed to intense rain the protective layers had been washed out during the years, exposing the bronze corrosion products to the environment (this explains the lower impedance modulus). Instead, sheltered or vertically oriented areas, preserved the applied protective layers, keeping a lower corrosion rate. Actually, impedance moduli in the range of 10⁶ Ω·cm² or above are characteristic of organic coatings with high protective capability, while these values are too high to be attributed to a corrosion products layer naturally grown on the bronze surface.

The performed measuring campaign allowed the restorers to assess the quality of the intervention carried out about a decade before. Actually, even though rain washout removed part of the applied organic protective layers, critical situations could not be found, and the corrosion phenomena were under control in all areas of the monument. Chlorides-containing compounds could not be found in any of the analysed corrosion patina, further highlighting the good conservation state of the artefact. Based on these conclusions, only a soft intervention was necessary for the monument. Restorers performed a light cleaning of the entire surface of the statue by means of organic solvents to remove wax layers and then applied the new protective coating based on acrylic varnishes and microcrystalline wax.
