Corrosion assessment of a bronze equestrian statue exposed to urban environment

This paper presents the characterization of the conservation state of a bronze equestrian statue exposed outdoor, through an in-situ, multi-analytical, and non-invasive approach. The artefact under study is a bronze equestrian statue, devoted to Alfonso La Marmora, placed in an urban environment in the city of Turin. The investigation was carried out in the framework of a restoration intervention, with the principal aim of characterizing the overall conservation state of the sculpture to provide the conservators with information useful to develop a tailored restoration plan. X-ray fluorescence spectroscopy (XRF) was carried out for the identification of the elements present in the artefact alloy, showing that the statue was made using mainly two bronze alloys. Electrochemical Impedance Spectroscopy (EIS) was performed to study the corrosion mechanisms and to define the protective effectiveness of the patina present on the surfaces. Eventually, Raman spectroscopy (RS) was performed to characterize the chemistry and microstructure of the corrosion products, mainly identified as sulphates. The combination

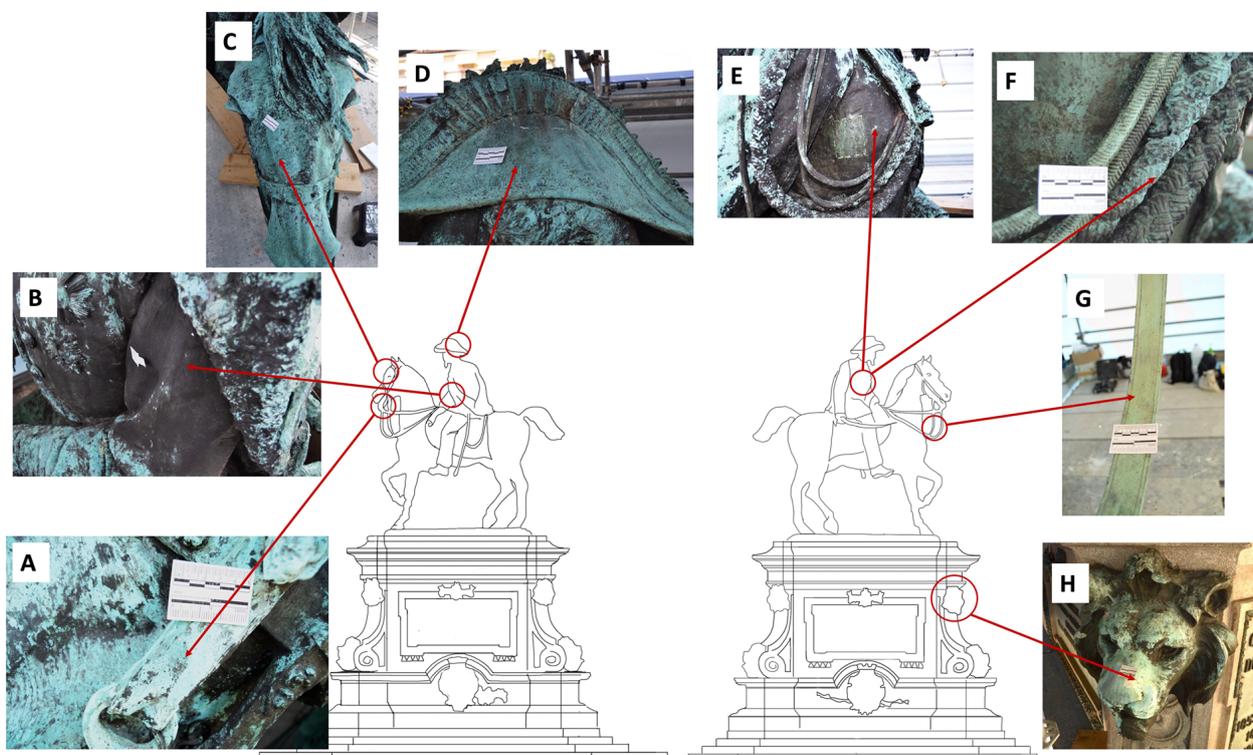
At visual inspection, the monument was characterized by the presence of patinas having different colours and aesthetical appearance, presumably corresponding to different conservation states. Colours ranged from light to dark green and some areas were covered by a blackish patina, presumably due to smog and particulate deposits. The initial survey was performed using XRF, in order to understand if the statue had been made from a single material or if different copper-based alloys were present. In some of the points, chosen considering the patina visual appearance, EIS and RS measurements were performed too, in order to have a complete characterization of the superficial layers. About 180 areas were analysed by means of XRF, and about 20 of them were also analysed using EIS and RS; the most significant ones are reported in Figure 2.

Fig. 2. Photographs of the most significant analysed areas, representative of the different colours and morphologies of the corrosion products, and their position on the statue

$10^6 \Omega \cdot \text{cm}^2$ at low frequencies and phase values of about -90° at high frequencies. These areas are characterized by a good protective effectiveness of the surface layers and thus by a low corrosion rate for the metal substrate (areas B and E in Figure 2). The second case, reported in Figure 4 (area G in Figure 2), is related to the areas with lower impedance module values (about $10^4 \Omega \cdot \text{cm}^2$) at low frequencies and phase values which remained below -50° in the whole analysed frequency range and reached a value of about -10° at low frequencies. So, these points are characterized by a higher corrosion rate (as can be deduced from the absolute impedance value) and are presumably no longer protected by any organic layer applied during the previous restorations (areas A, C, D, G, and H in Figure 2).

It is worth to notice that it was possible to correlate the impedance spectra collected in the different areas of the statue with the colour of the patina and its exposure to the environment. Actually, areas with a high impedance module had a blackish or dark brown appearance, while those with a low impedance module had a bright green appearance. Moreover, in virtually all cases, areas characterized by high impedance module were vertically oriented or in sheltered positions. On the other hand, patinas with bright green appearance were found in areas more exposed to rain washout, such as the bicorn, the horse head and the bridles. So, the formulated hypothesis was that in areas exposed to intense rain the protective layers had been washed out during the years, exposing the bronze corrosion products to the environment (this explains the lower impedance modulus). Instead, sheltered or vertically oriented areas, preserved the applied protective layers, keeping a lower corrosion rate. Actually, impedance moduli in the range of $10^6 \Omega \cdot \text{cm}^2$ or above are characteristic of organic coatings with high protective capability, while these values are too high to be attributed to a corrosion products layer naturally grown on the bronze surface.

The performed measuring campaign allowed the restorers to assess the quality of the intervention carried out about a decade before. Actually, even though rain washout removed part of the applied organic protective layers, critical situations could not be found, and the corrosion phenomena were under control in all areas of the monument. Chlorides-containing compounds could not be found in any of the analysed corrosion patina, further highlighting the good conservation state of the artefact. Based on these conclusions, only a soft intervention was necessary for the monument. Restorers performed a light cleaning of the entire surface of the statue by means of organic solvents to remove wax layers and then applied the new protective coating based on acrylic varnishes and microcrystalline wax.

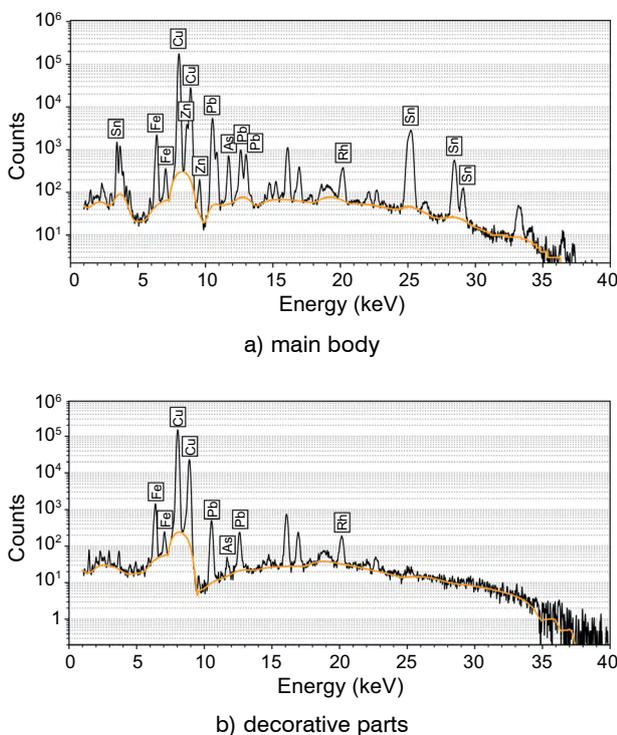
Results from XRF measurements showed that there are two main alloys used for the realization of the monument. The first one, whose characteristic XRF spectrum is reported in Figure 3a, was employed for the main body of the statue, namely for the horse and for the knight body (areas A, B, C, D, E, and H in Figure 2). The alloy is characterized by the presence of copper, tin, zinc, iron, lead, and arsenic, which are common elements in bronzes composition for artistic foundry; meanwhile rhodium characteristic lines at 20.22 keV are related to the anode material of the spectrometer. This finding is in agreement with the analyses performed during the previous restoration intervention which identified a ternary bronze constituted by copper, tin and zinc (90 wt%, 6 wt% and 4 wt%, respectively). In the 2006 campaign, the bronze composition was identified by means of EDS (Energy Dispersive X-ray Spectrometry) after a micro-sampling of the material. On the contrary, the experimental approach presented in this paper and based on XRF in-situ measurements, allowed analysing many different areas of the statue, thus highlighting the homogeneity in the alloy composition. As a matter of facts, the obtained results confirmed that the entire knight statue was made of the same bronze alloy. Moreover, it is important to underline that the discrepancies between these new data and the previous ones can be attributed to the fact that the EDS sampling was necessarily performed by

A second alloy was then identified in the decorative parts of the monument, namely the horse bridles and the decorations on the La Marmora blouse (areas F and G in Figure 2). Also this alloy is a bronze, characterized by the presence of copper, iron, lead and arsenic, as can be seen from the XRF spectrum reported in Figure 3b. PCA was also used in order to check if additional alloys could be discriminated among the acquired spectra, but only the two reported groups were identified.

Fig. 3. XRF spectra of the two alloys constituting the equestrian statue: a) main body (i.e. area C in Figure 2), b) decorative parts (i.e. area G in Figure 2) – in yellow the spectrum baseline

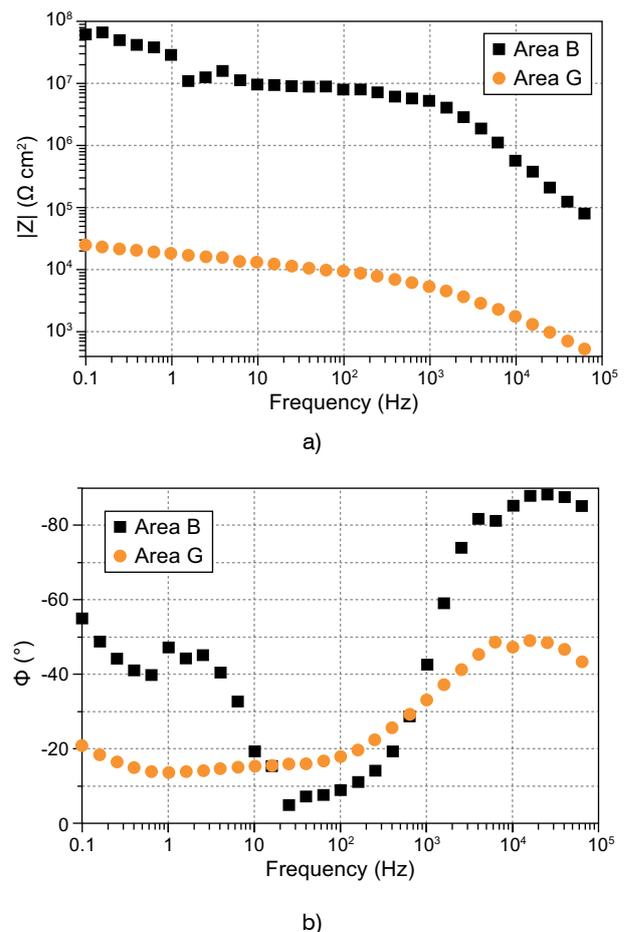
Two main cases were identified, based on the different trends in the impedance spectrum. The first one, reported in Figure 4 (area B in Figure 2), regards the areas with values of the impedance module above

Fig. 4. Impedance spectra acquired in different areas of the statue: area B – dark brown patina; area G – bright green patina (as shown in Figure 2)

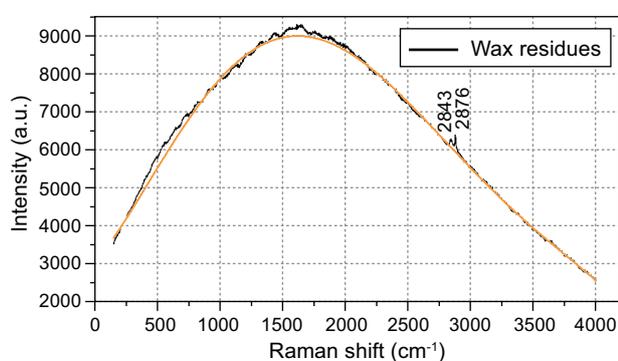
Fig. 5. Raman spectrum acquired in one of the 'blackish' areas in the statue (area E in Figure 2) – in black the acquired spectrum, in yellow the baseline (peaks, at 2843 cm^{-1} and 2876 cm^{-1} are characteristic of aliphatic chains)

In order to validate this hypothesis, RS measurements were carried out in most of the areas that were previously analysed by means of EIS. The results showed that wax residues were present in areas characterized by high impedance moduli. Actually, as can be seen from Figure 5, the Raman spectrum is composed by an intense fluorescence signal and two peaks, namely at 2843 cm^{-1} and 2876 cm^{-1} , characteristic of aliphatic chains and thus of organic material such as wax.

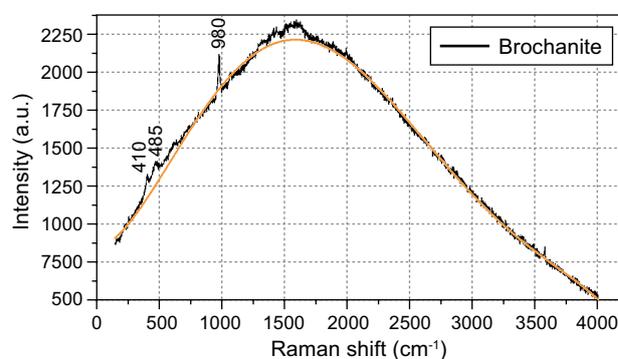
In areas with low impedance values at low frequencies, i.e. with low protective capability and bright green colour, the collected Raman spectra showed the characteristic peaks of sulphate-based corrosion products and the absence of peaks related to wax. As an example, in Figure 6 one of these spectra is shown, where the peaks at 410 cm^{-1} , 485 cm^{-1} , and 980 cm^{-1} , generally attributed to brochantite, are present [20,21]. The presence of this compound in the bronze patina is characteristic of copper alloys exposed to atmosphere in non-aggressive conditions and confirms the stable behaviour of the material as far as the corrosion processes are concerned [22].

Fig. 6. Raman spectrum, identified as brochantite (characteristic peaks at 410 cm^{-1} , 485 cm^{-1} , and 980 cm^{-1}), acquired in correspondence to the 'bright green' areas in the statue (area G in Figure 2) – in black the acquired spectrum, in yellow the baseline)
