Path of Knowledge for the Assessment of Structural Safety of the Pisan Tower of the Royal Palace of Palermo in Italy

Path of Knowledge for the Assessment of Structural Safety of the Pisan Tower of the Royal Palace of Palermo in Italy / La Mendola, L.; Accardi, M.; Agnello, F.; Monaco, A.. - In: HERITAGE. - ISSN 2571-9408. - 6:8(2023), pp. 5818-5847. [10.3390/heritage6080306]

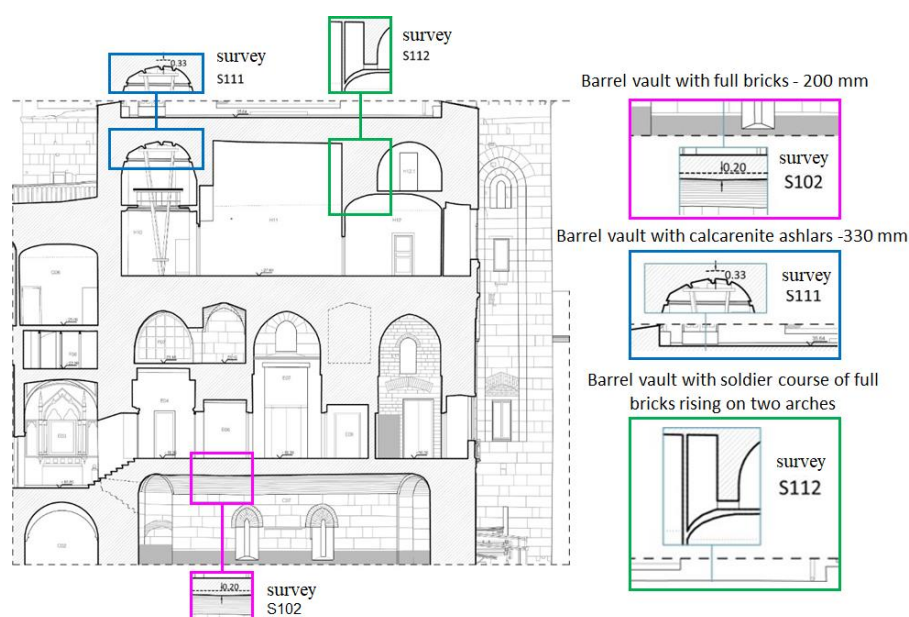
The results of these integrative surveys allowed the determination of both qualitative and quantitative data. In particular, a mostly incoherent infill was found above the vaults, in the northwest corner of the ambulatory surrounding the Treasure Room, also called the Mint Hall (sample S103), in correspondence with an edge of the interior wall of the south

tower on the same level (sample S104), and in the Director's Office on level H (samples S109 and S110). The width of the barrel vault of the ambulatory surrounding the Treasure Room (sample S102) and of the barrel vault above the Piazzzi Library (sample S111) were surveyed. Despite the latter being currently covered by plaster, the constituting material was determined to be calcarenite ashlar. Finally, the real current structural configuration of the vault on the passageway between the Piazzzi Library and the Observatory Director's Study was obtained, as it is hidden by partition walls and false ceilings. Horizontal sampling on a wall (sample S112) highlighted that the barrel vault had actually been realized with a soldier course of full bricks and that it rises on two arches: one of them is visible, while the other one is hidden by the abovementioned partition walls. Figure 13 shows the locations of samples S102, S111, and S112, which provided these results.

Figure 13. Results of endoscopic surveys S102, S111, and S112.

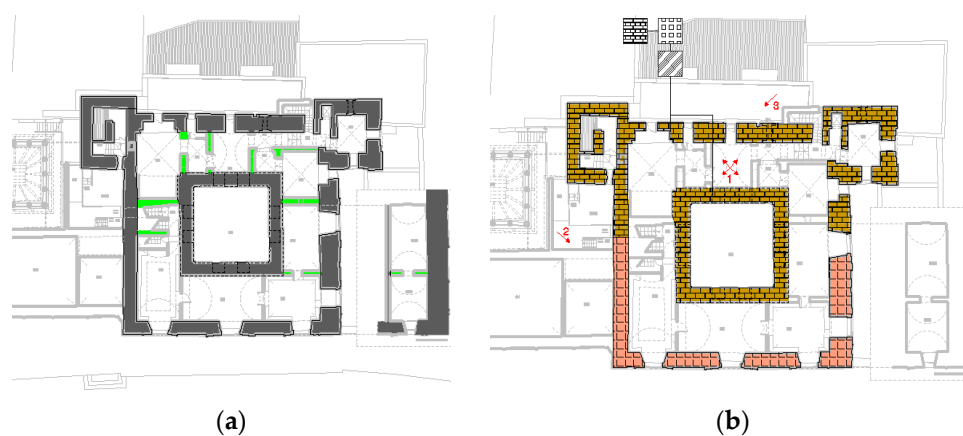
At the level of the Piazzini Library (level H), which hosts rooms of both the Astronomical Observatory and the ARS, the load-bearing structure provides the layout with concentric quadrilaterals (Figure 21a). The compactness and rigidity of the system are notably reduced by the narrow width of the walls, and by the numerous openings. As discussed in the previous paragraphs, the east side of the Tower probably represents an addition from the period of the Spanish Viceroyalty. Hence, techniques and materials differ significantly from the Norman construction (Figure 21b). This circumstance was also confirmed by the mechanical characteristics surveyed in the Spanish masonry, which was characterized by low values of compression strength as compared to those of the Norman masonry and to the suggested values for masonry walls in soft stone ashlars. These intrinsic flaws in the masonry, together with the presence of many transfer walls between the two squares in the load-bearing structure of the Tower, have certainly led to a relevant vulnerability. The effects of the 1968 earthquake and the constant and abundant infiltrations from the terrace of the upper level have produced several instability phenomena, including diffuse—and worrisome—cracks in both vertical and horizontal structural components. Following these damages, the rooms of the Observatory were shored up and made inaccessible. The cracks in the floor slabs are often extended in the walls, hence disrupting the wall structure and leading to additional vulnerability.

Figure 21. Identification of the structure of the Tower on level H (height 28.70 m): (a) hypothesized vertical load-bearing structure; (b) hypothesized materials.
