Path of Knowledge for the Assessment of Structural Safety of the Pisan Tower of the Royal Palace of Palermo in Italy

Path of Knowledge for the Assessment of Structural Safety of the Pisan Tower of the Royal Palace of Palermo in Italy / La Mendola, L.; Accardi, M.; Agnello, F.; Monaco, A.. - In: HERITAGE. - ISSN 2571-9408. - 6:8(2023), pp. 5818-5847. [10.3390/heritage6080306]

Abstract: This paper presents the path of knowledge developed for assessing the structural safety of the Norman-age Pisan Tower, which is mostly incorporated into the Royal Palace in Palermo, Italy. Historical, geomatic, and mechanical investigations were conducted and the most relevant results are herein collected and presented. The research path was addressed to specific tasks: identification of the building, geometric surveys, recognition of the sequence of phases of building transformation, detection of the components of the load-bearing structure, structural diagnostic surveys, and investigation of the subsoil and foundations. The explicit vulnerabilities found were mostly confined to the Piazza library floor, while implicit vulnerabilities were identified in the presence of false walls and in high loads

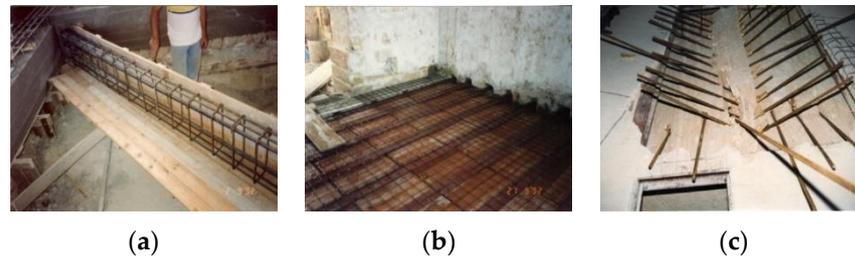
Boscarino and Cottone's intervention in the 1990s was performed after the damage due to the 1968 earthquake. In particular, the floor of the President's Room is still severely damaged, as well as the room with the Piazzini Library, which is even more damaged, with a strongly cracked vault, shored up in a currently visible safety intervention, which should have been provisional.

In 1985, almost 20 years after the earthquake, the general study realized by S. Boscarino highlighted the "...precarious conditions of most rooms, with instability phenomena on floors and roofs, and of poor roof coverings and windows..." (*Consolidamento, restauro e sistemazione dei locali dell'Osservatorio Astronomico nel Palazzo dei Normanni*, Palermo, 1985, published by the Technical Bureau of the University of Palermo, in Italian), and proposed a restoration intervention for the severe state of decay, which resulted in the "Extraordinary maintenance project for the rooms of the G.S. Vaiana Astronomical Observatory in the Norman Palace in Palermo" by A. Cottone. The intervention restored the state to that at the time of the construction of the Observatory by eliminating the partition walls that divided the gallery; only the scissors ladder differed, as it was realized anew in steel inside the residual cavity between the wall of the room and the transfer wall of 1865. The intervention involved the two floors at 37 and 40 m, respectively, which corresponded to the spring line and the roof covering of the gallery. At the level of the spring line of the gallery, two slab spans were realized externally, above the vaults, with steel profiles and hollow flooring blocks, sustained by rim joists and by a diagonal crossbeam (Figure 11a,b). On the other hand, the central vault was simply reinforced on the extrados through the insertion of metal dowels and the addition of reinforced concrete to support the reticular steel column which sustains

Figure 11. Details of the execution of the Boscarino–Cottone intervention (1990s): (a,b) photos related to the floor slab of the room on the left of the gallery, showing the diagonal crossbeam and the electro-welded mesh above hollow blocks; (c) reinforcement of the central vault for the sustainment of the steel reticular column which supports Mertz's equatorial telescope.

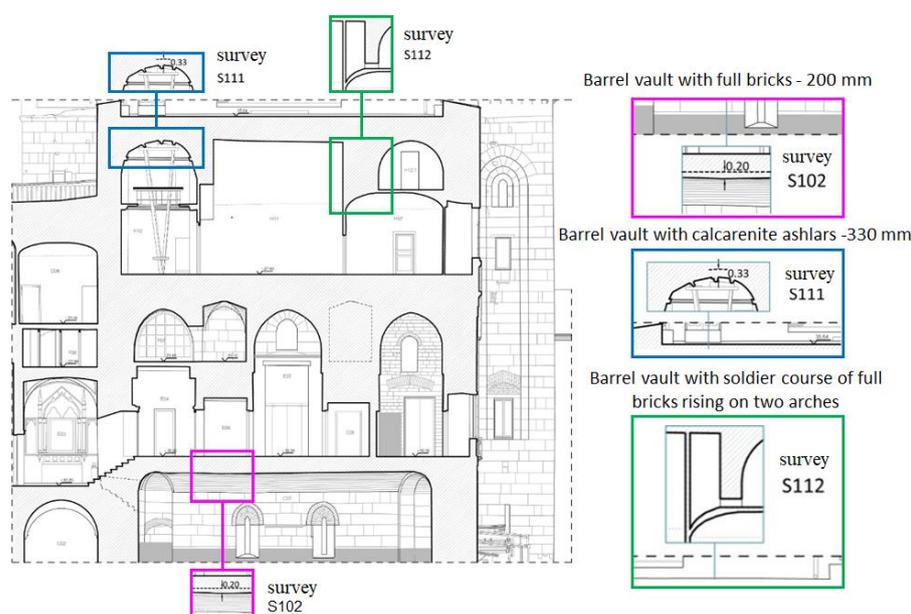
The results of these integrative surveys allowed the determination of both qualitative and quantitative data. In particular, a mostly incoherent infill was found above the vaults, in the northwest corner of the ambulatory surrounding the Treasure Room, also called the Mint Hall (sample S103), in correspondence with an edge of the interior wall of the south

tower on the same level (sample S104), and in the Director's Office on level H (samples S109 and S110). The width of the barrel vault of the ambulatory surrounding the Treasure Room (sample S102) and of the barrel vault above the Piazzini Library (sample S111) were surveyed. Despite the latter being currently covered by plaster, the constituting material was determined to be calcarenite ashlar. Finally, the real current structural configuration of the vault on the passageway between the Piazzini Library and the Observatory Director's Study was obtained, as it is hidden by partition walls and false ceilings. Horizontal sampling on a wall (sample S112) highlighted that the barrel vault had actually been realized with a soldier course of full bricks and that it rises on two arches: one of them is visible, while the other one is hidden by the abovementioned partition walls. Figure 13 shows the locations of samples S102, S111, and S112, which provided these results.

Figure 13. Results of endoscopic surveys S102, S111, and S112.

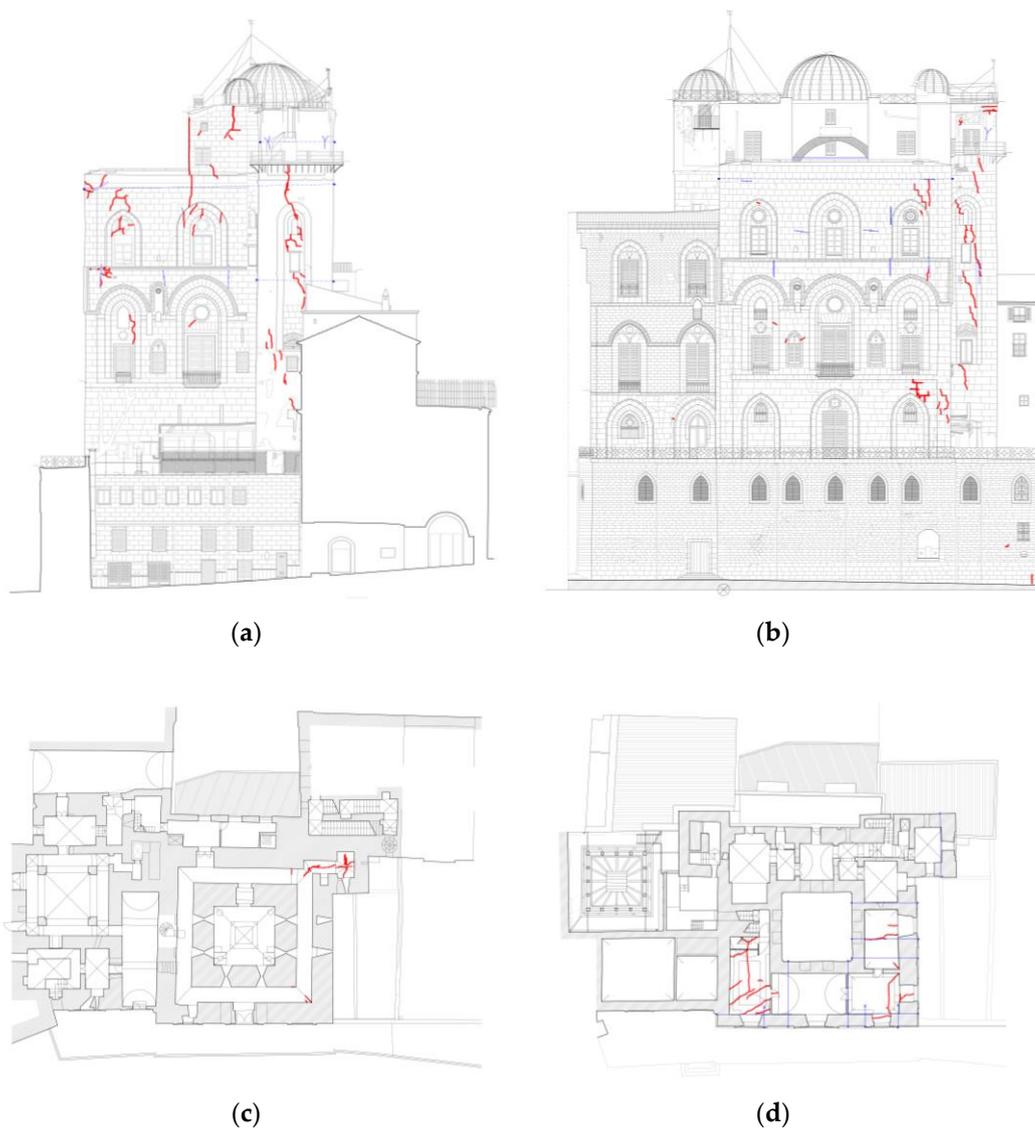
During the long life of the Royal Palace, many significant seismic events have occurred, and these have produced damage, which has been documented since 1693 [22] because of the various architectural modifications and the proximity of the Kemonia creek, which had a higher flow at that time. In particular, the Pisan Tower suffered significant damage during the 1968 earthquake, leading to the unavailability of some rooms on the level of the Observatory, with severe cracks in the vault of the Piazzini Library, which is currently still shored up for safety reasons. Comparison should be made of the current crack pattern—possibly worsened by the recent earthquake on 6 September 2002—with surveys of previous cracks; however, there was no available documentation for this purpose. Figure 14 shows some of the technical drawings by Officina per le Arti Opera, which illustrate the crack patterns.

Figure 14. Crack patterns (in red) and steel ties (in blue) (from the drawings of the Officina per le Arti Opera company): (a) on the north side; (b) on the east side; (c) on the floor plan at the height of 13.00 m; (d) on the floor plan at the height of 28.70 m.

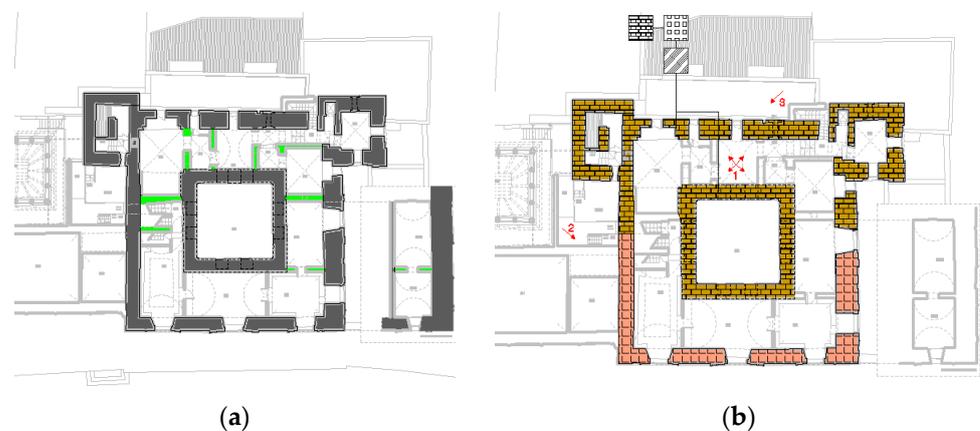
Level H (height 28.70 m) is currently the floor of the Piazzini Library, which hosts rooms of both the Astronomical Observatory and the ARS. The rooms of the Observatory, mainly used as offices and a library, were severely damaged by the 1968 earthquake; still today, they are damaged and unusable. The rooms of the ARS were involved in Valenti's intervention, which reconfigured them by also intervening on vertical and horizontal load-bearing structures. At this level, the following tests were performed: cone penetration tests on mortar, double flat-jack tests, and static and dynamic load tests. The performed tests allowed assessment of the mechanical characteristics of the materials and the operating tension. Two endoscopic tests were performed as well, to determine the width of the vault of the Piazzini Library and the width of the adjacent wall.

At the level of the Piazzini Library (level H), which hosts rooms of both the Astronomical Observatory and the ARS, the load-bearing structure provides the layout with concentric quadrilaterals (Figure 21a). The compactness and rigidity of the system are notably reduced by the narrow width of the walls, and by the numerous openings. As discussed in the previous paragraphs, the east side of the Tower probably represents an addition from the period of the Spanish Viceroyalty. Hence, techniques and materials differ significantly from the Norman construction (Figure 21b). This circumstance was also confirmed by the mechanical characteristics surveyed in the Spanish masonry, which was characterized by low values of compression strength as compared to those of the Norman masonry and to the suggested values for masonry walls in soft stone ashlars. These intrinsic flaws in the masonry, together with the presence of many transfer walls between the two squares in the load-bearing structure of the Tower, have certainly led to a relevant vulnerability. The effects of the 1968 earthquake and the constant and abundant infiltrations from the terrace of the upper level have produced several instability phenomena, including diffuse—and worrisome—cracks in both vertical and horizontal structural components. Following these damages, the rooms of the Observatory were shored up and made inaccessible. The cracks in the floor slabs are often extended in the walls, hence disrupting the wall structure and leading to additional vulnerability.

Figure 21. Identification of the structure of the Tower on level H (height 28.70 m): (a) hypothesized vertical load-bearing structure; (b) hypothesized materials.

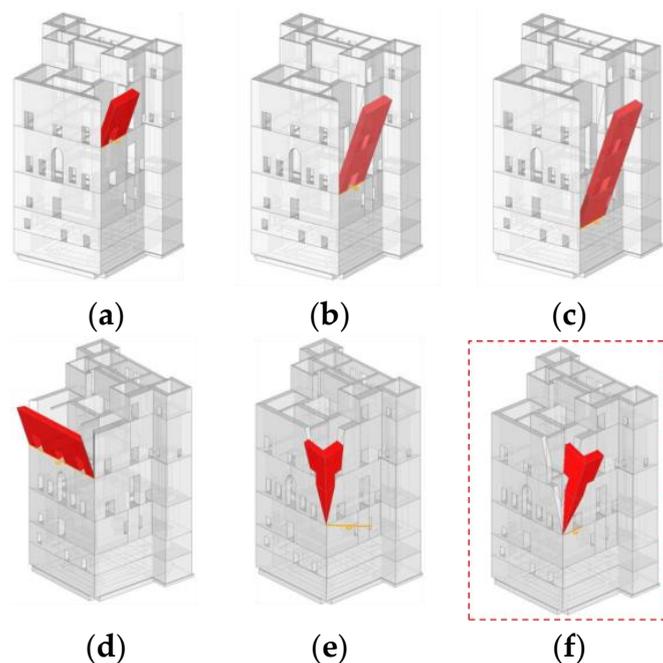
Among the vulnerabilities examined, particular attention is required for the recent rupture of the bolt and consequent unthreading of the contrasting chain of the roof vault that insists on the north-east cantonal. This may lead to a local mechanism associated with a rotation of the north wall of the Tower, the east wall, or the corner area. The parts of masonry involved in the local mechanism have been determined according to the existing crack pattern, and the mechanisms indicated in Figure 29 have been studied with a cinematic linear analysis.

Figure 29. Axonometric views of the theoretical local collapse mechanisms: (a–c) rotation of the north wall at different levels; (d) rotation of the east wall; (e) rotation of the north-east corner area; (f) most probable simple overturning of the north wall (angle $\gamma = 0$) and a portion of masonry in the east wall.

The obtained results show that the most likely failure mechanism involves the simple overturning of the north wall (angle $\gamma = 0$) and a portion of masonry in the east wall.
