Path of Knowledge for the Assessment of Structural Safety of the Pisan Tower of the Royal Palace of Palermo in Italy

# Path of Knowledge for the Assessment of Structural Safety of the Pisan Tower of the Royal Palace of Palermo in Italy

**Abstract:** This paper presents the path of knowledge developed for assessing the structural safety of the Norman-age Pisan Tower, which is mostly incorporated into the Royal Palace in Palermo, Italy. Historical, geomatic, and mechanical investigations were conducted and the most relevant results are herein collected and presented. The research path was addressed to specific tasks: identification of the building, geometric surveys, recognition of the sequence of phases of building transformation, detection of the components of the load-bearing structure, structural diagnostic surveys, and investigation of the subsoil and foundations. The explicit vulnerabilities found were mostly confined to the Piazza library floor, while implicit vulnerabilities were identified in the presence of false walls and in high loads and fillings on the vaults of the last levels. The results of the analyses allowed the individuation of the confidence factors to use in

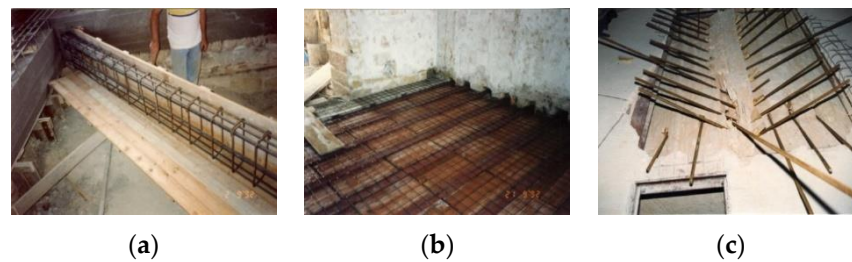
Boscarino and Cottone's intervention in the 1990s was performed after the damage due to the 1968 earthquake. In particular, the floor of the President's Room is still severely damaged, as well as the room with the Piazzesi Library, which is even more damaged, with a strongly cracked vault, shored up in a currently visible safety intervention, which should have been provisional.

In 1985, almost 20 years after the earthquake, the general study realized by S. Boscarino highlighted the "...precarious conditions of most rooms, with instability phenomena on floors and roofs, and of poor roof coverings and windows..." (*Consolidamento, restauro e sistemazione dei locali dell'Osservatorio Astronomico nel Palazzo dei Normanni*, Palermo, 1985, published by the Technical Bureau of the University of Palermo, in Italian), and proposed a restoration intervention for the severe state of decay, which resulted in the "Extraordinary maintenance project for the rooms of the G.S. Vaiana Astronomical Observatory in the Norman Palace in Palermo" by A. Cottone. The intervention restored the state to that at the time of the construction of the Observatory by eliminating the partition walls that divided the gallery; only the scissors ladder differed, as it was realized anew in steel inside the residual cavity between the wall of the room and the transfer wall of 1865. The intervention involved the two floors at 37 and 40 m, respectively, which corresponded to the spring line and the roof covering of the gallery. At the level of the spring line of the gallery, two slab spans were realized externally, above the vaults, with steel profiles and hollow flooring blocks, sustained by rim joists and by a diagonal crossbeam (Figure 11a,b). On the other hand, the central vault was simply reinforced on the extrados through the insertion of metal dowels and the addition of reinforced concrete to support the reticular steel column which sustains

**Figure 11.** Details of the execution of the Boscarino–Cottone intervention (1990s): (a,b) photos related to the floor slab of the room on the left of the gallery, showing the diagonal crossbeam and the electro-welded mesh above hollow blocks; (c) reinforcement of the central vault for the sustainment of the steel reticular column which supports Mertz's equatorial telescope.

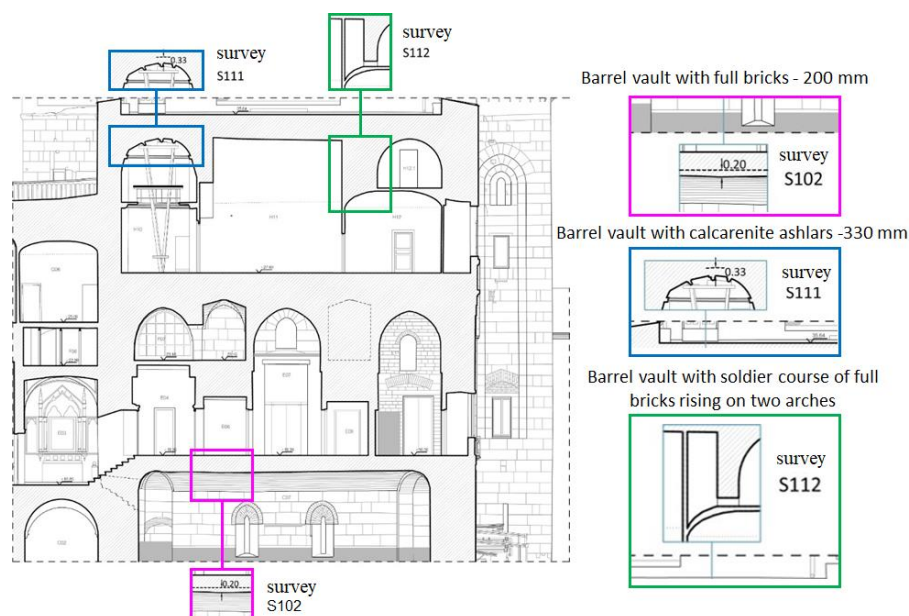
The results of these integrative surveys allowed the determination of both qualitative and quantitative data. In particular, a mostly incoherent infill was found above the vaults, in the northwest corner of the ambulatory surrounding the Treasure Room, also called the Mint Hall (sample S103), in correspondence with an edge of the interior wall of the south

tower on the same level (sample S104), and in the Director's Office on level H (samples S109 and S110). The width of the barrel vault of the ambulatory surrounding the Treasure Room (sample S102) and of the barrel vault above the Piazzzi Library (sample S111) were surveyed. Despite the latter being currently covered by plaster, the constituting material was determined to be calcarenite ashlar. Finally, the real current structural configuration of the vault on the passageway between the Piazzzi Library and the Observatory Director's Study was obtained, as it is hidden by partition walls and false ceilings. Horizontal sampling on a wall (sample S112) highlighted that the barrel vault had actually been realized with a soldier course of full bricks and that it rises on two arches: one of them is visible, while the other one is hidden by the abovementioned partition walls. Figure 13 shows the locations of samples S102, S111, and S112, which provided these results.

**Figure 13.** Results of endoscopic surveys S102, S111, and S112.

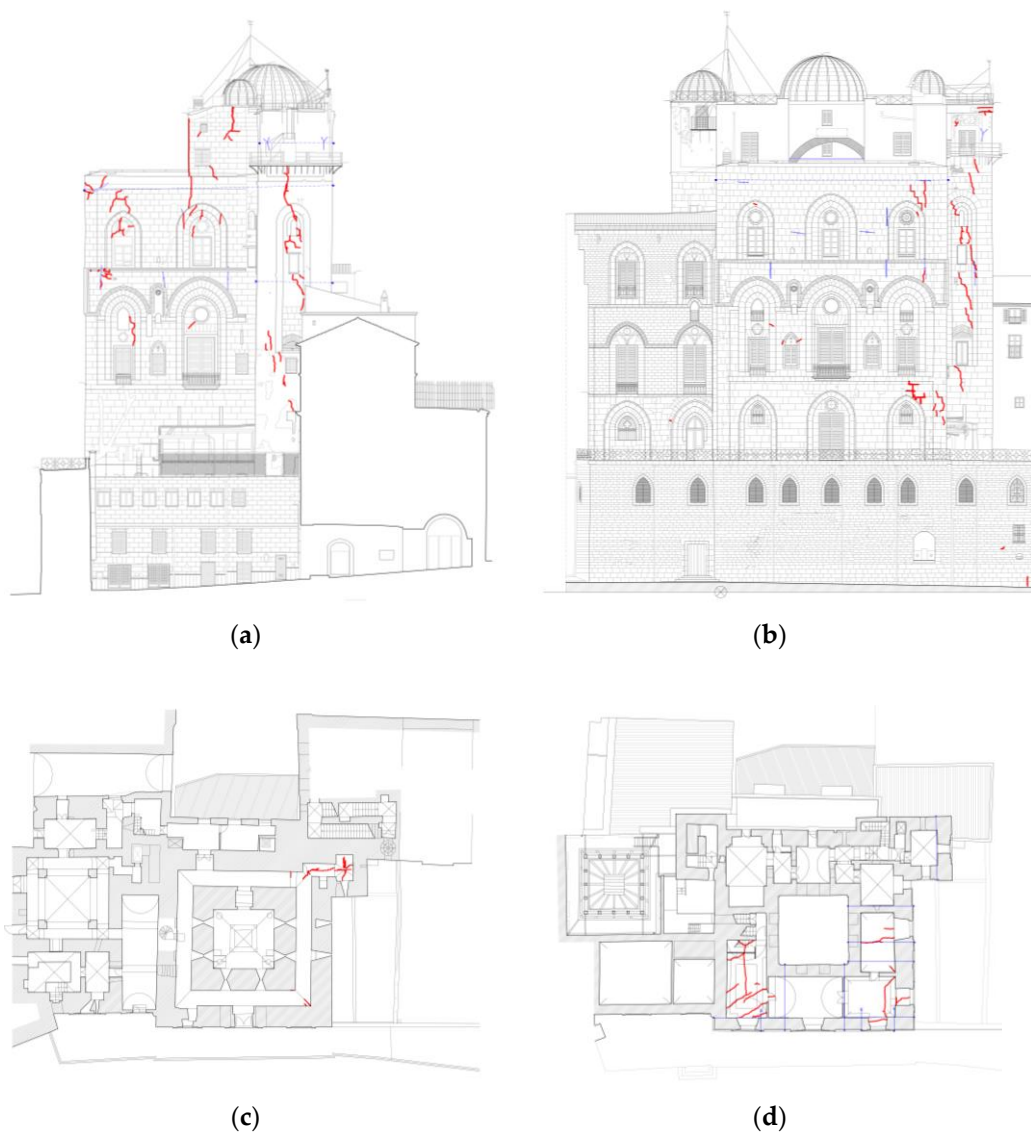
During the long life of the Royal Palace, many significant seismic events have occurred, and these have produced damage, which has been documented since 1693 [22] because of the various architectural modifications and the proximity of the Kemonia creek, which had a higher flow at that time. In particular, the Pisan Tower suffered significant damage during the 1968 earthquake, leading to the unavailability of some rooms on the level of the Observatory, with severe cracks in the vault of the Piazzzi Library, which is currently still shored up for safety reasons. Comparison should be made of the current crack pattern—possibly worsened by the recent earthquake on 6 September 2002—with surveys of previous cracks; however, there was no available documentation for this purpose. Figure 14 shows some of the technical drawings by Officina per le Arti Opera, which illustrate the crack patterns.

**Figure 14.** Crack patterns (in red) and steel ties (in blue) (from the drawings of the Officina per le Arti Opera company): (a) on the north side; (b) on the east side; (c) on the floor plan at the height of 13.00 m; (d) on the floor plan at the height of 28.70 m.

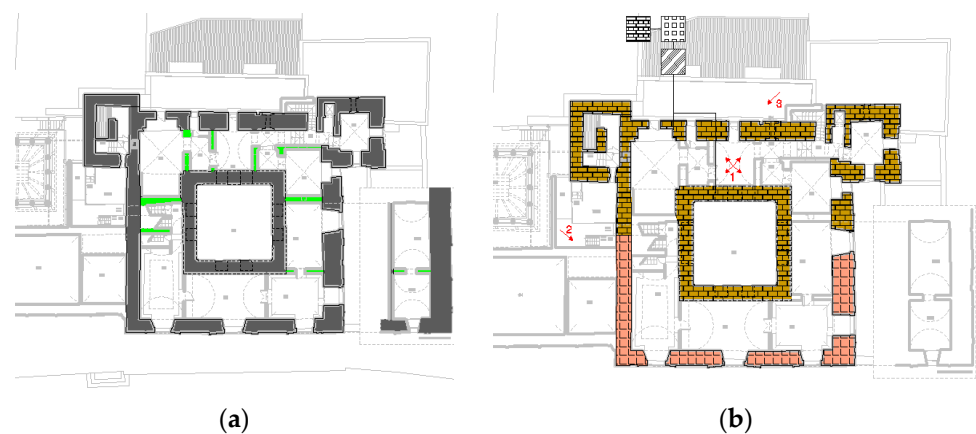
At the level of the Piazzini Library (level H), which hosts rooms of both the Astronomical Observatory and the ARS, the load-bearing structure provides the layout with concentric quadrilaterals (Figure 21a). The compactness and rigidity of the system are notably reduced by the narrow width of the walls, and by the numerous openings. As discussed in the previous paragraphs, the east side of the Tower probably represents an addition from the period of the Spanish Viceroyalty. Hence, techniques and materials differ significantly from the Norman construction (Figure 21b). This circumstance was also confirmed by the mechanical characteristics surveyed in the Spanish masonry, which was characterized by low values of compression strength as compared to those of the Norman masonry and to the suggested values for masonry walls in soft stone ashlars. These intrinsic flaws in the masonry, together with the presence of many transfer walls between the two squares in the load-bearing structure of the Tower, have certainly led to a relevant vulnerability. The effects of the 1968 earthquake and the constant and abundant infiltrations from the terrace of the upper level have produced several instability phenomena, including diffuse—and worrisome—cracks in both vertical and horizontal structural components. Following these damages, the rooms of the Observatory were shored up and made inaccessible. The cracks in the floor slabs are often extended in the walls, hence disrupting the wall structure and leading to additional vulnerability.

**Figure 21.** Identification of the structure of the Tower on level H (height 28.70 m): (a) hypothesized vertical load-bearing structure; (b) hypothesized materials.

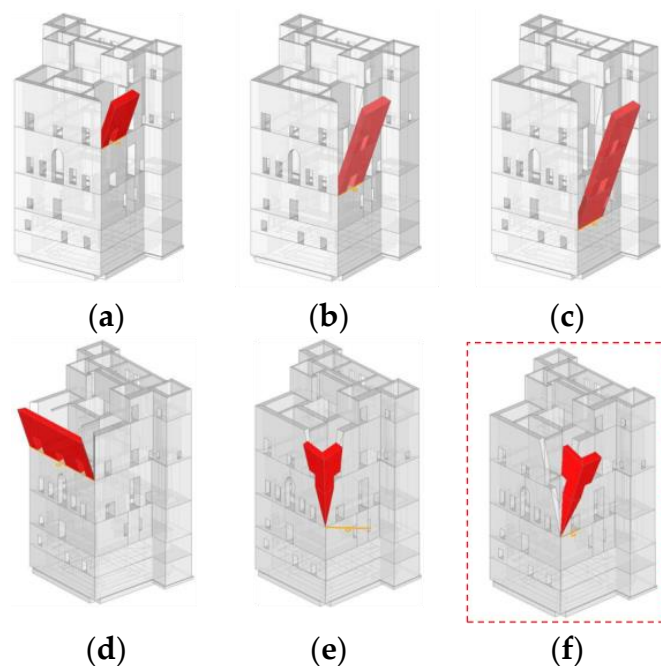
Among the vulnerabilities examined, particular attention is required for the recent rupture of the bolt and consequent unthreading of the contrasting chain of the roof vault that insists on the north-east cantonal. This may lead to a local mechanism associated with a rotation of the north wall of the Tower, the east wall, or the corner area. The parts of masonry involved in the local mechanism have been determined according to the existing crack pattern, and the mechanisms indicated in Figure 29 have been studied with a cinematic linear analysis.

**Figure 29.** Axonometric views of the theoretical local collapse mechanisms: (a–c) rotation of the north wall at different levels; (d) rotation of the east wall; (e) rotation of the north-east corner area; (f) most probable simple overturning of the north wall (angle  $\gamma = 0$ ) and a portion of masonry in the east wall.

The obtained results show that the most likely failure mechanism involves the simple overturning of the north wall (angle  $\gamma = 0$ ) and a portion of masonry in the east wall.
