Path of Knowledge for the Assessment of Structural Safety of the Pisan Tower of the Royal Palace of Palermo in Italy / La Mendola, L.; Accardi, M.; Agnello, F.; Monaco, A.. - In: HERITAGE. - ISSN 2571-9408. - 6:8(2023), pp. 5818-5847. [10.3390/heritage6080306]

Path of Knowledge for the Assessment of Structural Safety of the Pisan Tower of the Royal Palace of Palermo in Italy

Lidia La Mendola ¹, Matteo Accardi ², Fabrizio Agnello ³

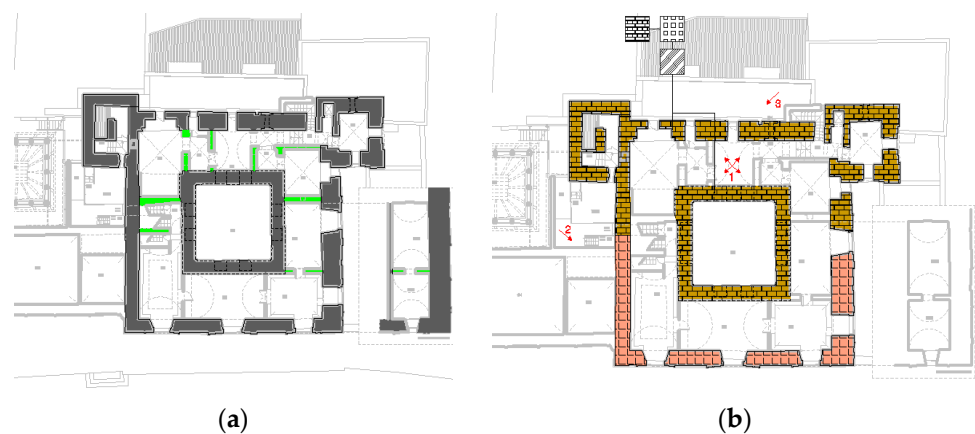
At the level of the Piazzzi Library (level H), which hosts rooms of both the Astronomical Observatory and the ARS, the load-bearing structure provides the layout with concentric quadrilaterals (Figure 21a). The compactness and rigidity of the system are notably reduced by the narrow width of the walls, and by the numerous openings. As discussed in the previous paragraphs, the east side of the Tower probably represents an addition from the period of the Spanish Viceroyalty. Hence, techniques and materials differ significantly from the Norman construction (Figure 21b). This circumstance was also confirmed by the mechanical characteristics surveyed in the Spanish masonry, which was characterized by low values of compression strength as compared to those of the Norman masonry and to the suggested values for masonry walls in soft stone ashlars. These intrinsic flaws in the masonry, together with the presence of many transfer walls between the two squares in the load-bearing structure of the Tower, have certainly led to a relevant vulnerability. The effects of the 1968 earthquake and the constant and abundant infiltrations from the terrace of the upper level have produced several instability phenomena, including diffuse—and worrisome—cracks in both vertical and horizontal structural components. Following these damages, the rooms of the Observatory were shored up and made inaccessible. The cracks in the floor slabs are often extended in the walls, hence disrupting the wall structure and leading to additional vulnerability.

Figure 21. Identification of the structure of the Tower on level H (height 28.70 m): (a) hypothesized vertical load-bearing structure; (b) hypothesized materials.
