# Path of Knowledge for the Assessment of Structural Safety of the Pisan Tower of the Royal Palace of Palermo in Italy

**Abstract:** This paper presents the path of knowledge developed for assessing the structural safety of the Norman-age Pisan Tower, which is mostly incorporated into the Royal Palace in Palermo, Italy. Historical, geomatic, and mechanical investigations were conducted and the most relevant results are herein collected and presented. The research path was addressed to specific tasks: identification of the building, geometric surveys, recognition of the sequence of phases of building transformation, detection of the components of the load-bearing structure, structural diagnostic surveys, and investigation of the subsoil and foundations. The explicit vulnerabilities found were mostly confined to the Piazza library floor, while implicit vulnerabilities were identified in the presence of false walls and in high loads and fillings on the vaults of the last levels. The results of the analyses allowed the individuation of the confidence factors to use in structural analysis models aimed at the assessment of the seismic safety of the building.

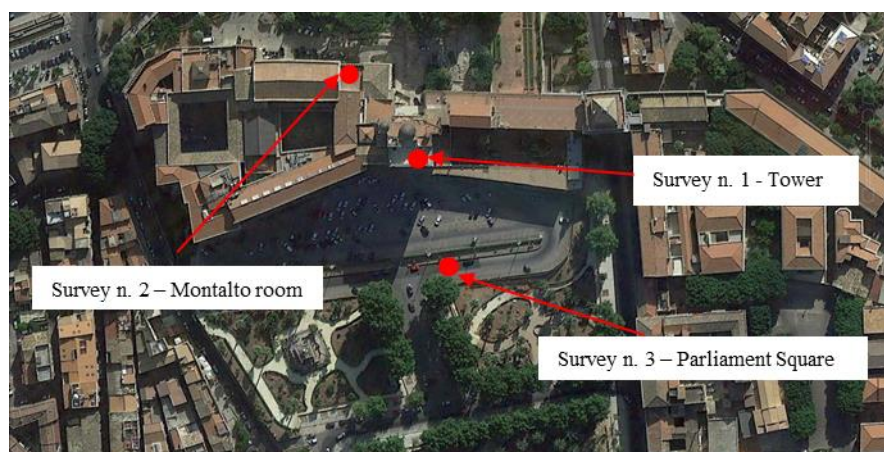
The surveys were performed at the points shown on the planimetry in Figure 27; the first one was inside the Tower at the lowest height (n. 1), the second one was outside the Tower, but at a lower height corresponding to the Montalto Room (n. 2), and the third one was in Parliament Square (n. 3), just beyond the caretaker's office at the entrance. Survey n. 1, named "Tower", obtained a value of  $V_{S,30} = 342 \text{ m/s}$  and a width of 8 m for landfill on the sandy–calcarenite complex. Survey n. 2, named "Montalto room", obtained a value of  $V_{S,30} = 345 \text{ m/s}$  and a width of 5 m for landfill on the sandy–calcarenite complex. Survey n. 3, named "Parliament Square", obtained a value of  $V_{S,30} = 352 \text{ m/s}$  and a width of 5 m for landfill on the sandy–calcarenite complex.

**Figure 27.** Planimetry with the location of the surveys.
